RV Inspection Report

Inspection Date / RV Model:
18 Apr 2024: 2022 Grand Design Reflection 367BHS

5Js RV LLC

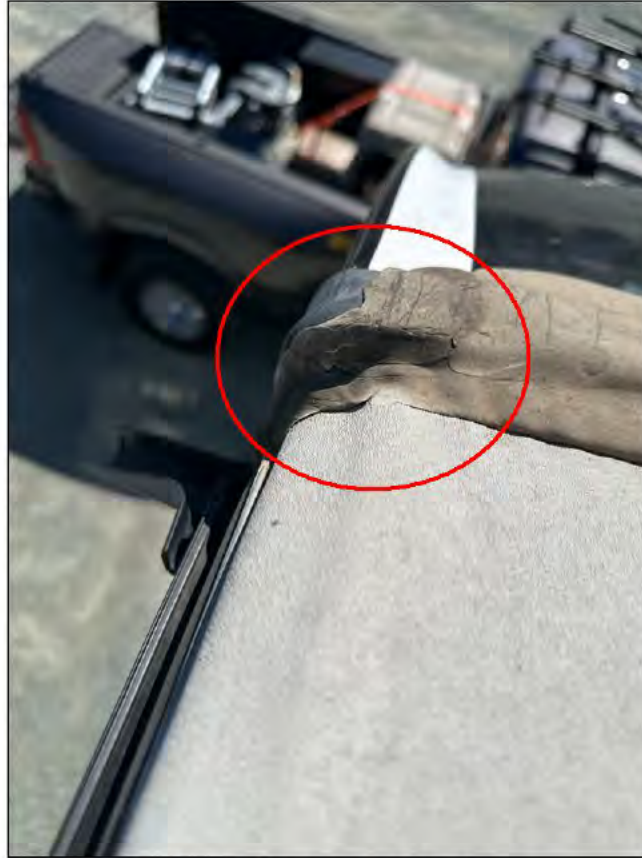
Front streetside roof seal

(1) Inspector noted gaps in sealant at the corner of the front streetside cap seal. It is recommended that a qualified RV technician repair to prevent possible future water intrusion.

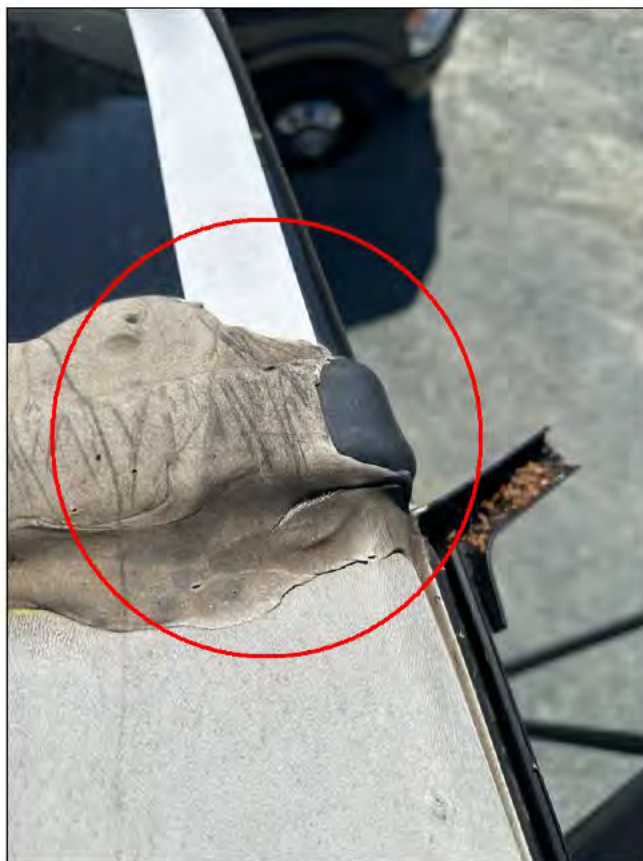
Front curbside cap seal

(2) Inspector noted gaps in sealant at the corner of the front curbside cap seal. It is recommended that a qualified RV technician repair to prevent possible future water intrusion.

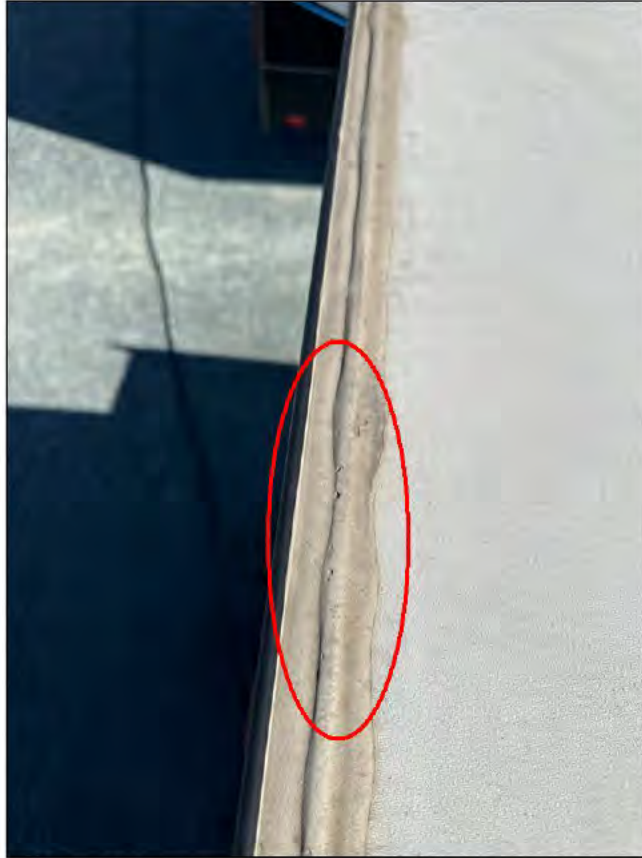
Top rear cap sealant toward middle (from top curbside)

- (2) Inspector noted gaps in sealant in the top middle of the rear cap seal. It is recommended that a qualified RV technician repair to prevent possible future water intrusion.

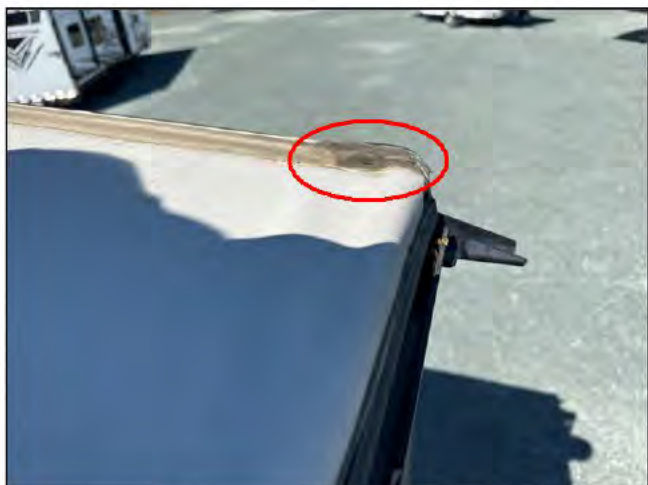
Top streetside rear cap corner seal (from front)

- (3) Inspector noted gaps in sealant at the top corner of the rear streetside cap seal. It is recommended that a qualified RV technician repair to prevent possible future water intrusion.

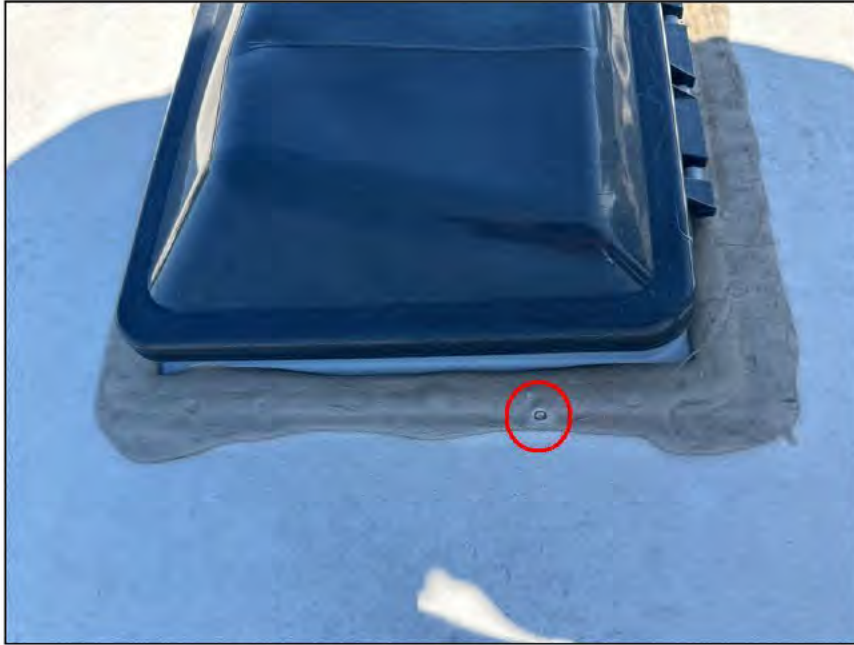
Curbside of front manual vent

- (1) Inspector noted hole/gap in sealant on the curbside of the front manual vent. It is recommended that a qualified RV technician repair to prevent possible future water intrusion.

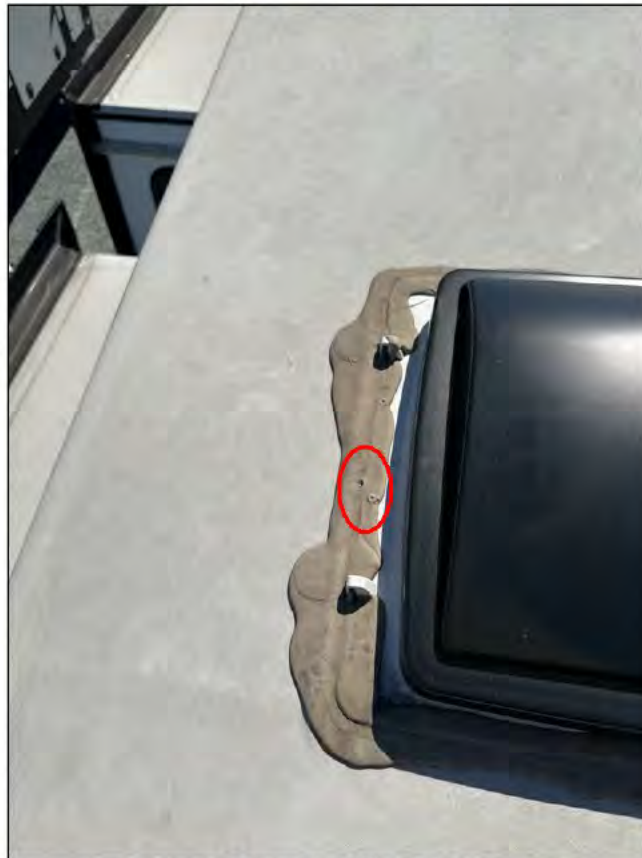
Rear manual vent (from rear streetside)

- (2) Inspector noted hole/gap in sealant on the streetside of the rear manual vent. It is recommended that a qualified RV technician repair to prevent possible future water intrusion.

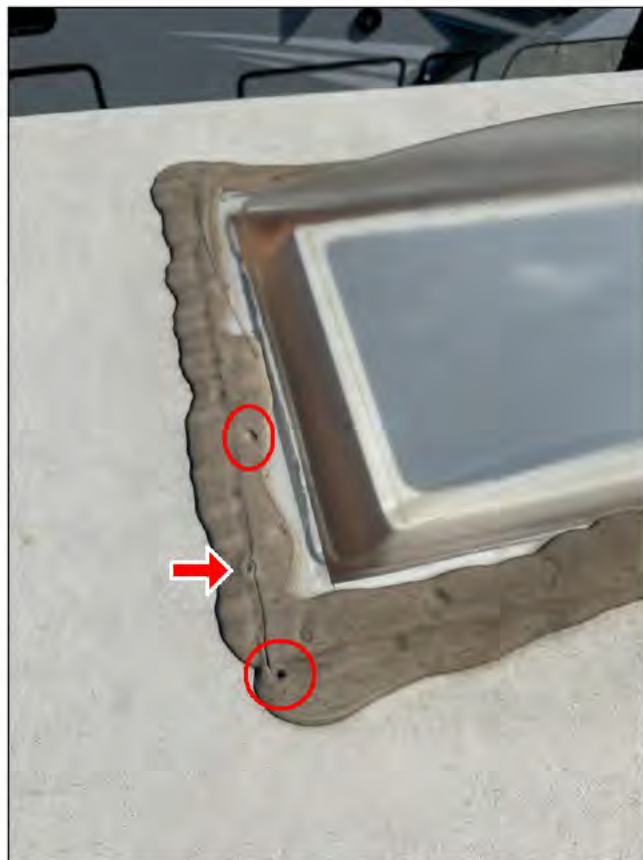
Streetside skylight from rear curbside corner

- Inspector noted holes/gaps in sealant on the rear edge of the streetside skylight. It is recommended that a qualified RV technician repair to prevent possible future water intrusion.

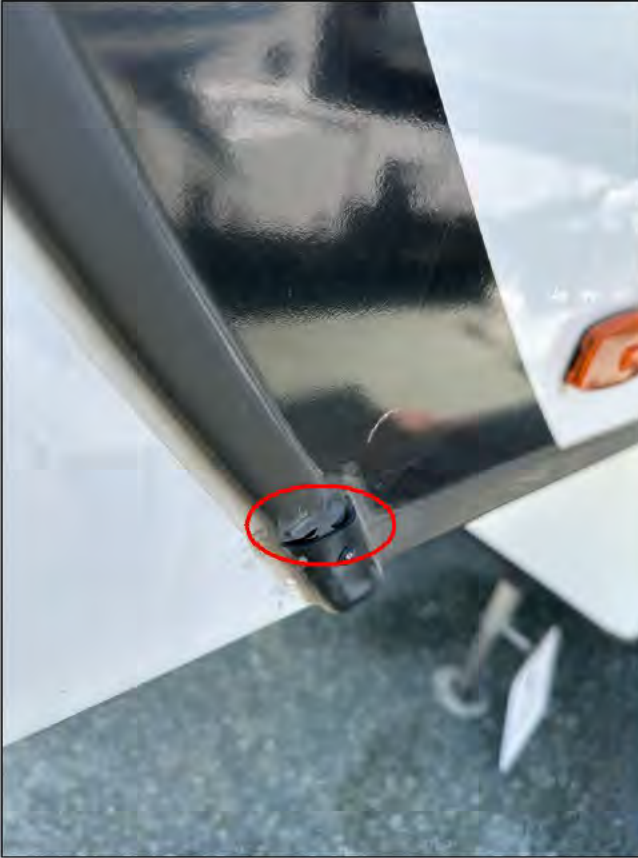
Streetside Front Cap Bottom Corner (from Front, Top Down)

- (2) Inspector noted gaps in sealant along the streetside front cap seam, including the bottom front corner and the upper rear edge. It is recommended that a qualified RV technician repair to prevent possible future water intrusion.

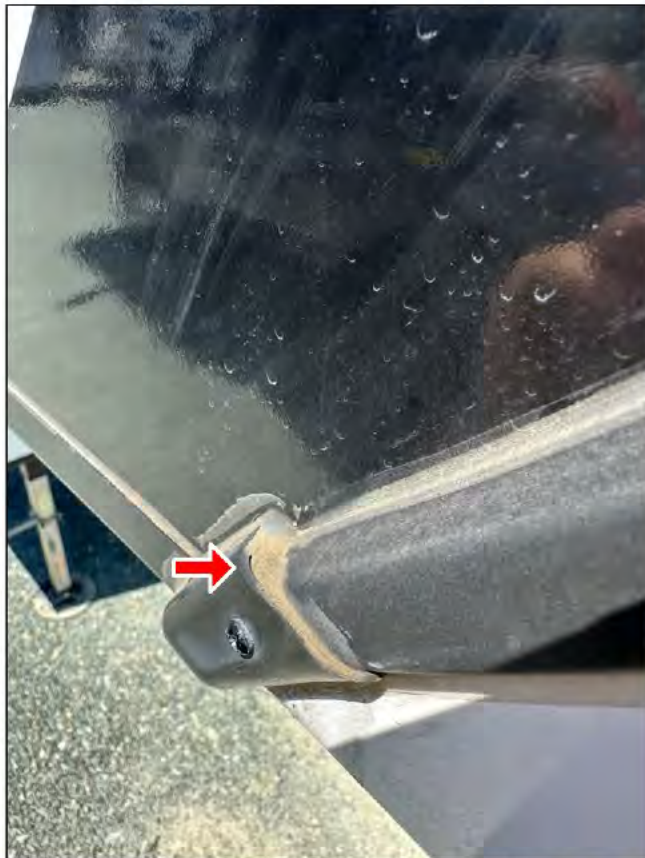
Curbside Front Cap Bottom Corner (Top Down)

- 🔧 (3) Inspector noted gaps in sealant along the curbside front cap seam at the bottom front corner. It is recommended that a qualified RV technician repair to prevent possible future water intrusion.

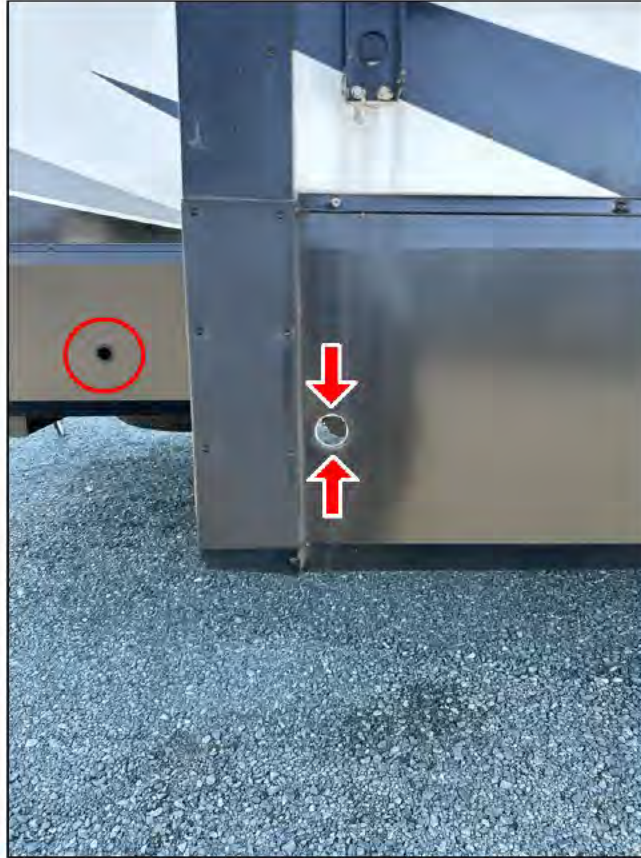
Curbside Slide (Rear Bottom)

- (1) Inspector noted that a grommet is missing from the curbside slide rear bottom. (Compare with the hole visible in the photo further to the rear--the red circle.)

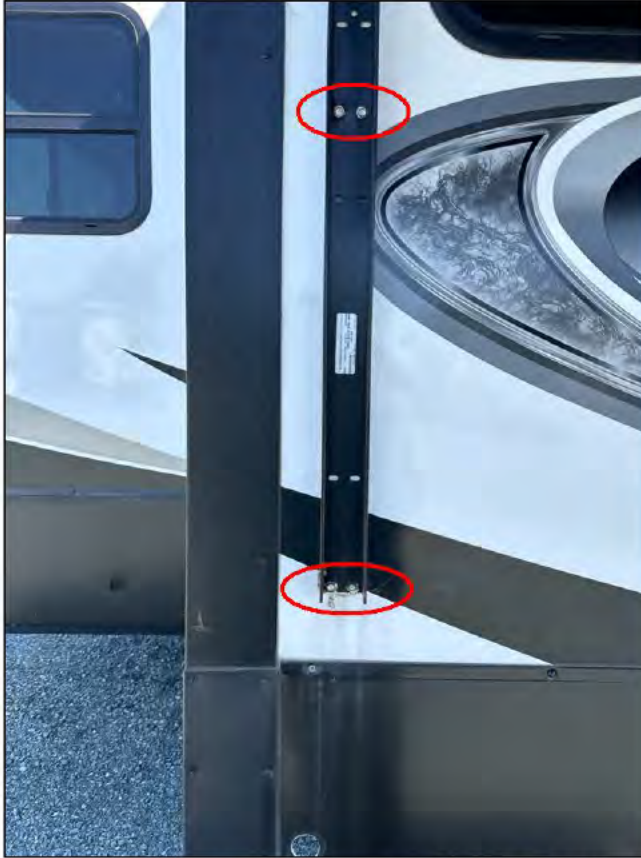
Bottom Rear Awning Arm on Curbside Slide

(2) Inspector noted that all the screws holding the curbside awnings do not have sealant over the top of them. It is recommended that a qualified RV technician repair to prevent possible future water intrusion.

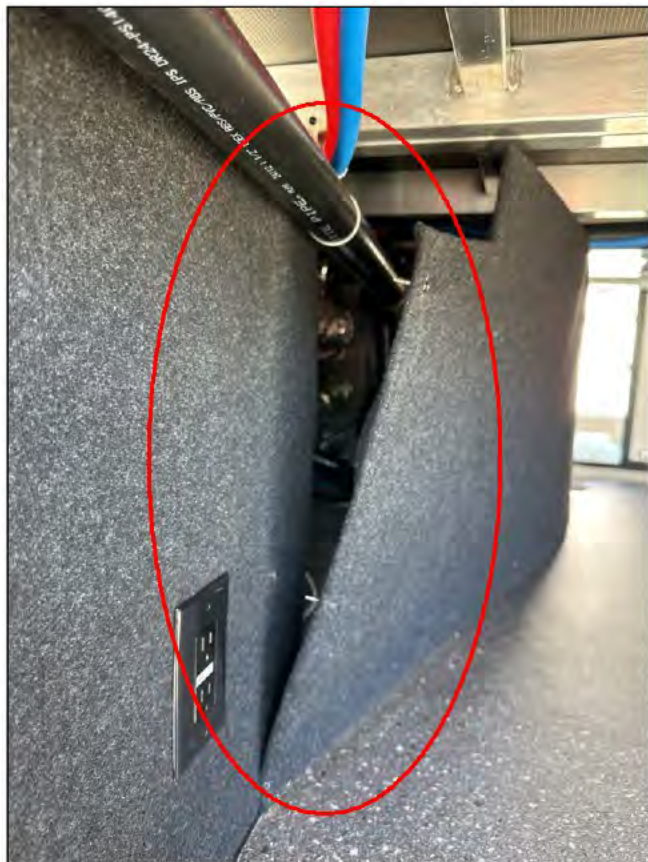
Middle Cargo Bay (Rear Wall) from Curbside

- (2) Inspector noted that the rear wall of the middle cargo bay (pass through) is unscrewed and has puckered carpeting on it toward the streetside. It is recommended that a qualified RV technician repair.

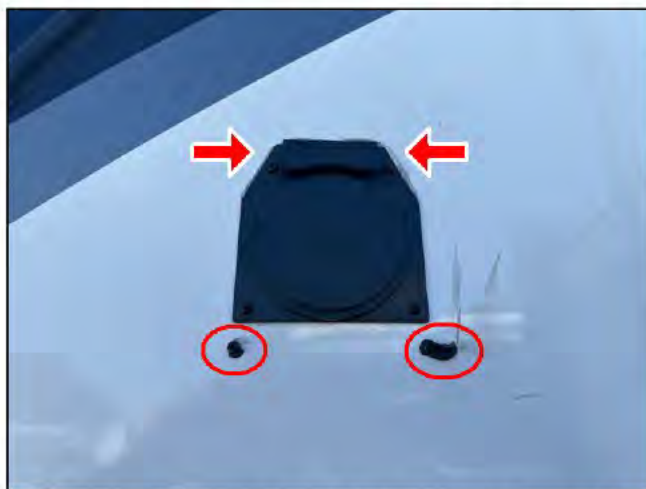
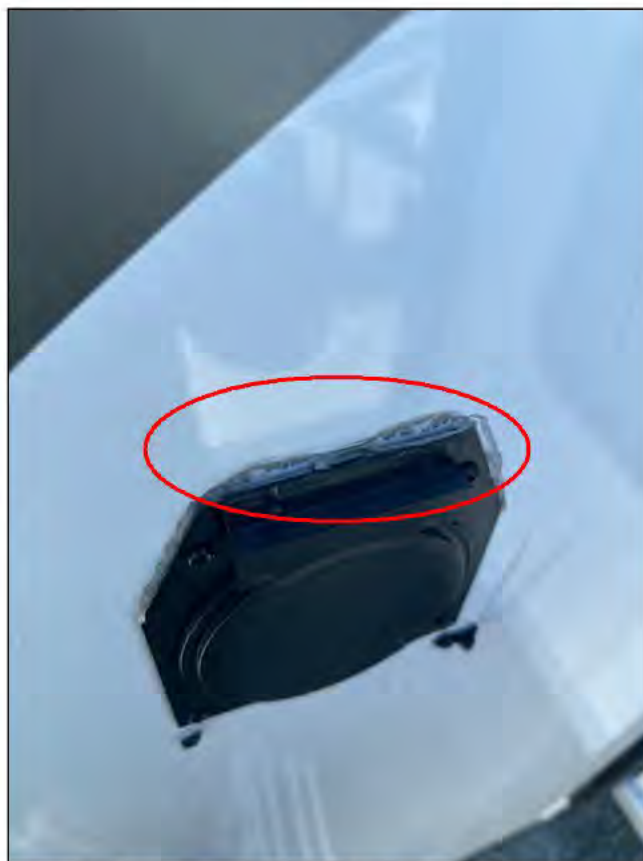
Dryer vent cover at top front of the streetside sidewall (from below)

(1) Inspector noted dryer vent cover on top front streetside wall was broken and had gaps in the sealant along the top edge. It is recommended that a qualified RV technician repair or replace the vent cover to prevent possible future water intrusion.

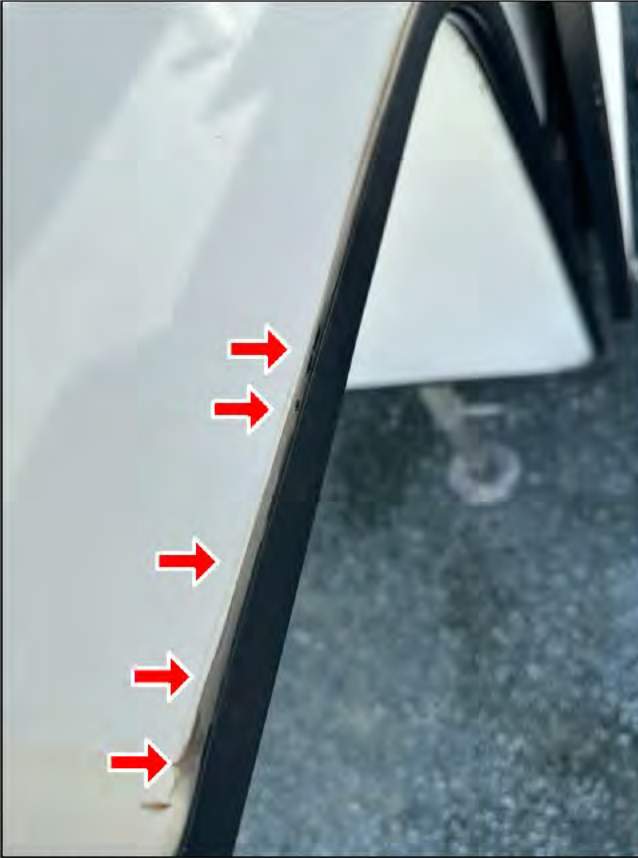
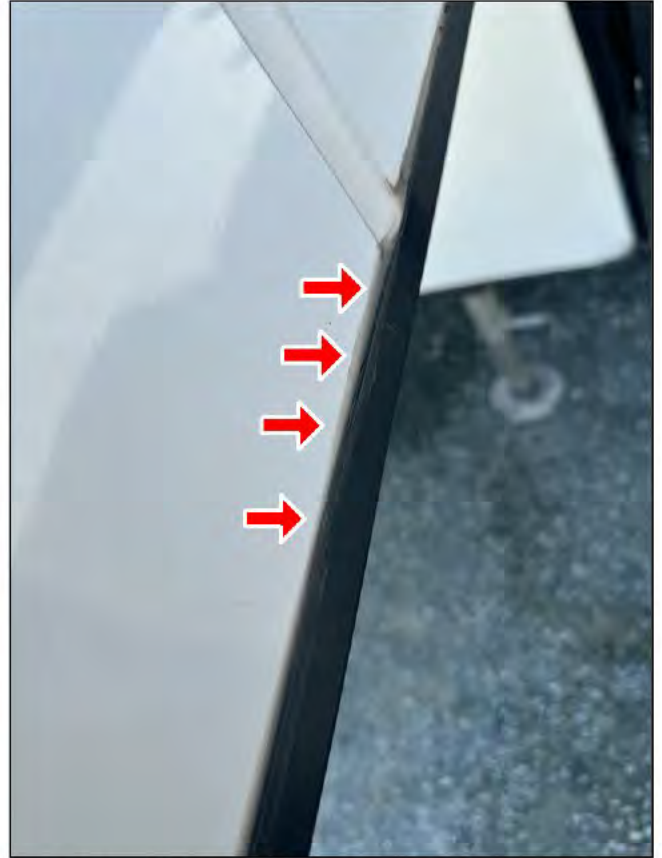
Front streetside side wall from top looking toward rear

\$ (2) Inspector noted gaps in sealant on front portion of streetside sidewall over the hitch area. It is recommended that a qualified RV technician repair to prevent possible future water intrusion.

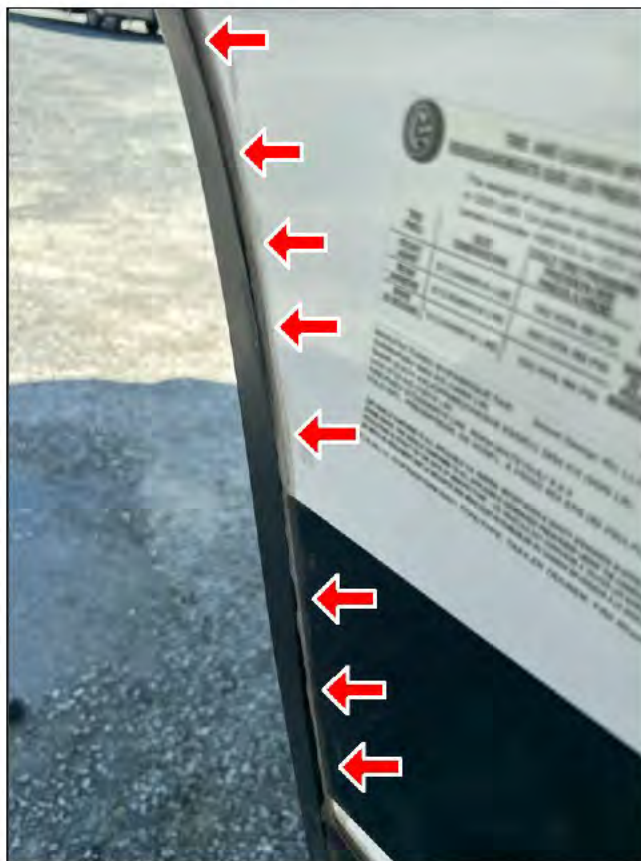
Front edge of streetside sidewall just behind hitch area

\$ (3) Inspector noted gaps in sealant on front portion of streetside sidewall behind the hitch area. It is recommended that a qualified RV technician repair to prevent possible future water intrusion.

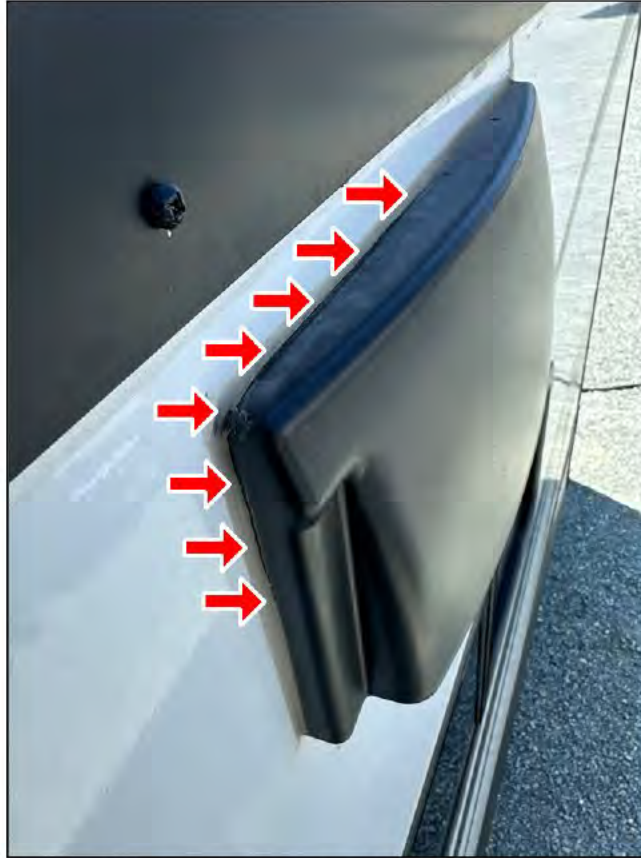
Vent cover on streetside rear slide

\$ (4) Inspector noted gaps in sealant on the top of the vent on the rear streetside slide. It is recommended that a qualified RV technician repair to prevent possible future water intrusion.

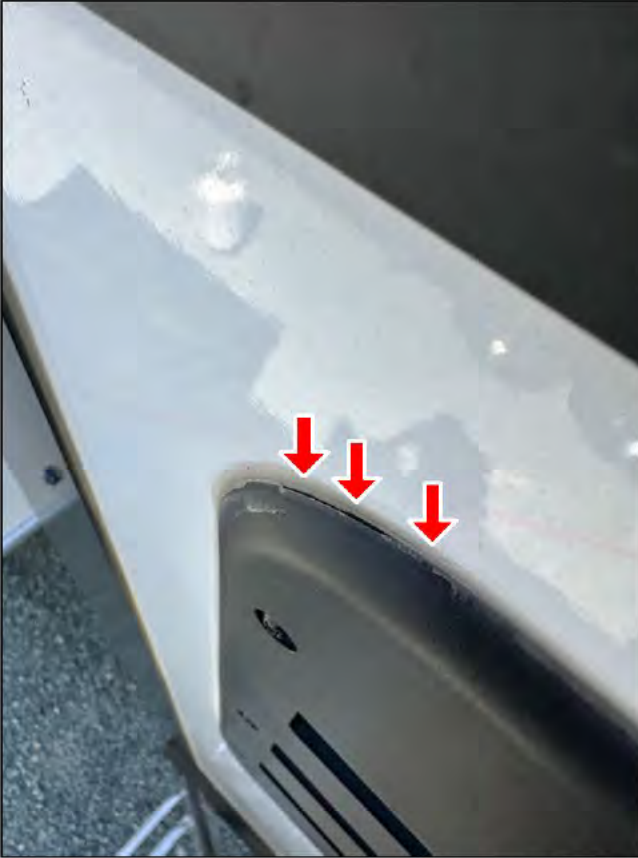
Front top corner of upper refrigerator vent on streetside

\$ (5) Inspector noted gaps in sealant on the top of the upper refrigerator vent on the rear streetside slide. It is recommended that a qualified RV technician repair to prevent possible future water intrusion.

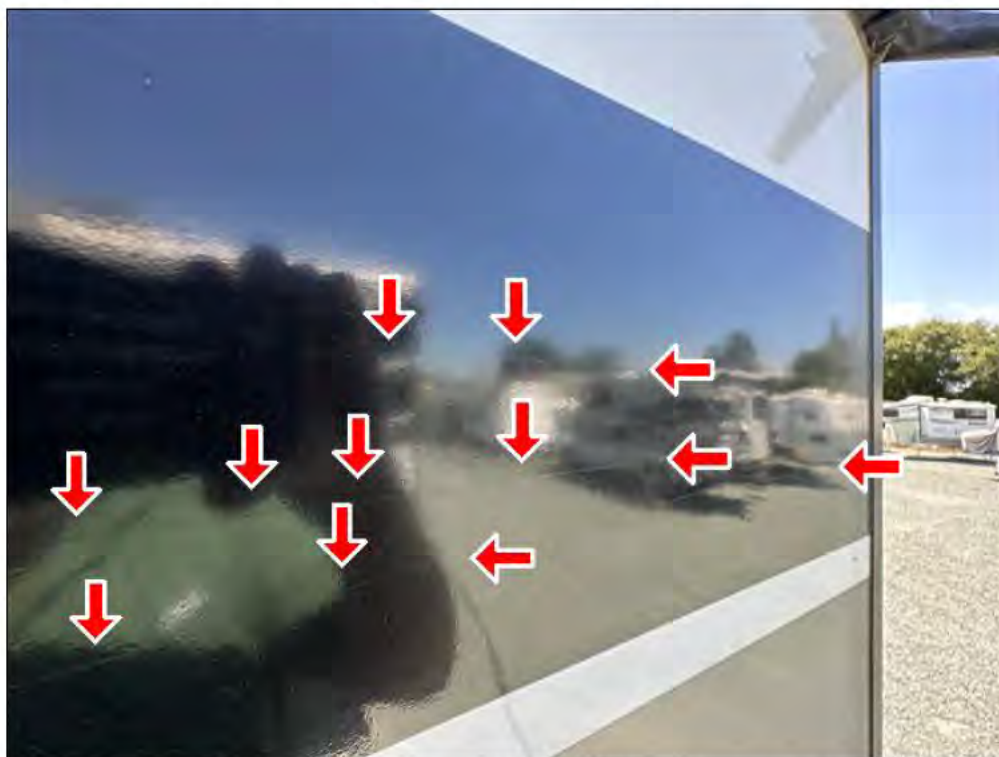
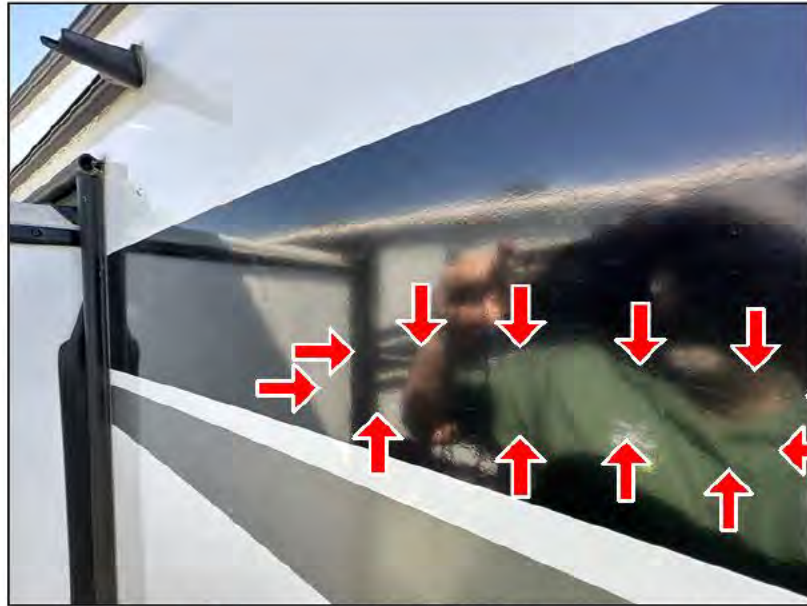
Top Rear of Streetside Sidewall (looking toward rear)

(1) Inspector noted scuffs in the decals on the top rear of the streetside sidewall.

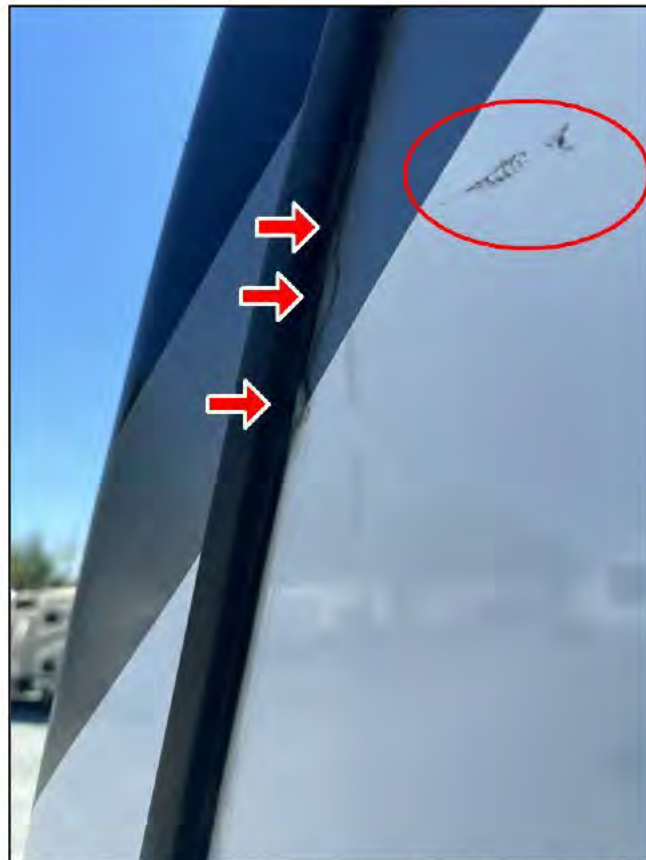
Streetside sidewall just rear of front cap toward roof

(2) Inspector noted gaps in sealant and marks on streetside sidewall immediately behind front cap toward the roof. It is recommended that a qualified RV technician repair the sealant to prevent possible future water intrusion.

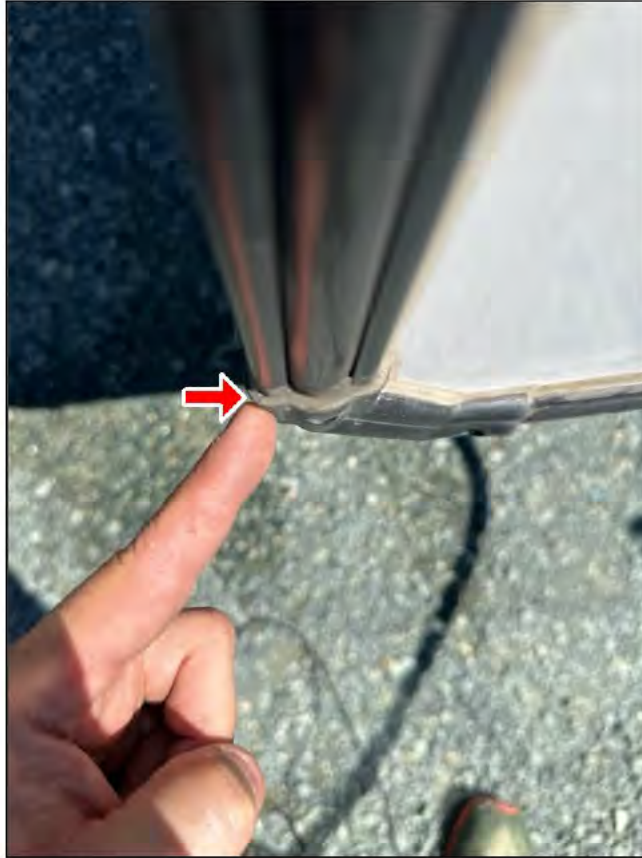
Bottom streetside corner of rear sidewall

(1) Inspector noted gaps in sealant on bottom streetside corner of the rear sidewall. It is recommended that a qualified RV technician repair to prevent possible future water intrusion.

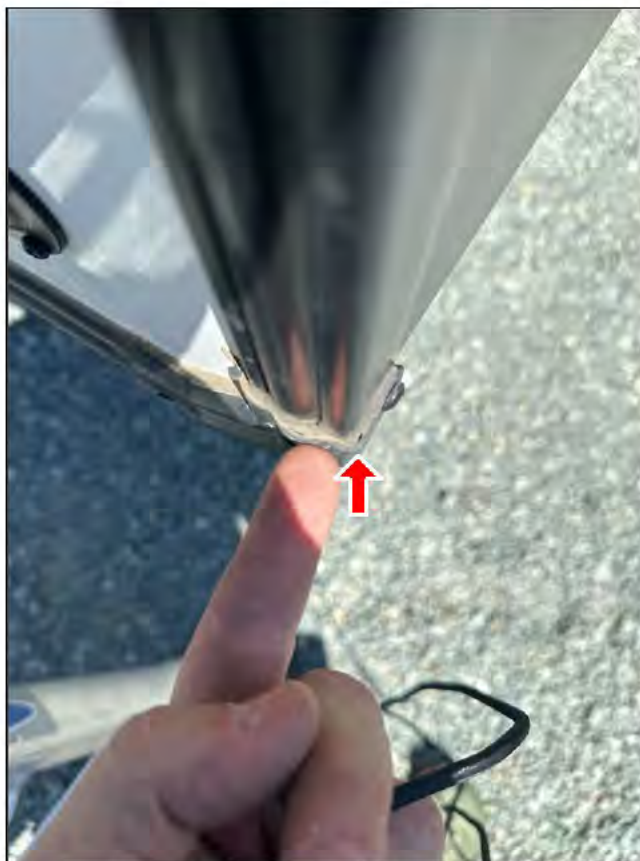
Bottom curbside corner of rear sidewall

(2) Inspector noted gaps in sealant on bottom curbside corner of the rear sidewall. It is recommended that a qualified RV technician repair to prevent possible future water intrusion.

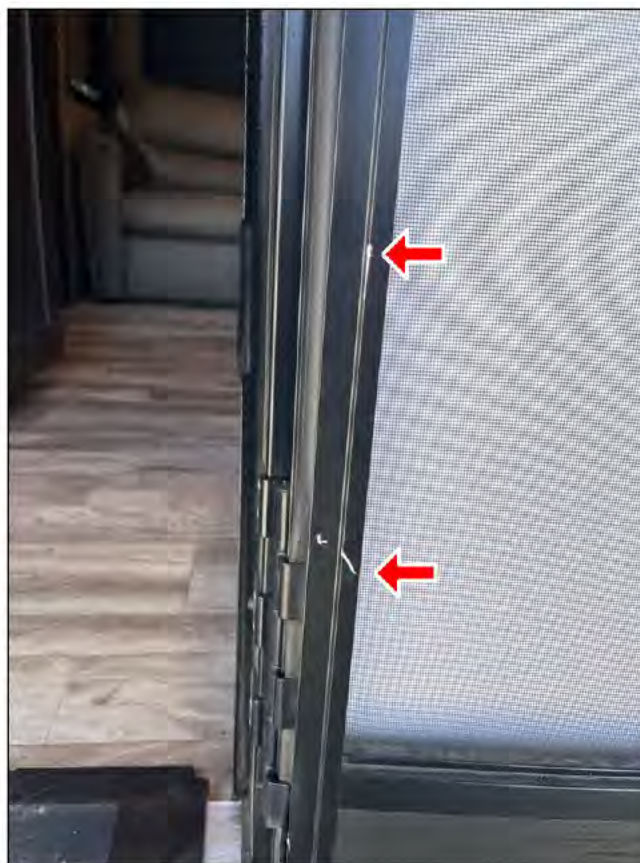
Inside front edge of screen door

(1) Inspector observed small gashes on the lower interior frame of screen door.

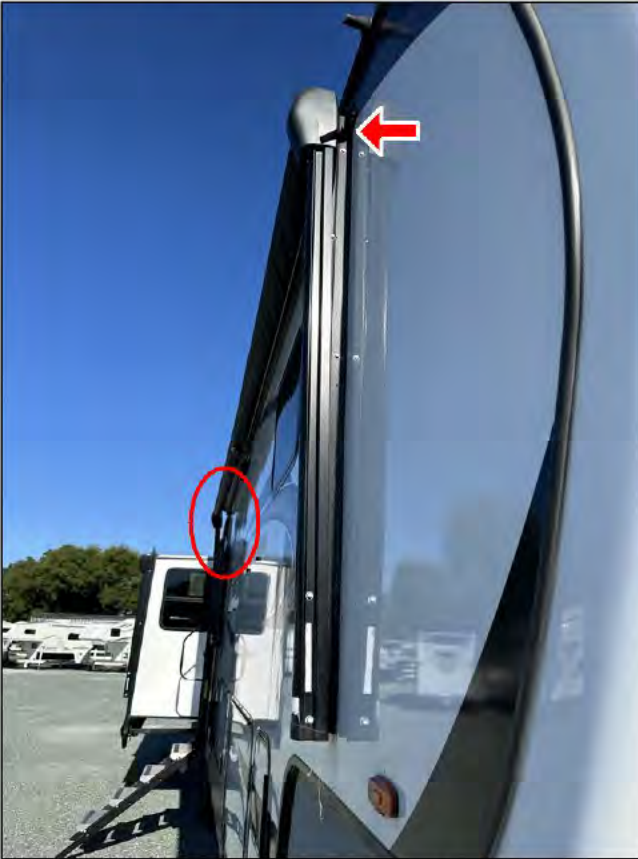
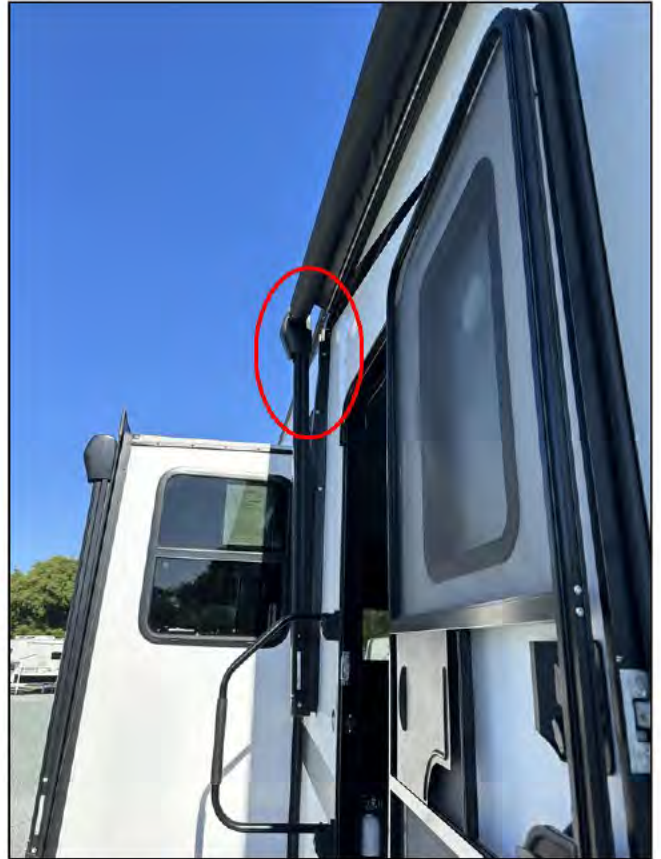
Front Curbside Awning from Front

\$ (1) Inspector noted that the rear arm of the front curbside awning did not fully close upon retracting the awning. Note the circle in the bottom left of the photo with the daylight showing versus the top right of the photo with a fully closed awning arm. It is recommended that a qualified RV technician repair before the rig is driven.

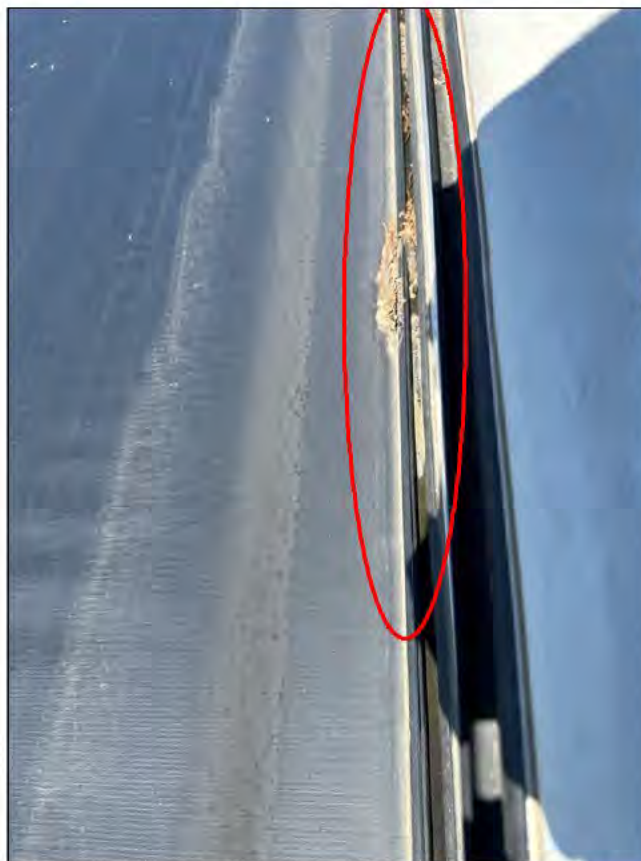
Front Curbside Awning Gutter from Top

- (2) Inspector noted the gutter above the front curbside awning was filled with debris in many places. It is recommended that a qualified RV technician repair to prevent future possible water intrusion.

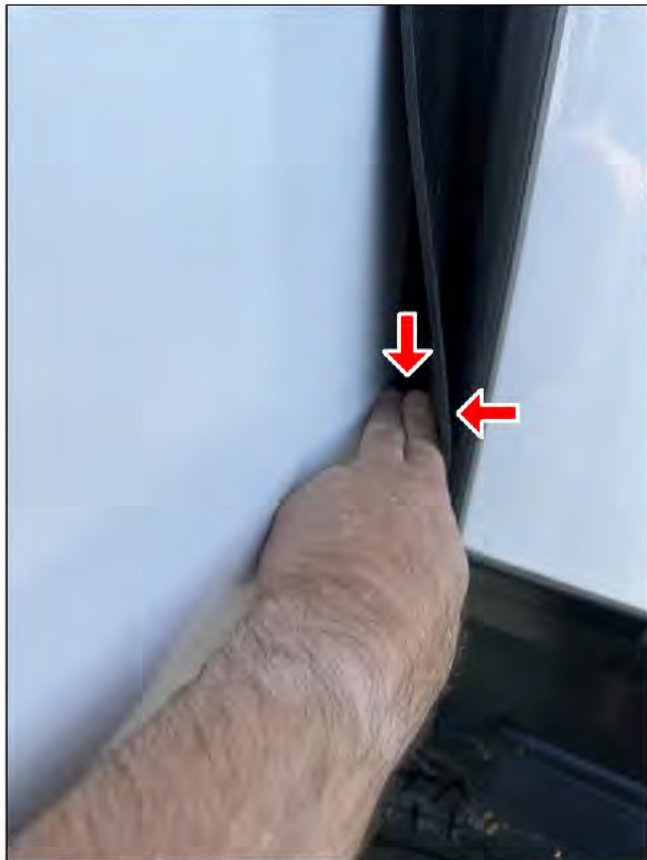
Front bottom seal of curbside rear slide

\$ Inspector noted that front side of curbside rear slide has a larger gap than the rear of the curbside slide indicating possible misalignment of slide. It is recommended that a qualified RV technician repair.

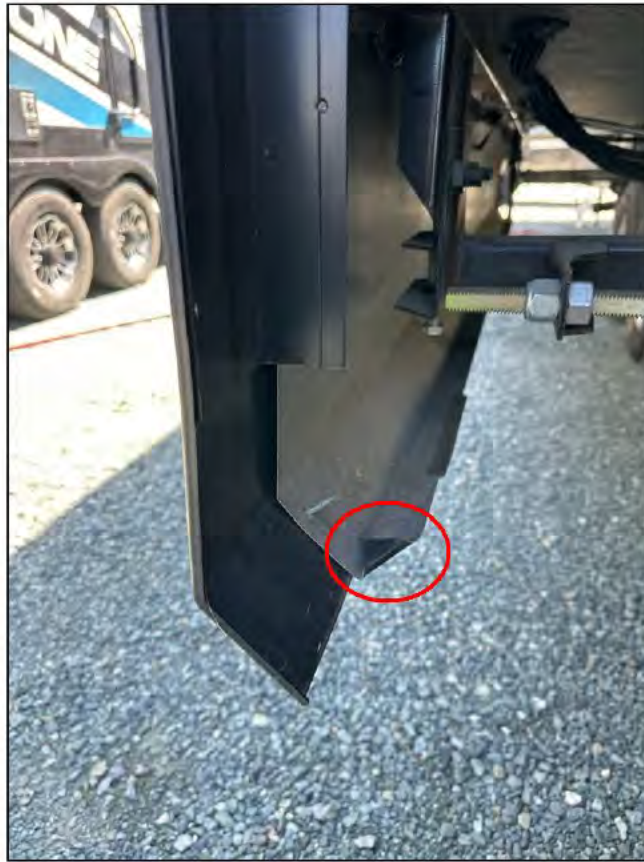
Streetside rear slide bottom rear corner

🔍 Inspector noted that the J-wrap on the rear bottom corner of the streetside rear slide was bent.

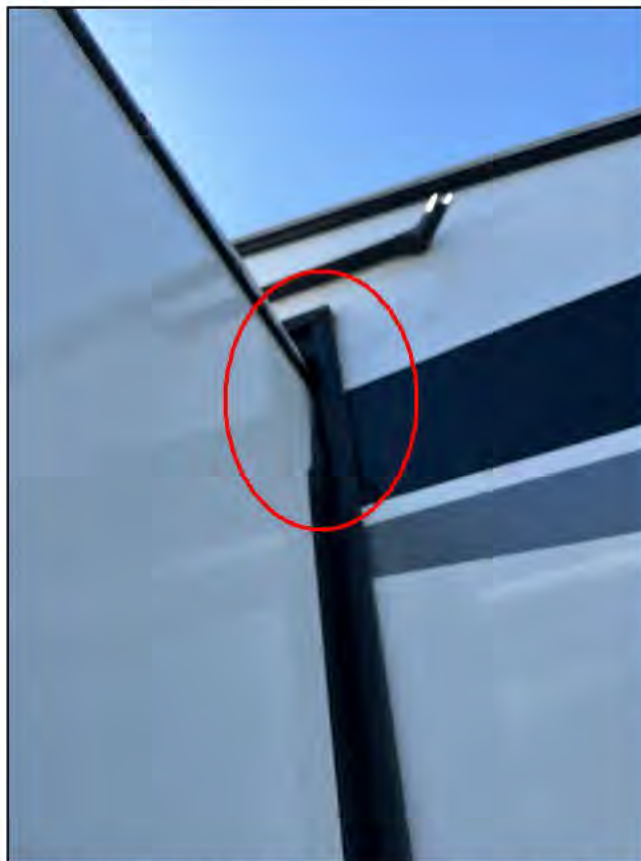
Top rear streetside slide blade seal (from rear below)

Inspector noted that the top rear blade seal on the streetside rear slide did not flip fully to the outside upon slide extension. If this continues, it is recommended that a qualified RV technician replace or repair the blade seal to prevent possible future water intrusion.

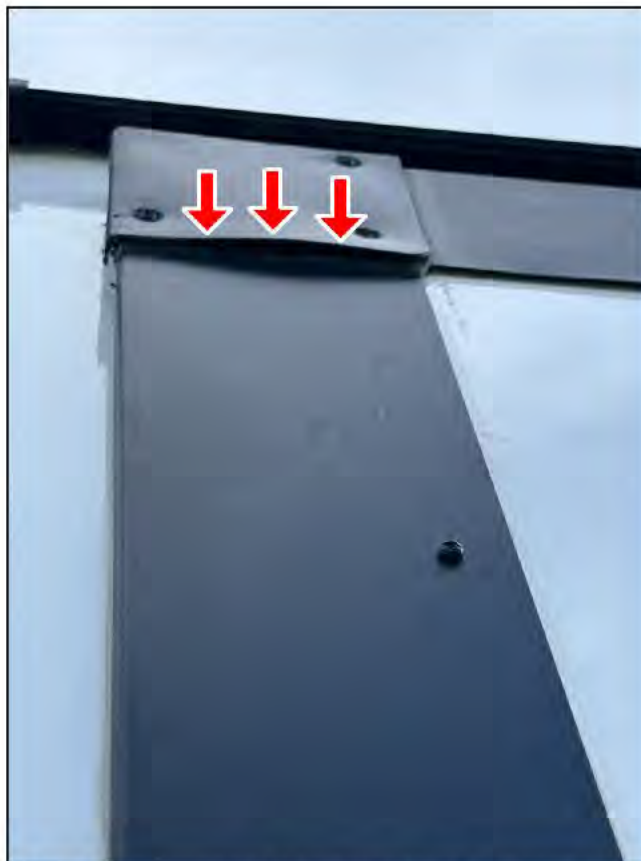
Top front corner of the streetside center slide (from bottom)

Inspector noted that the top front T-molding corner of the streetside center slide has a gap at the bottom. It is recommended that a qualified RV technician repair to prevent possible future water intrusion.

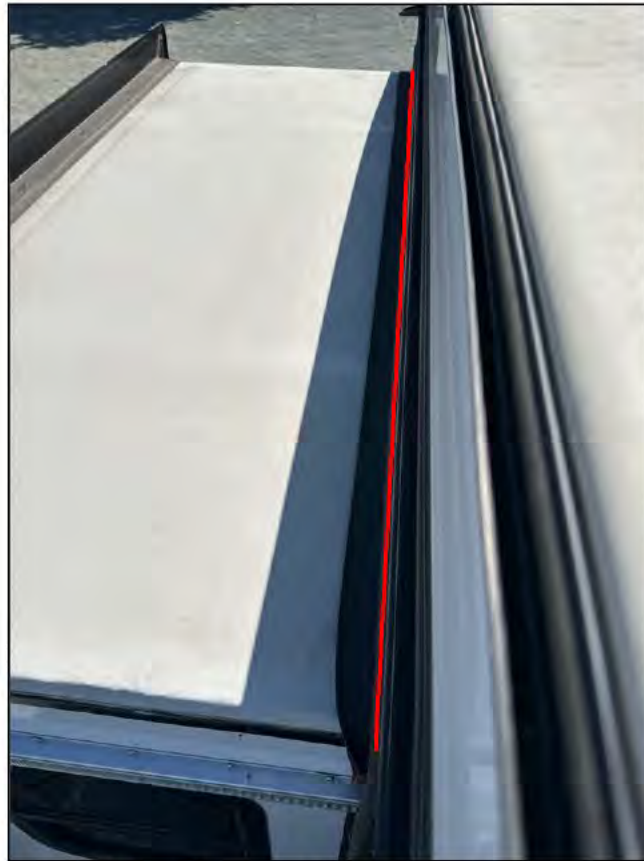
Streetside front slideout (rear top down)

Inspector noted a fine separation between the bulb seal and the streetside sidewall above the streetside front slideout. The photo shows the small crack/break in the seal in a representative portion of the seal from the top down. It is recommended that a qualified RV technician repair to prevent possible future water intrusion.

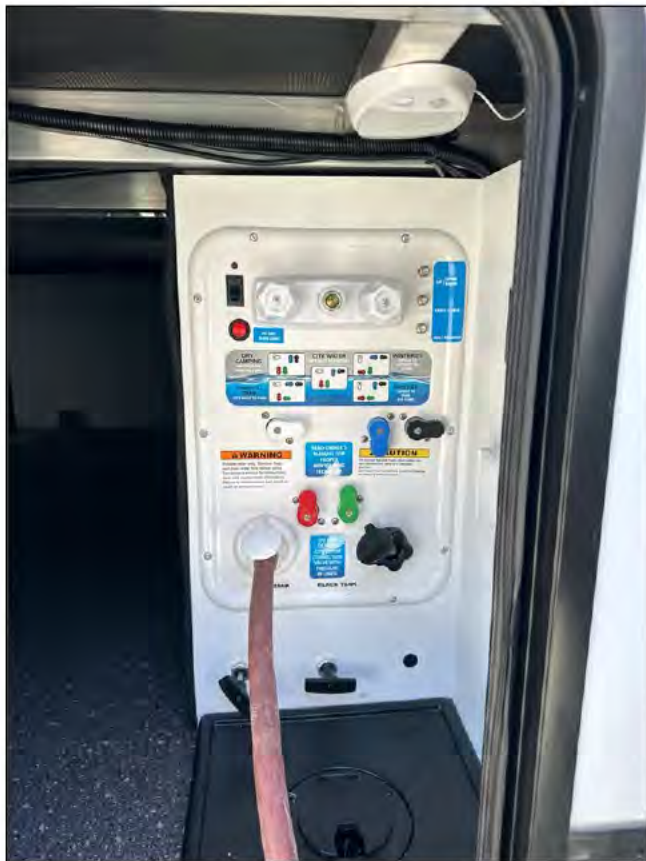
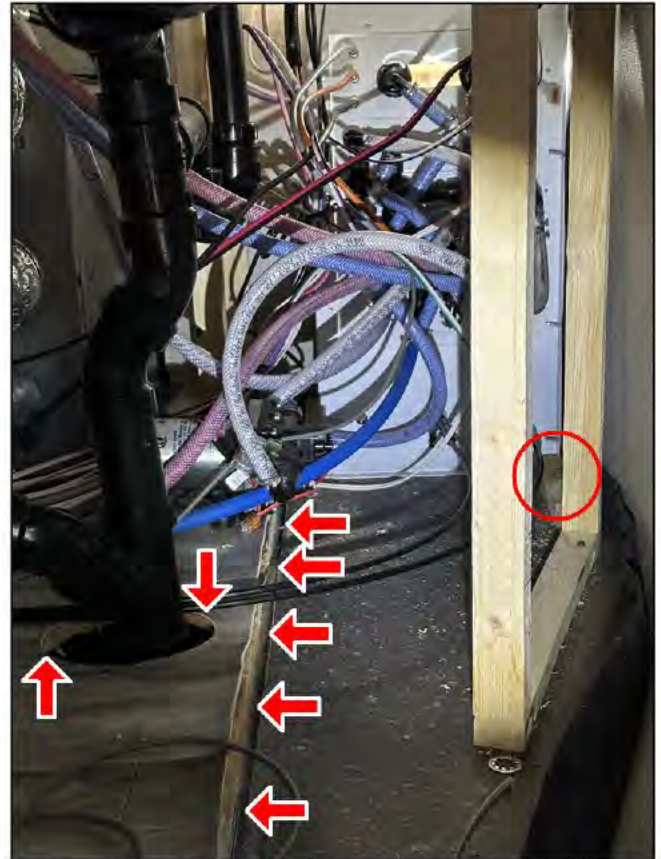
\$ Inspector noted that when using city water, water leaked behind the water panel and came out into the pass through. Upon looking behind the wet bay panel (through the unscrewed panel in the pass through), inspector noted signs of prior water intrusion, including separation of the vinyl flooring from the subfloor. It is recommended that a qualified RV technician repair to prevent future possible water intrusion.

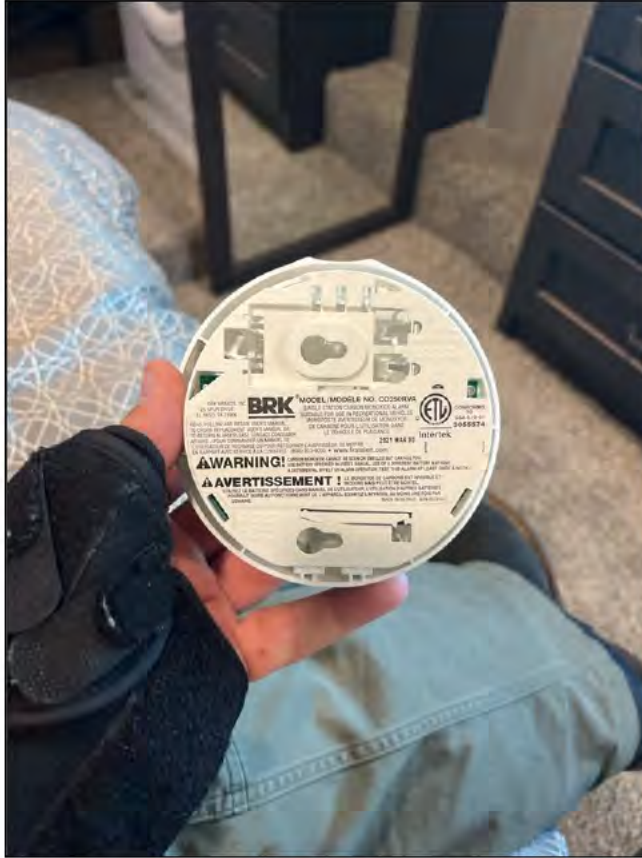
Carbon monoxide detector located in master bedroom

- +** Inspector noted while inspecting the unit, the master bedroom carbon monoxide detector was signaling low battery. Inspector recommends this be repaired by a qualified RV technician before the unit is occupied.

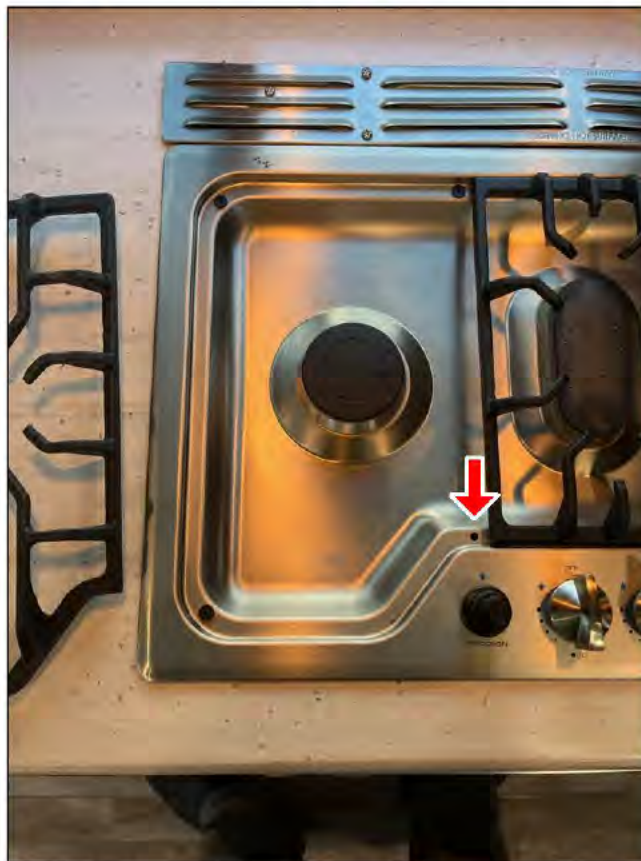
Cooktop rubber grommet, front most second from the left

Inspector noted a missing rubber grommet above the ignition button on the cooktop.
