RV Inspection Report

Inspection Date / RV Model:
18 Apr 2024: 2022 Grand Design Reflection 367BHS

5Js RV LLC

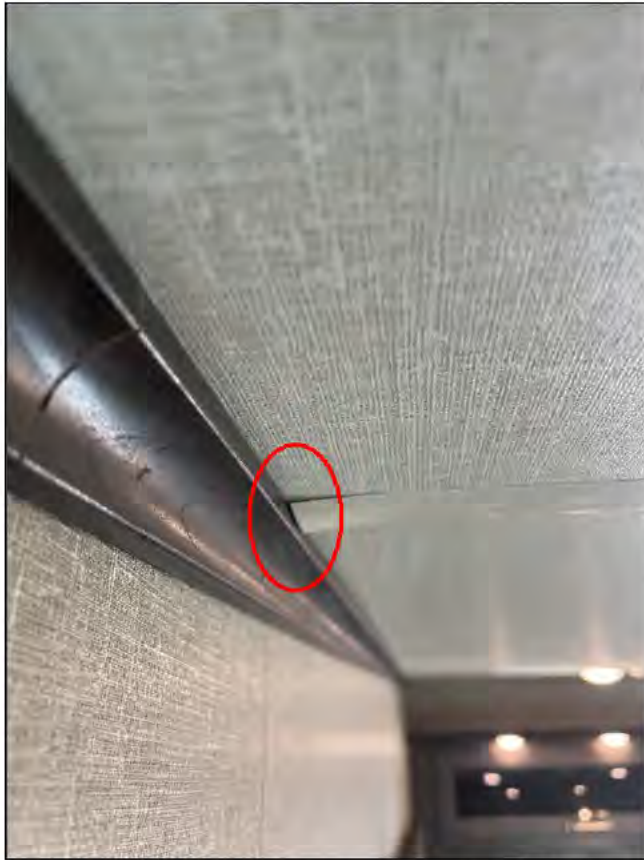
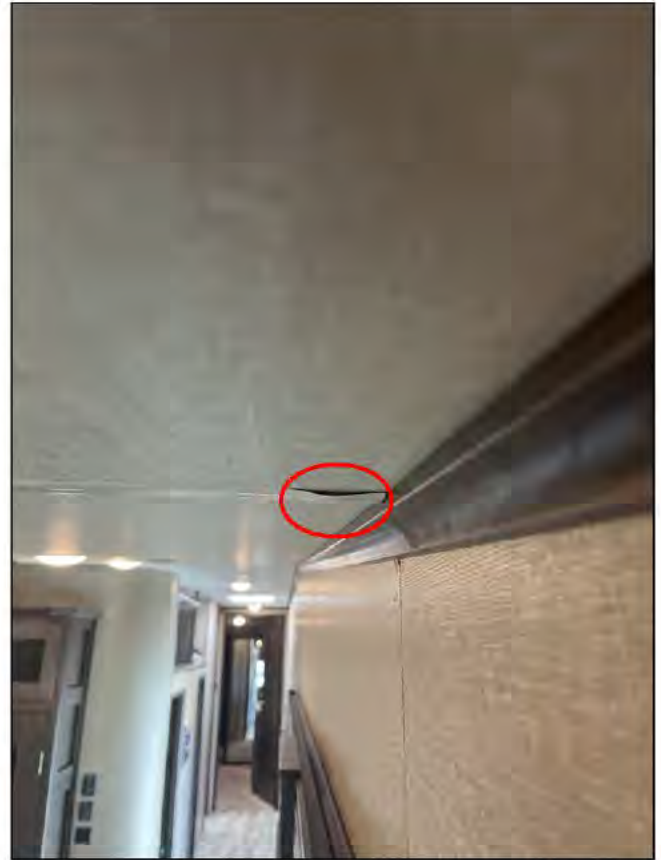
- On both the curb and streetside rear ceiling panel, inspector observed raised edges where the ceiling panel seam cover meets the wall.

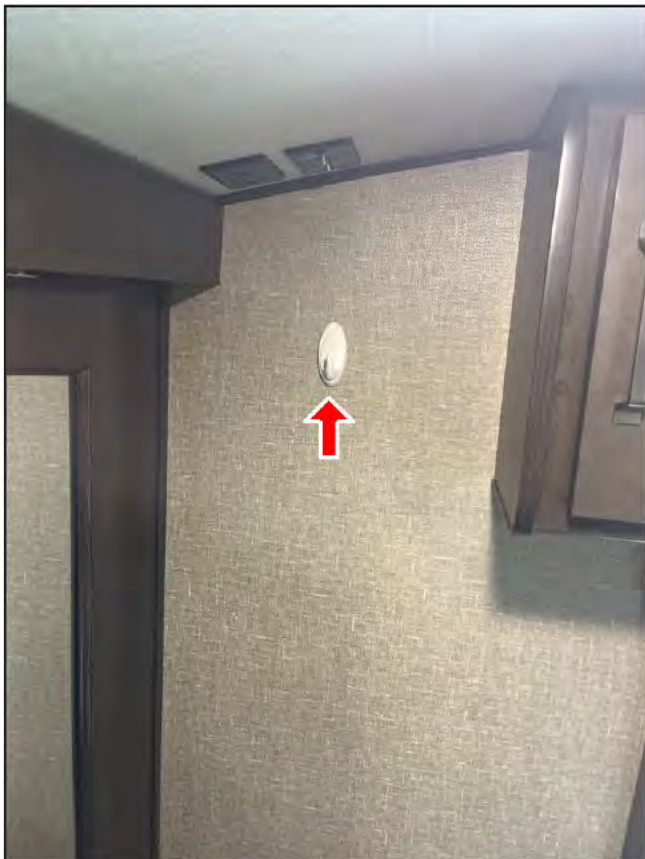
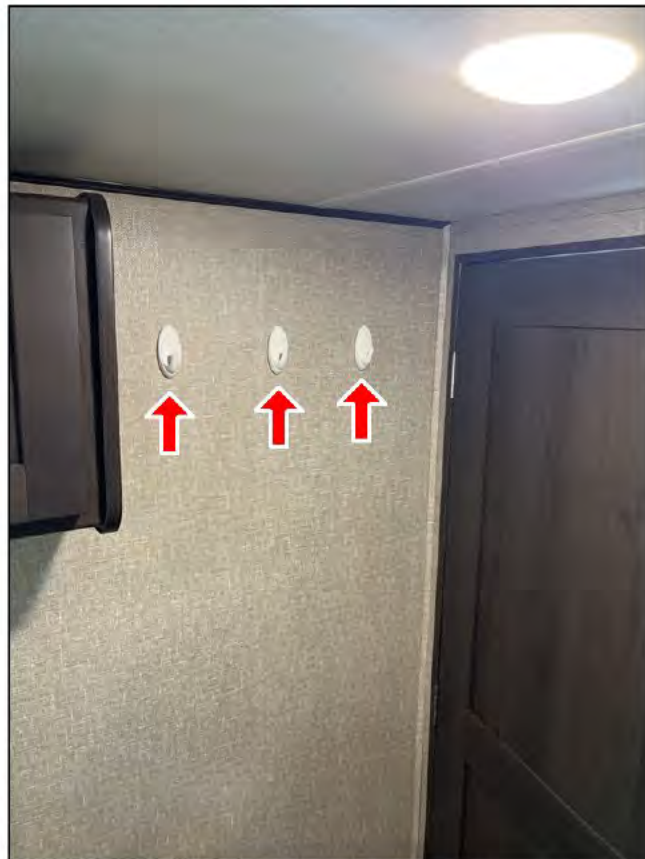
🔍 (1) Inspector noted aftermarket wall hooks in the master bedroom on the curbside rear wall.

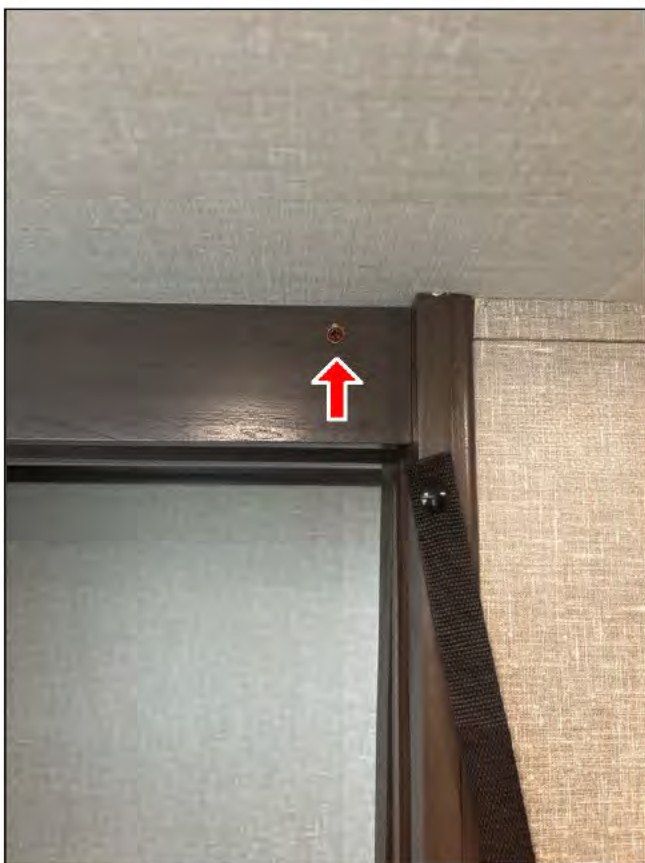
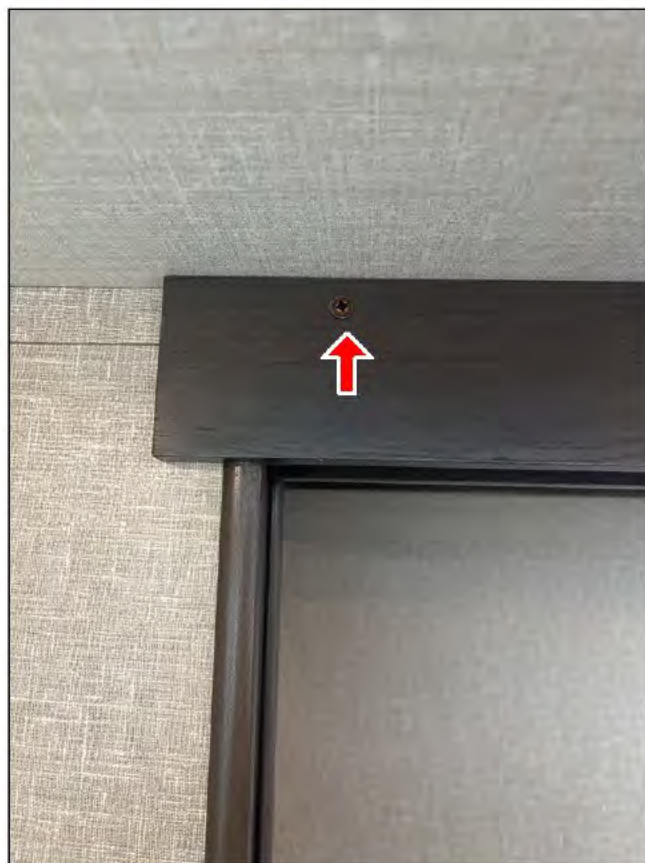
🔍 (2) Inspector noted rusty screws inside the bathroom above the doorway.

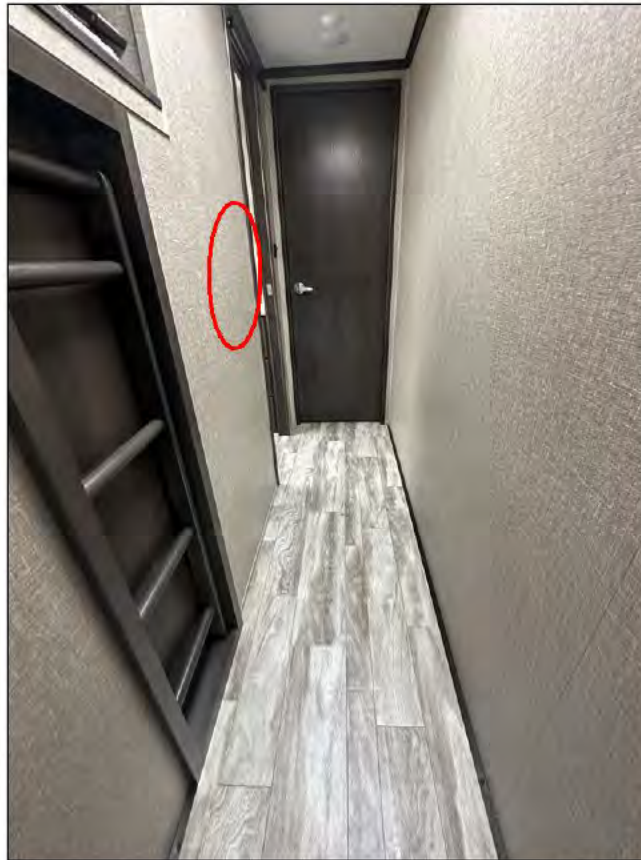
Soft spot location between loft and bathroom

Inspector observed a soft spot on the streetside bathroom/hall wall.

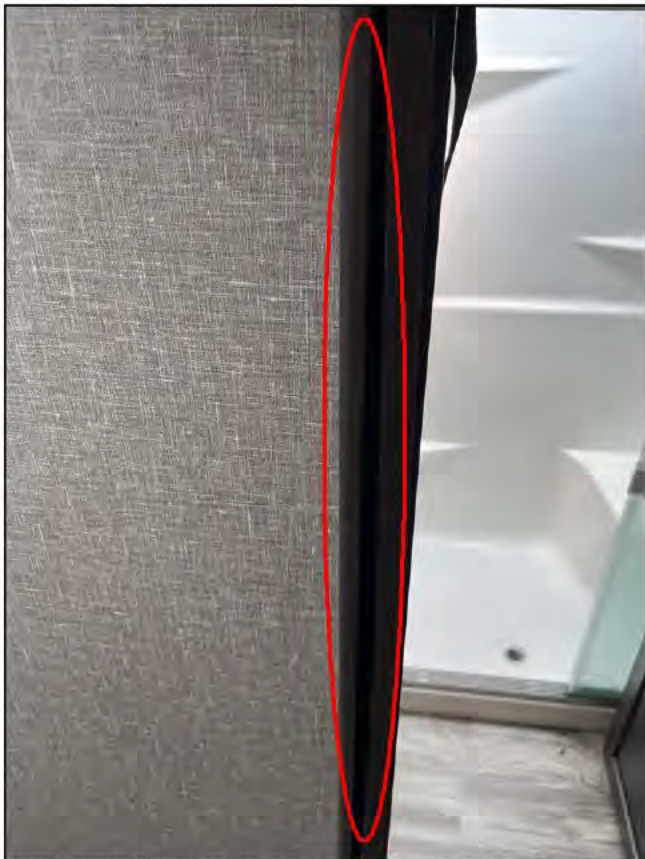
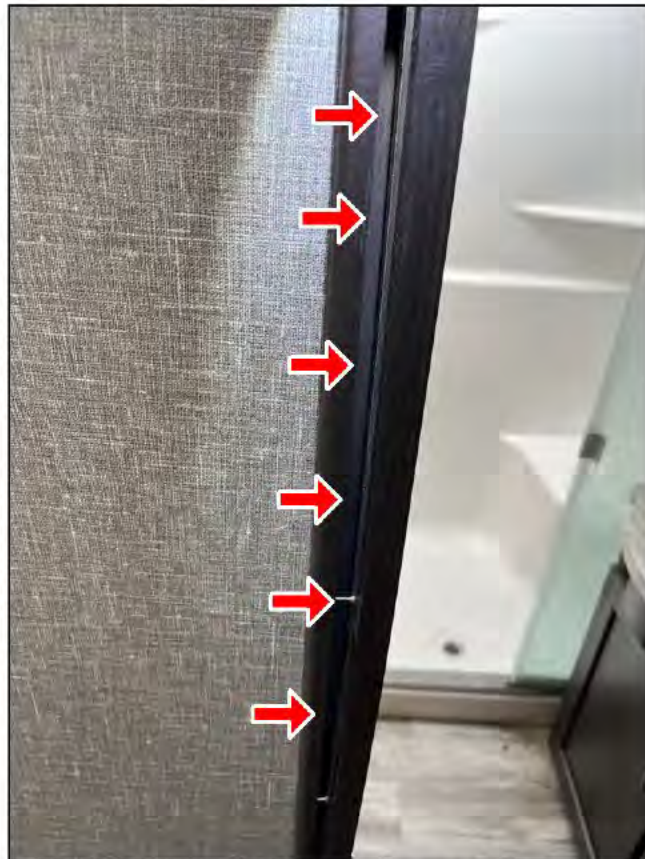
Streetside rear bathroom door frame

- (1) Inspector observed that the street side rear bathroom door frame is popping out from the wall starting about a third of the way up from the floor. Inspector recommends this be repaired by qualified RV technician.

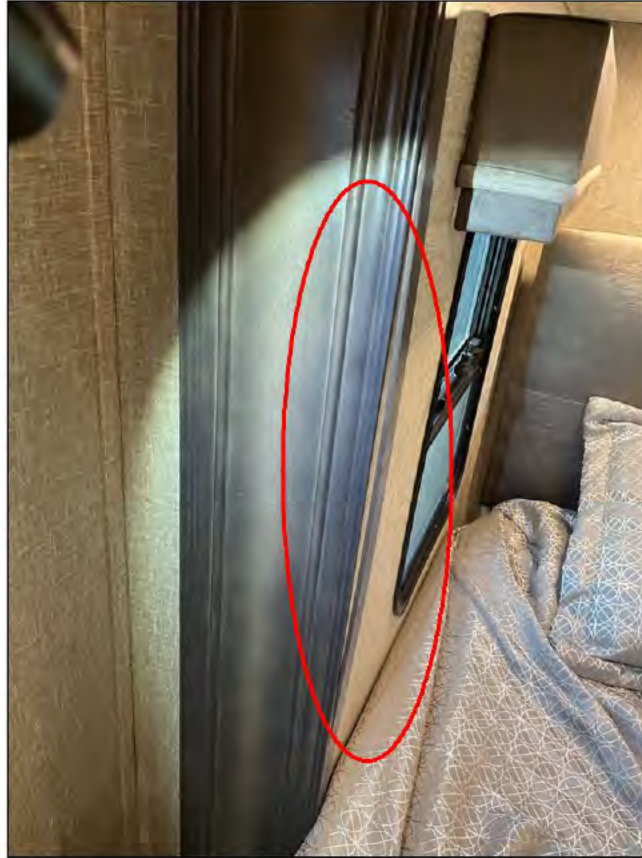
Streetside rear master bedroom slideout wall trim

- (2) On the streetside rear master bedroom slideout, inspector observed bulging wall trim. Inspector recommends this be repaired by a qualified RV technician.

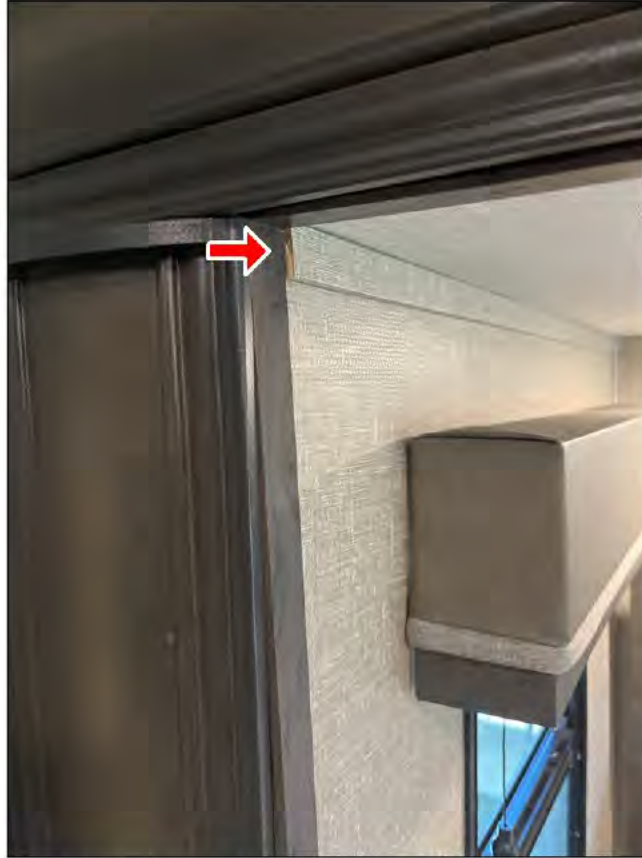
Streetside rear master bedroom slideout ceiling trim

- (3) On the street side, rear master bedroom slideout at the upper edge closest to the master bedroom main entry door, inspector noted loose and raised trim. Inspector recommends this be repaired by a qualified RV technician.

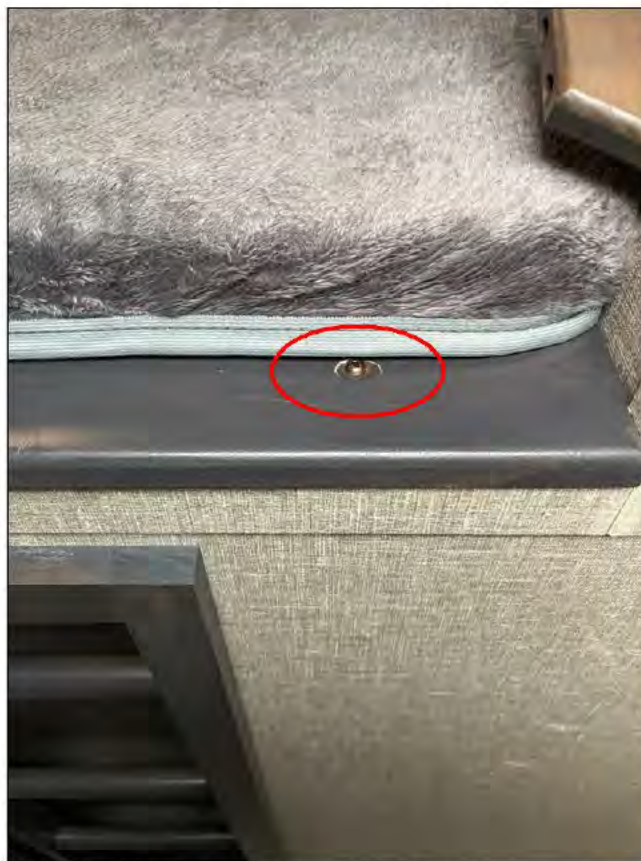
Dented trim on hallway wall that connects to loft

- (4) Inspector observed dented and scratched trim under the front-most screw where the hallway wall meets the loft.

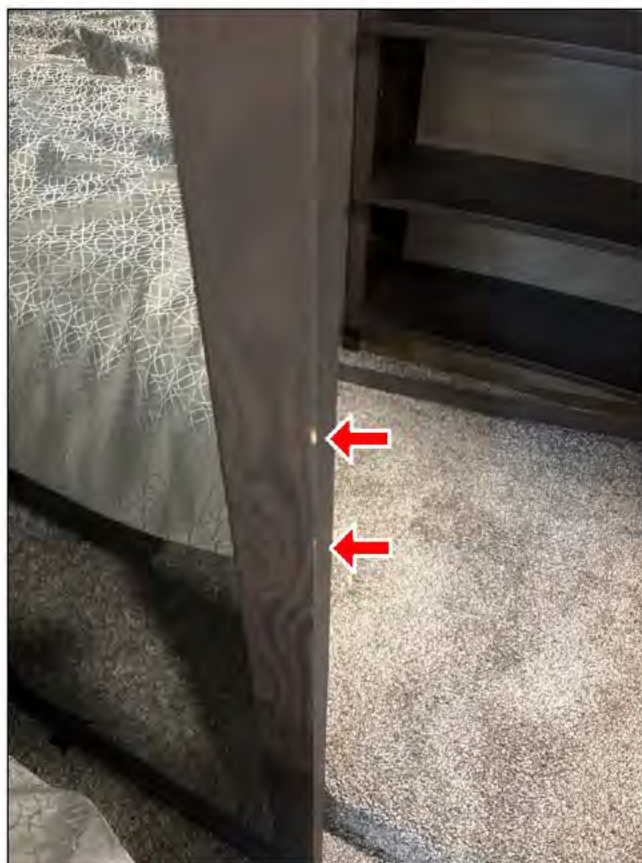
Streetside master bedroom closet door

🔍 (1) Inspector observed damage to the streetside, master bedroom closet door.

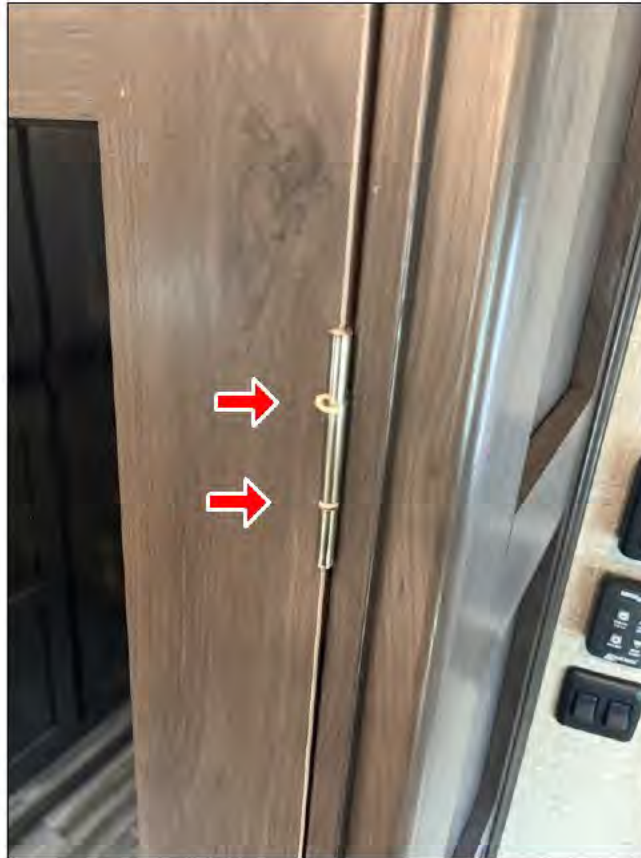
Curbside, top pantry door hinge

- (3) Inspector observed on the curbside, top of the pantry door hinge, one of the plastic rings on the hinge is popping out. Inspector recommends this be repaired by a qualified RV technician.

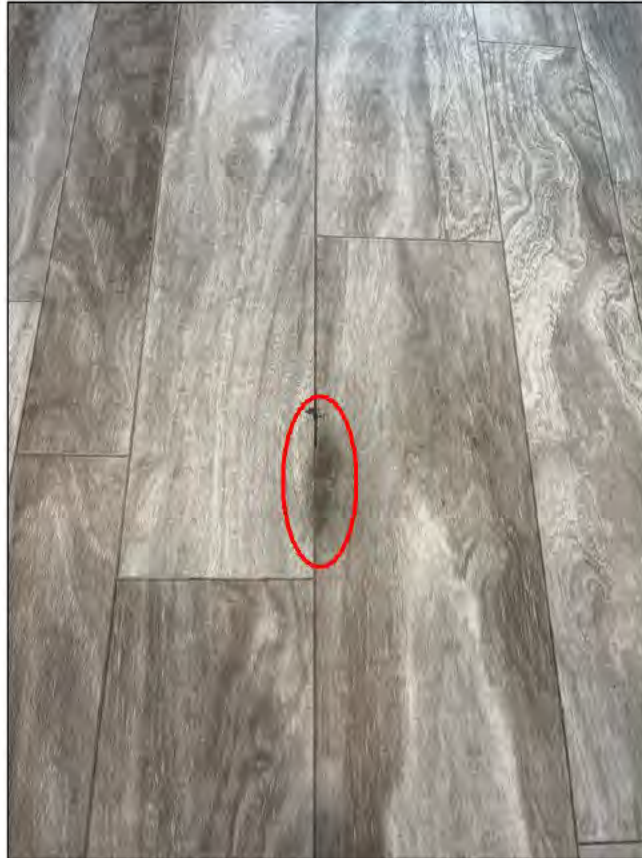
Middle rear, 3 feet from rear couch

Inspector noted discoloration on the floor towards the rear middle of the unit roughly 3 feet from the rear couch.

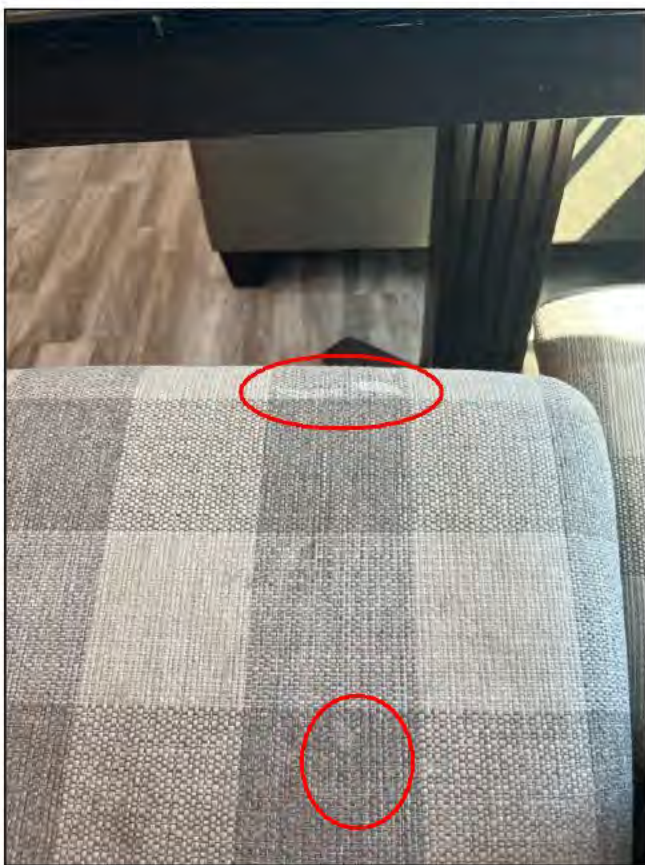
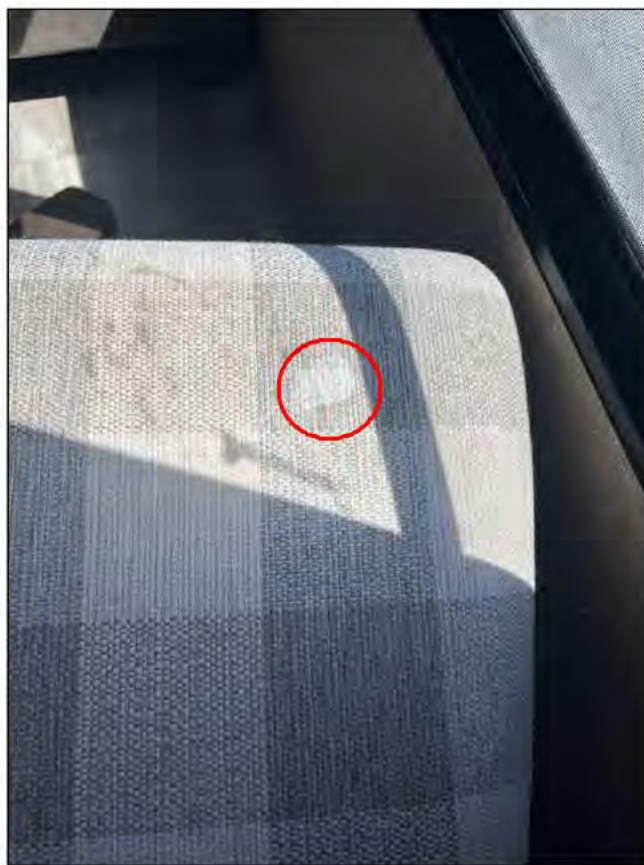
Inspector observed that both the curbside and streetside dinette chairs had stains.
