# RV Inspection Report

**Inspection Date / RV Model:**  
**29 May 2024: 2019 Newmar Dutch Star 4369**

5Js RV LLC

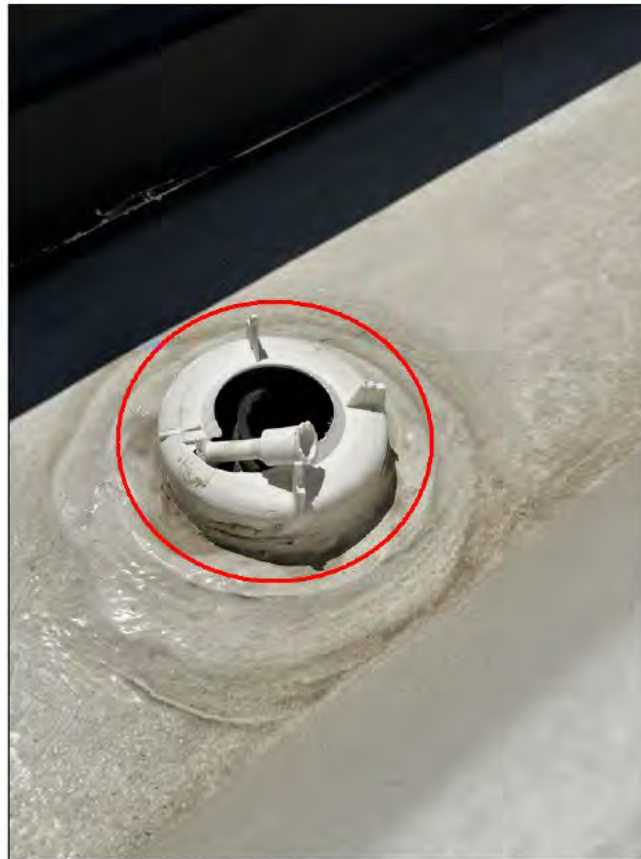
(1) Inspector noted that the plumbing vent on the curbside roof to the curbside of the bedroom ceiling bump was missing a cap. It is recommended that a qualified RV technician replace the cap to prevent possible future water intrusion.

Plumbing vent to the curbside of the bedroom ceiling bump

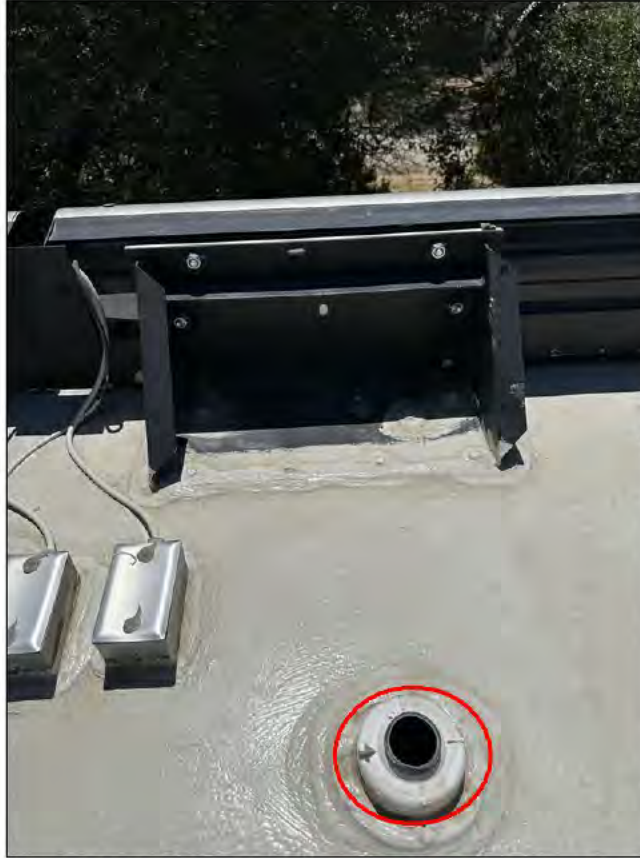
(2) Inspector noted that the plumbing vent on the curbside roof between the rear and center AC units was missing a cap. It is recommended that a qualified RV technician replace the cap to prevent possible future water intrusion.

- \$** (2) Inspector noted that the plumbing vent on the curbside roof between the rear and center AC units was missing a cap. It is recommended that a qualified RV technician replace the cap to prevent possible future water intrusion.

Curbside roof between rear and center AC units  
(from streetside)

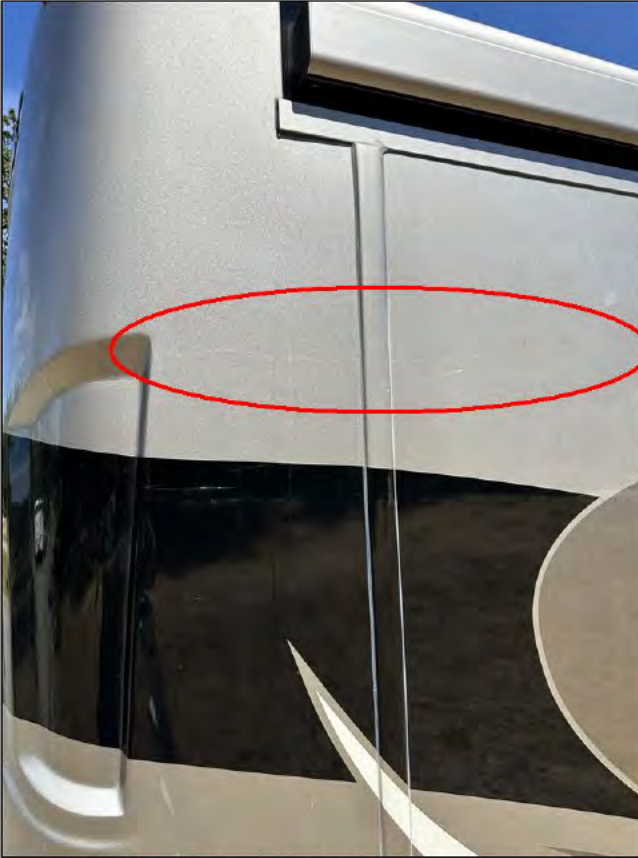
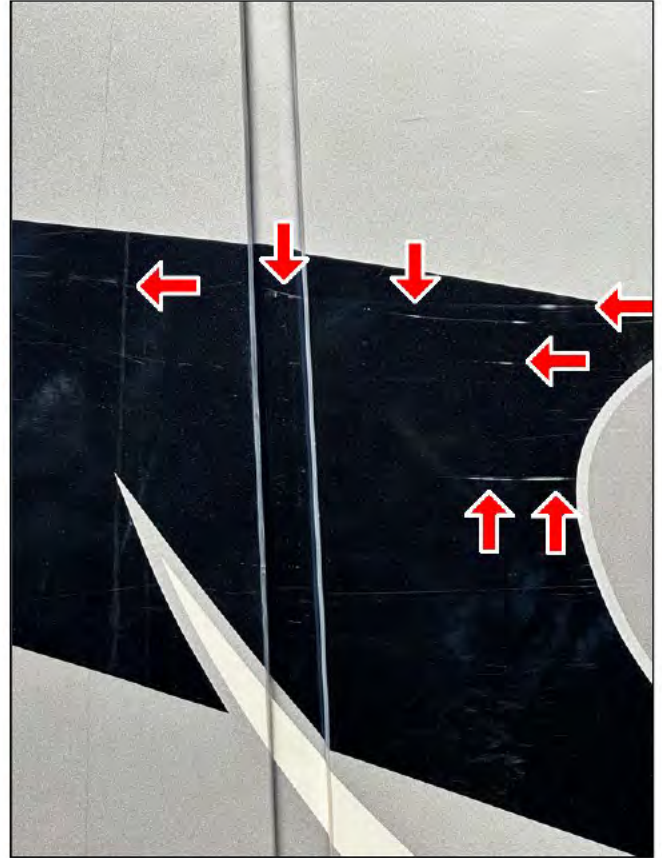
Inspector noted scratches in the clear coat and/or paint on the upper curbside side wall to the rear of the slide.

Curbside sidewall just forward of rear cap

Middle curbside side wall forward of rear wall

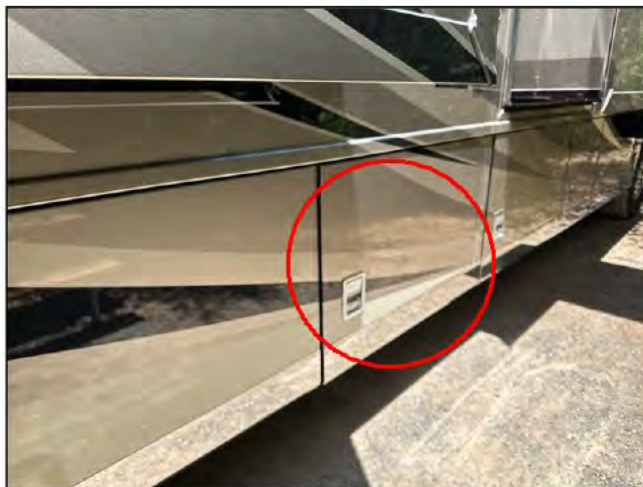
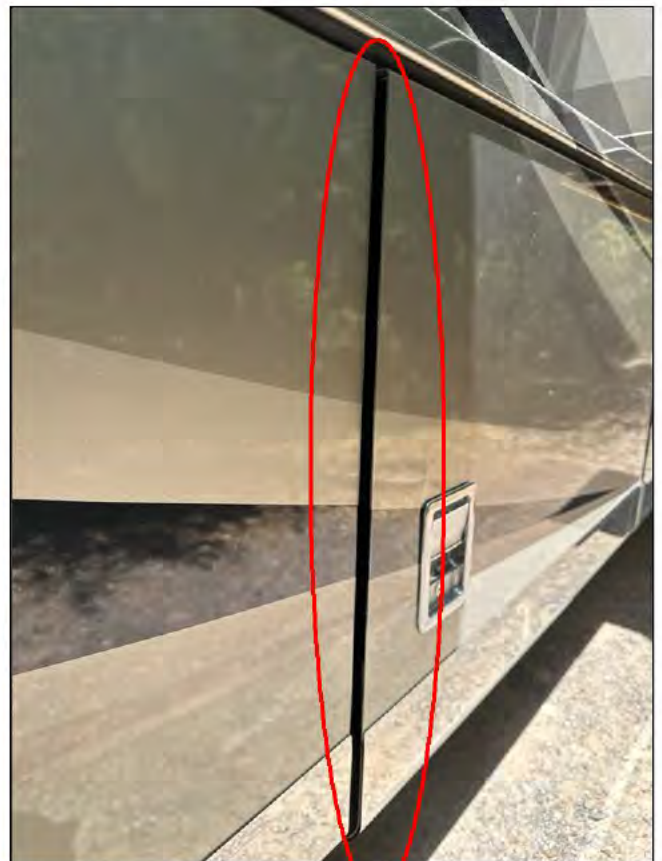
- (1) Inspector noted that the curbside cargo door 3rd to rear from front tire would latch but would have play in it when pressed. Seller indicates that the door has been that way from day one.

Curbside cargo door 3rd from front tire

Gap in curbside cargo bay door 3rd from front tire when closed

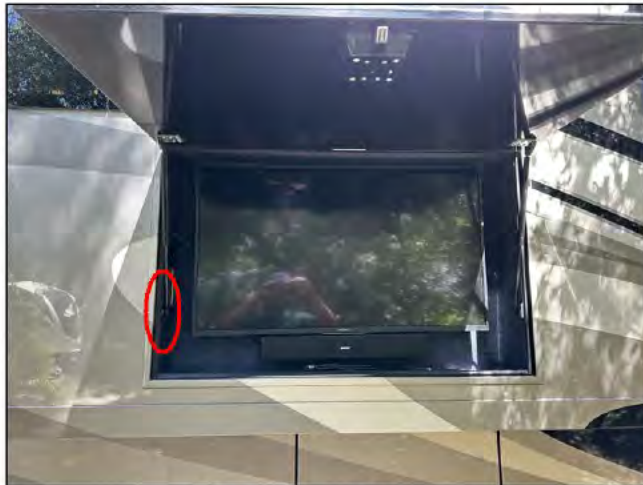
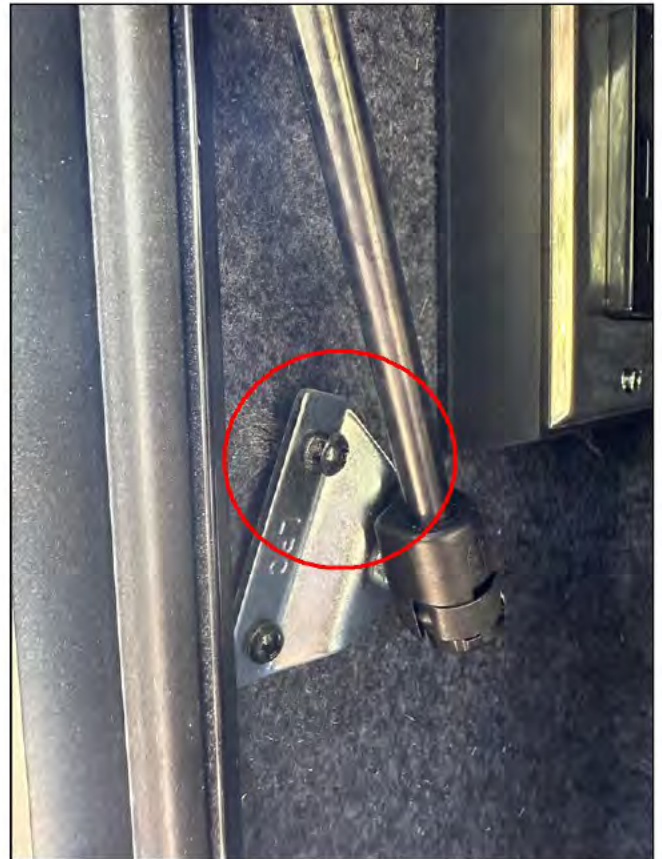
(2) Inspector noted that the rear pneumatic hinge of the curbside outdoor TV cargo bay had a loose screw at its bottom mounting point making the door difficult to operate. It is recommended that a qualified RV technician repair the hinge mount.

Curbside outdoor TV cargo bay

Curbside outdoor TV cargo bay (close-up of rear internal bottom door pneumatic)

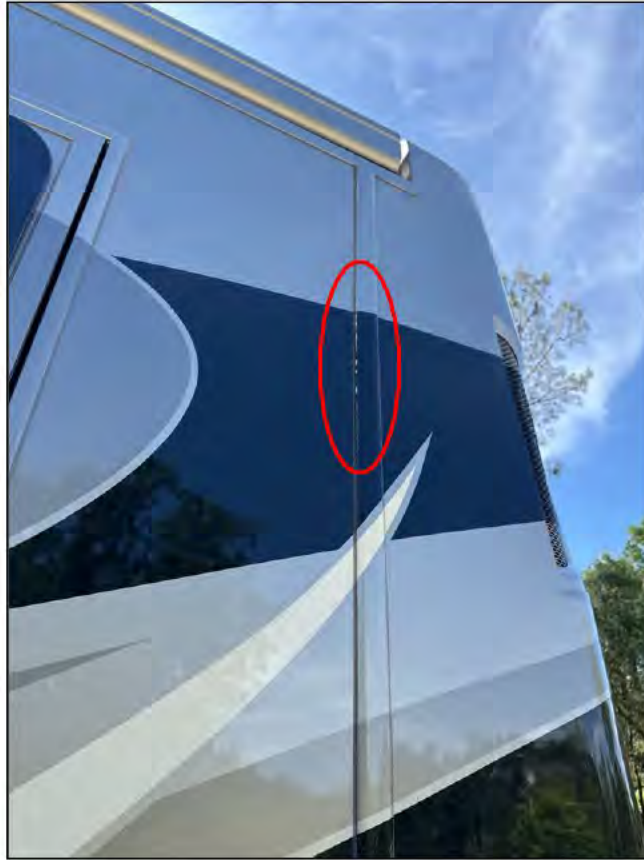
Inspector noted chips in the paint on the moulding at the upper rear of the streetside side wall.

Upper streetside side wall at rear

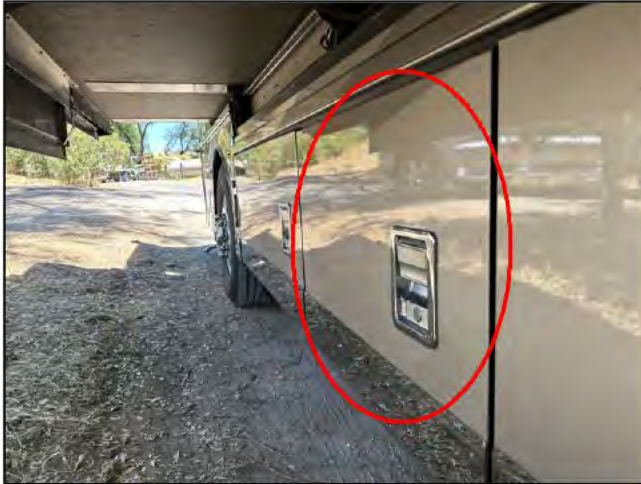
Inspector noted that the house battery cargo door was difficult to open and to close, requiring downward pressure to make closing and opening possible.

House battery cargo door on streetside

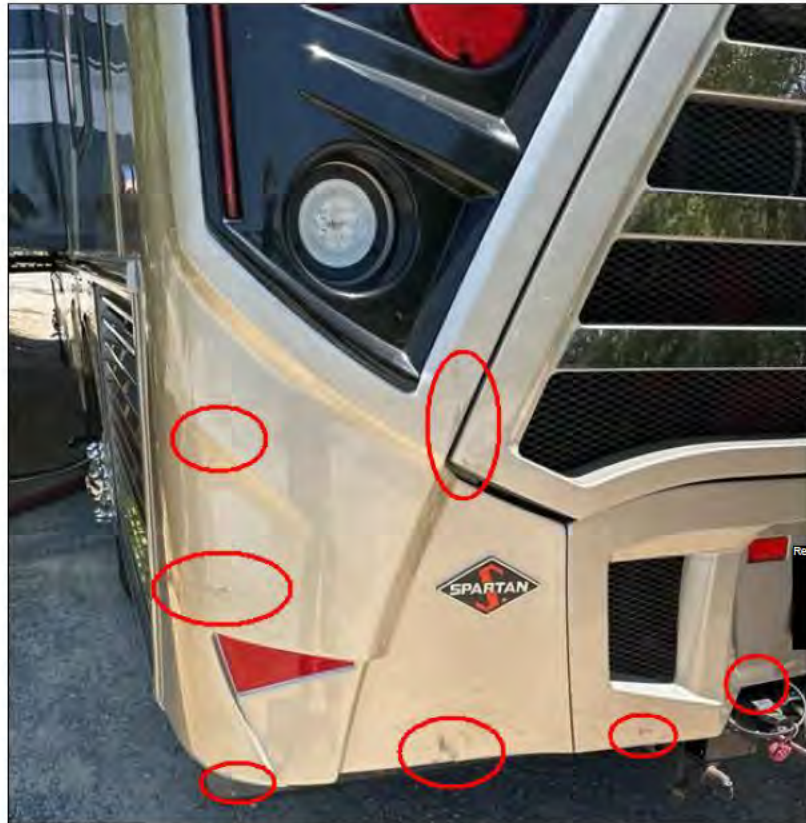
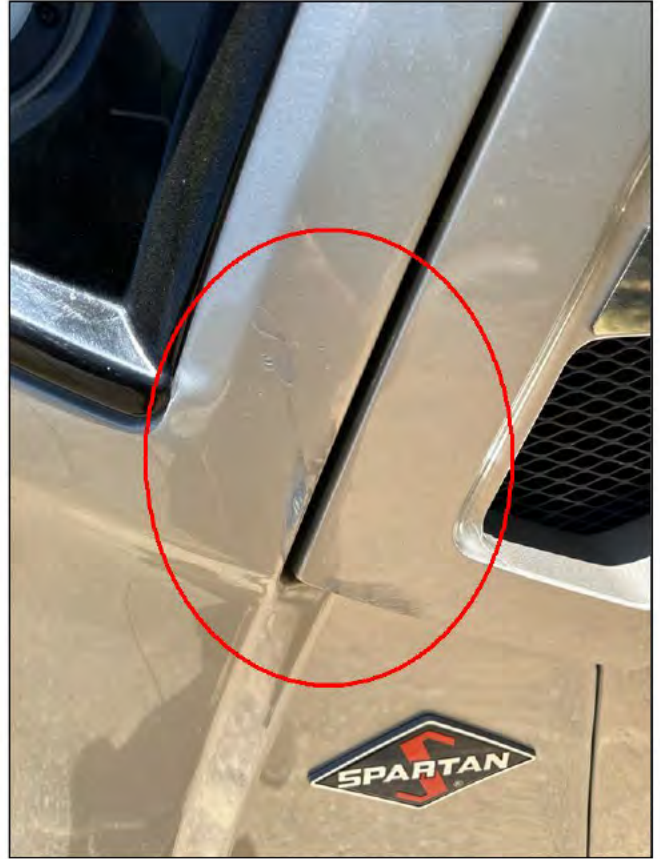
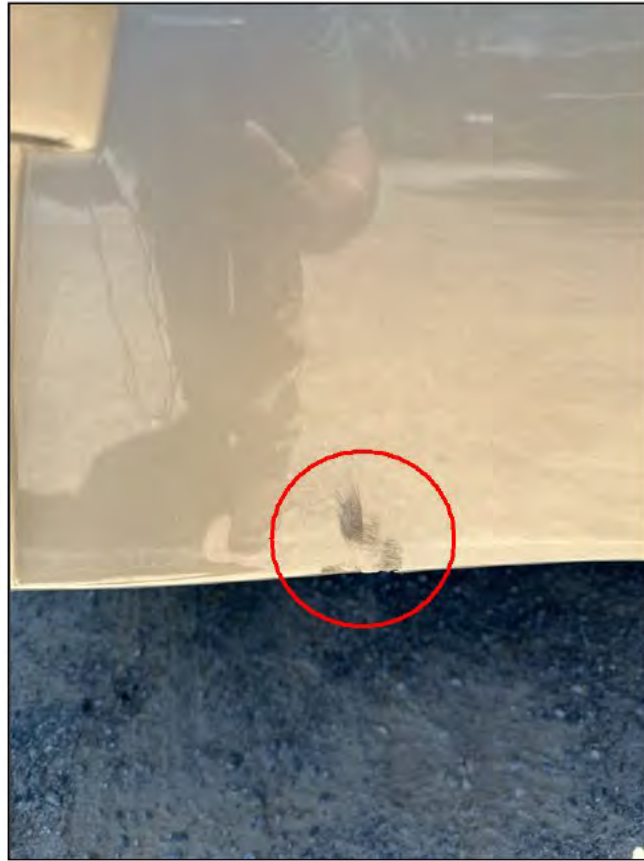
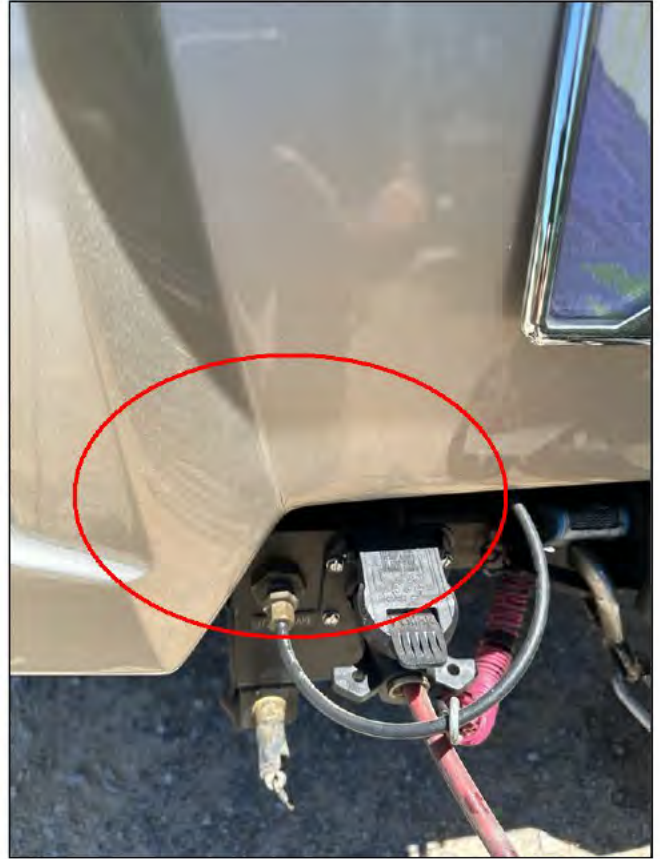
Inspector noted scrapes and cracks along the rear cap wall from the mid-line to the streetside.

Streetside rear cap wall

Streetside rear cap wall just streetside of the engine compartment

Streetside rear cap wall just under the Spartan logo

Hairline cracks above air brake line on hitch

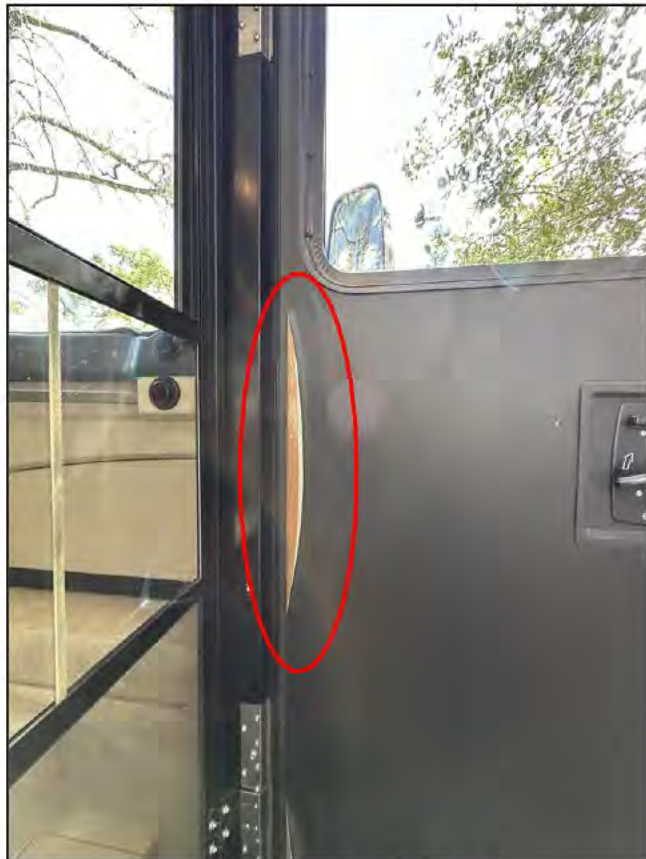
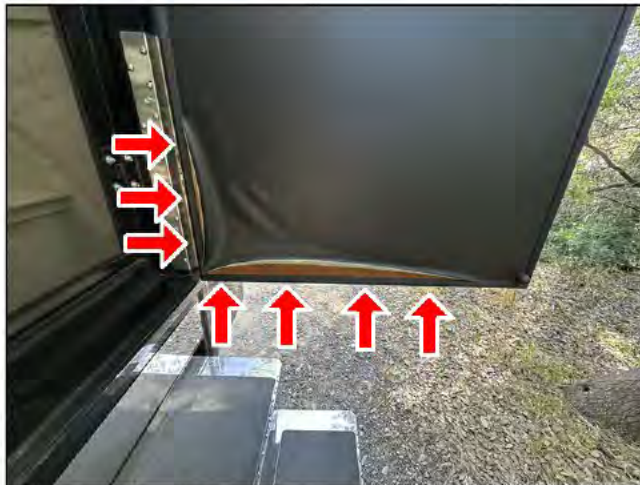
- (1) Inspector noted that the black facing on the interior of the main door is peeling off in several places. It is recommended that a qualified RV technician repair the door facing.

Middle front edge of main door

Bottom and front interior edges of main door

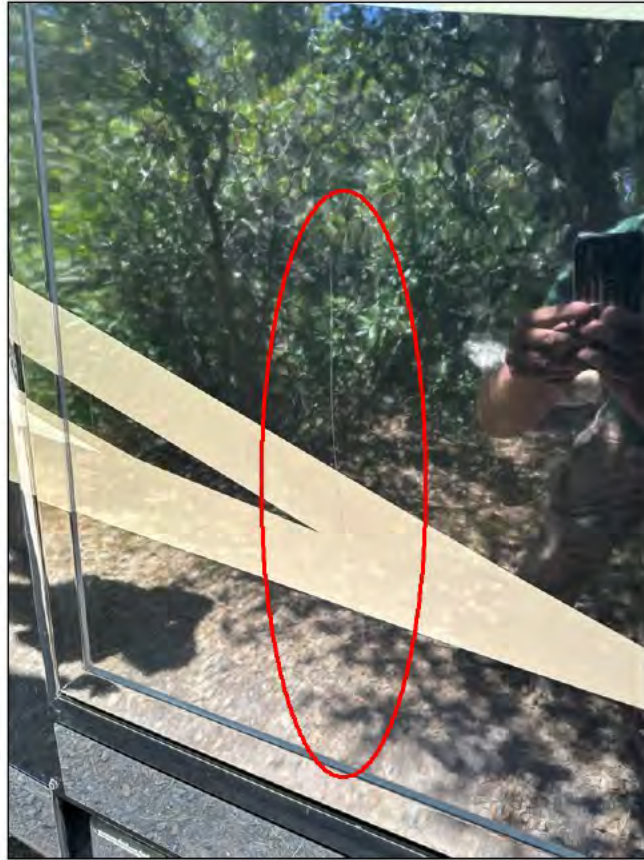
(2) Inspector noted a vertical scratch at the bottom portion of the main door.

Bottom middle of main door

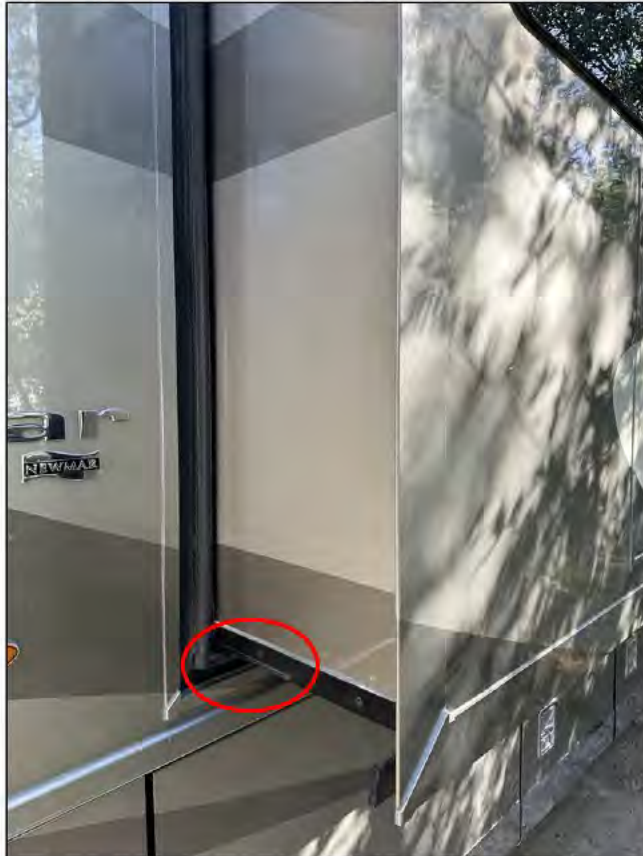
Inspector noted scratches along the bottom rear bracket of the front curbside slide. It is recommended that a qualified RV technician ensure there is no on-going scraping occurring and repair as needed.

Rear bottom bracket of front curbside slide

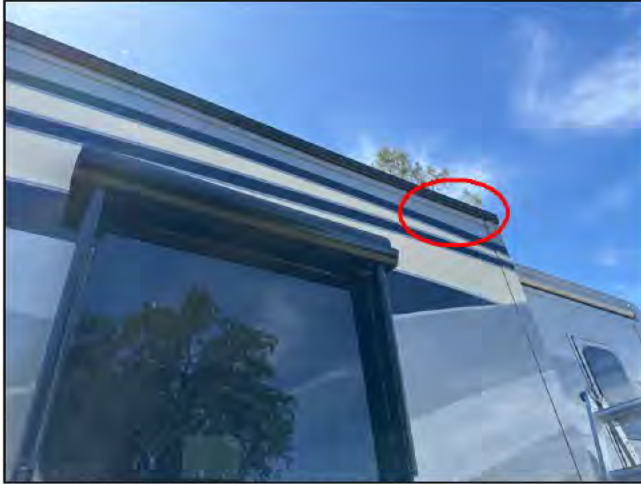
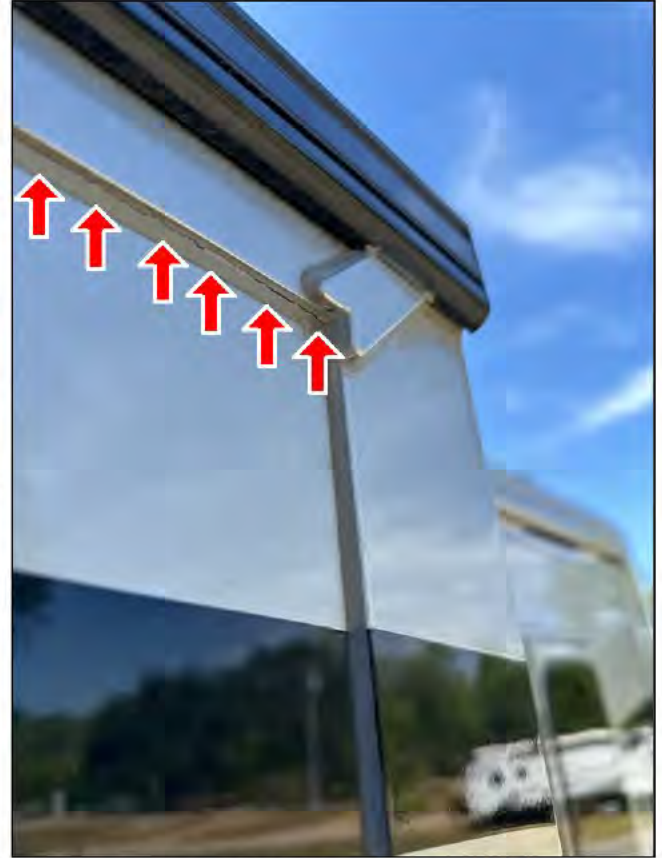
- Inspector noted cracking in the sealant of the front slide at the top front corner under the T-molding. It is recommended that a qualified RV technician repair the sealant to prevent possible future water intrusion.

Top front corner of front curbside slide

Top front corner of curbside front slide

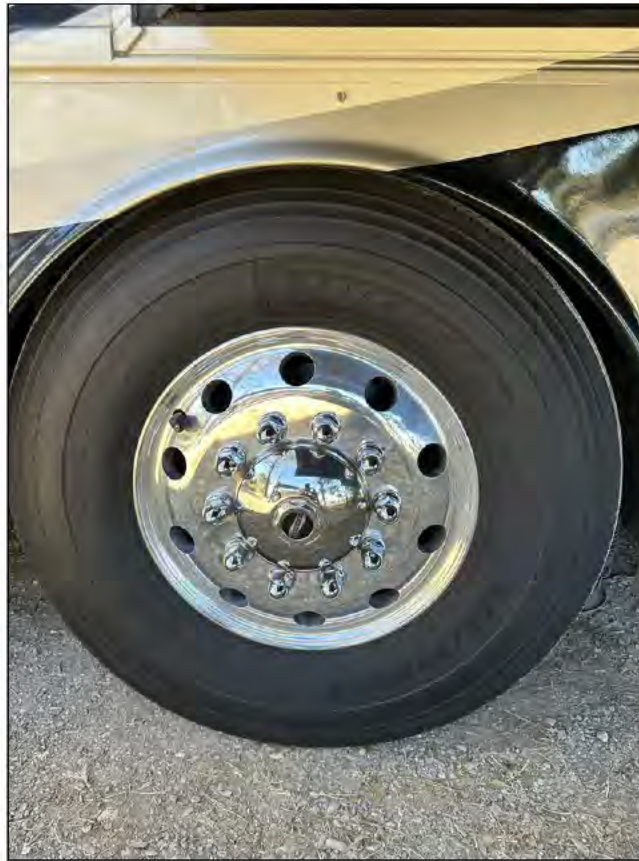
Inspector noted that the front curbside tire was manufactured in 2017, making it more than 6 years old. The National Transportation Safety Board (NTSB) and some tire manufacturers are recommending that all tires older than six years should be replaced, regardless of their condition.

Front curbside tire and wheel

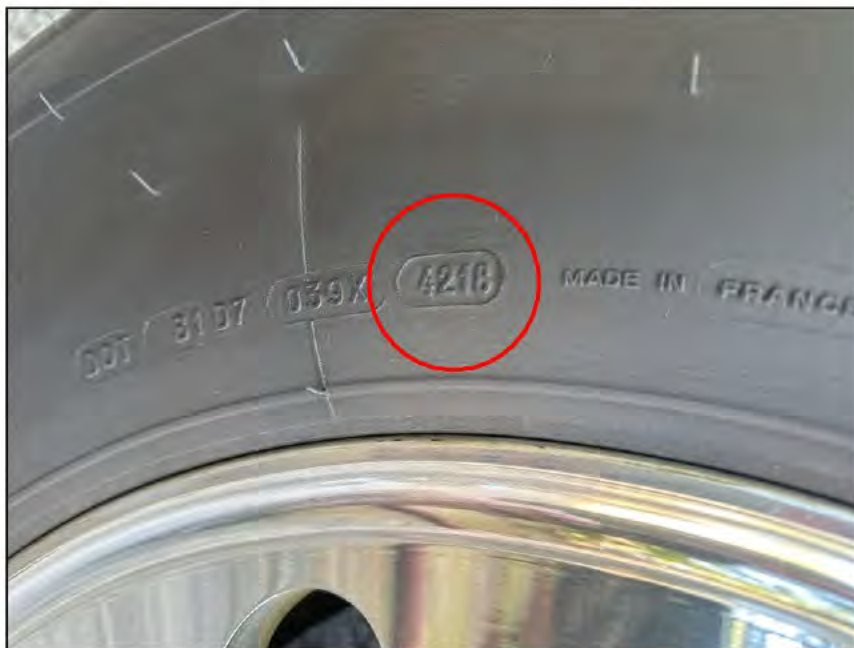
**\$** Inspector noted that the streetside tag tire was manufactured in 2018, making it almost 6 years old. The National Transportation Safety Board (NTSB) and some tire manufacturers are recommending that all tires older than six years should be replaced, regardless of their condition.

DOT date on streetside tag axle tire

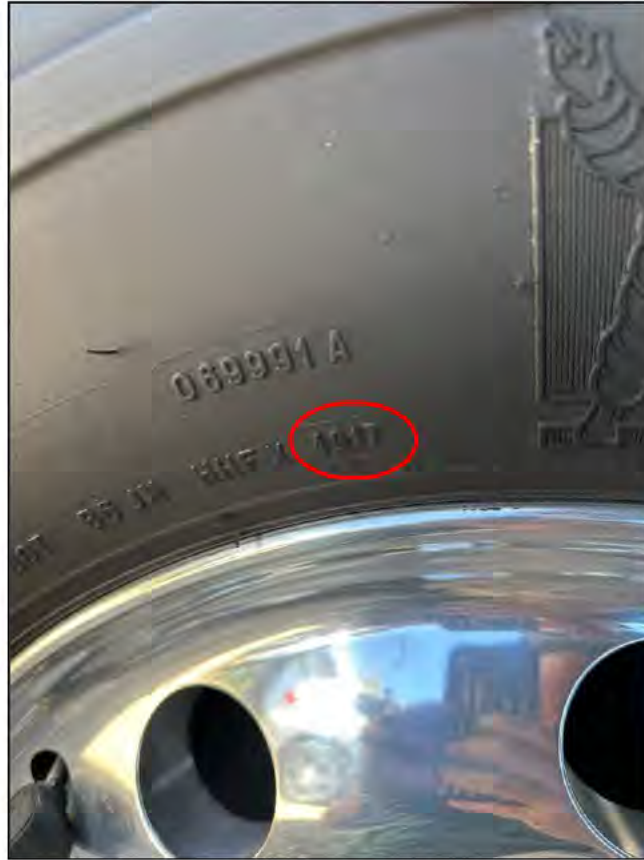
**+** Inspector noted that the front streetside tire was manufactured in 2017, making it more than 6 years old. The National Transportation Safety Board (NTSB) and some tire manufacturers are recommending that all tires older than six years should be replaced, regardless of their condition.

DOT date on streetside front tire

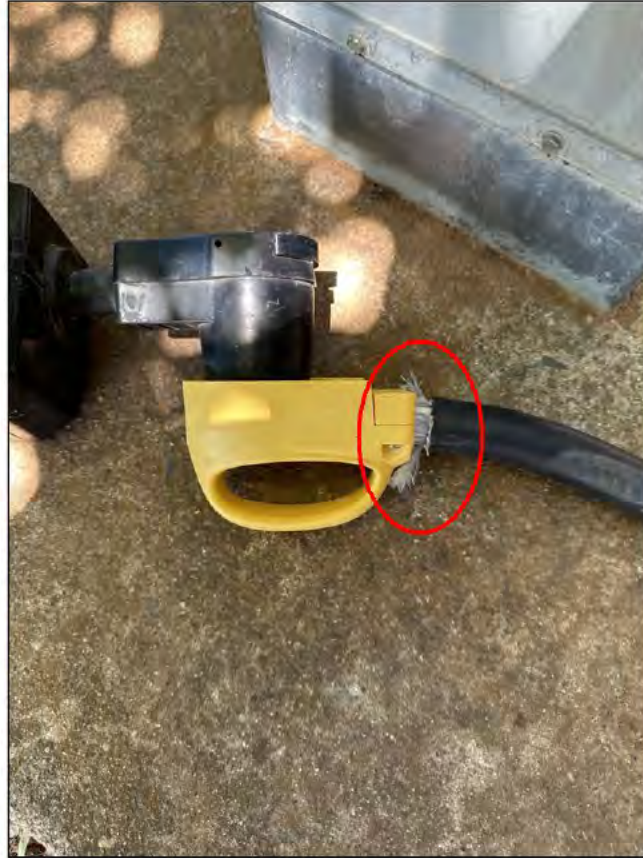
**\$** Inspector noted that the insulation at the male end of the cord has pulled away from the plug. It is recommended that a qualified RV technician repair or replace the cord before the RV is used.

Male end of power cord

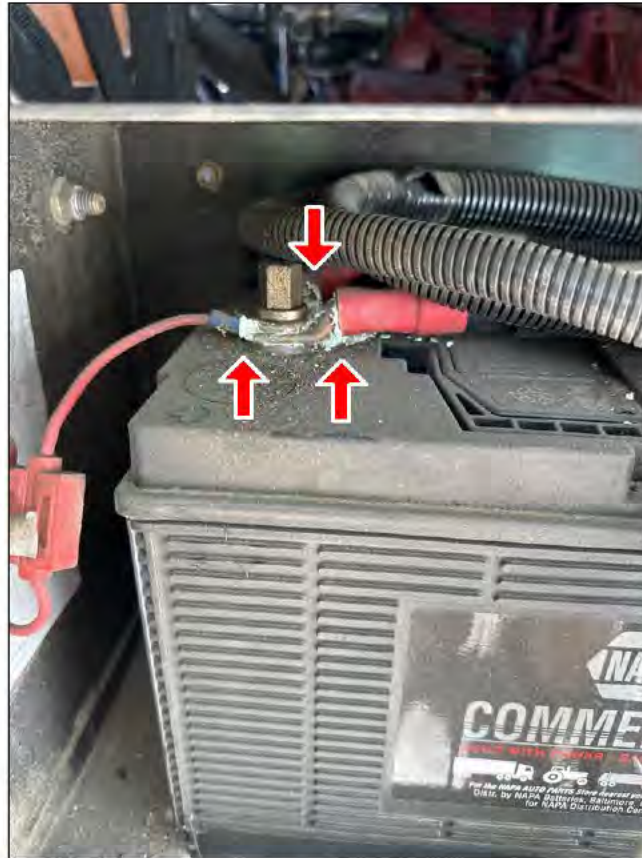
Inspector noted that the rear-most chassis battery had corrosion around the positive terminal. It is recommended that a qualified RV technician repair this issue before the RV is used.

Rear-most chassis battery in curbside rear cargo bay

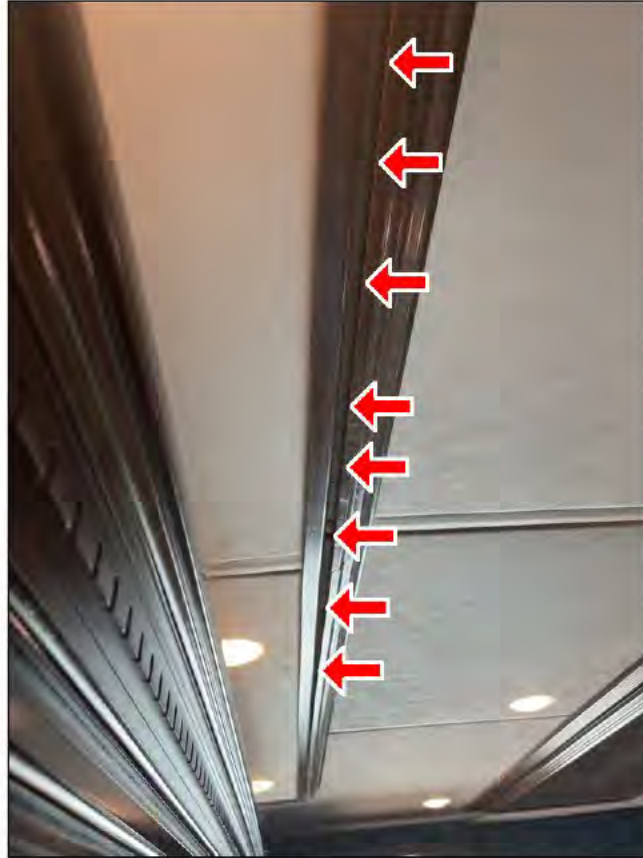
Inspector noted that the the front streetside slideout trim had began to separate from the wall. It is recommended that this be repaired by a qualified RV technician.

Front streetside slideout ceiling trim located above the center table

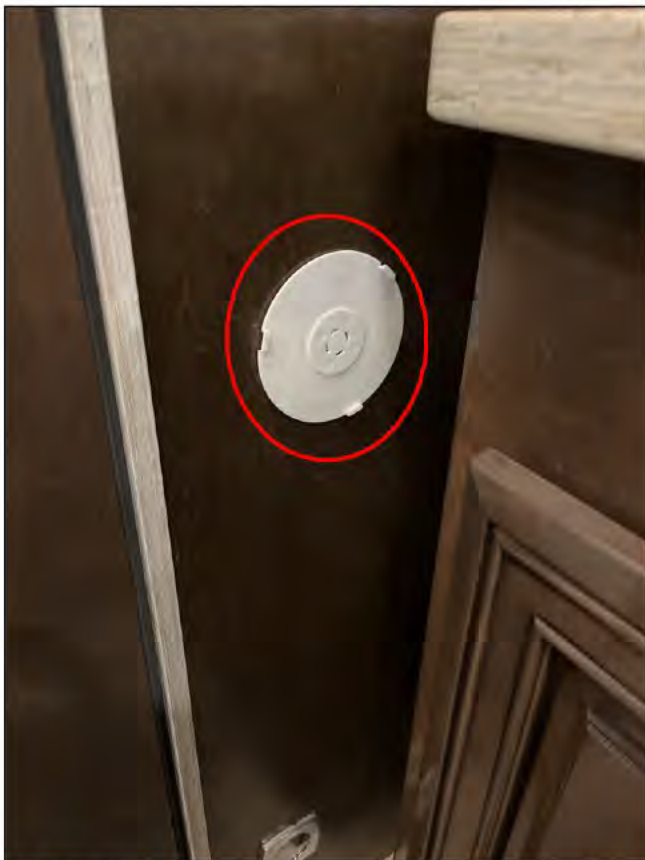
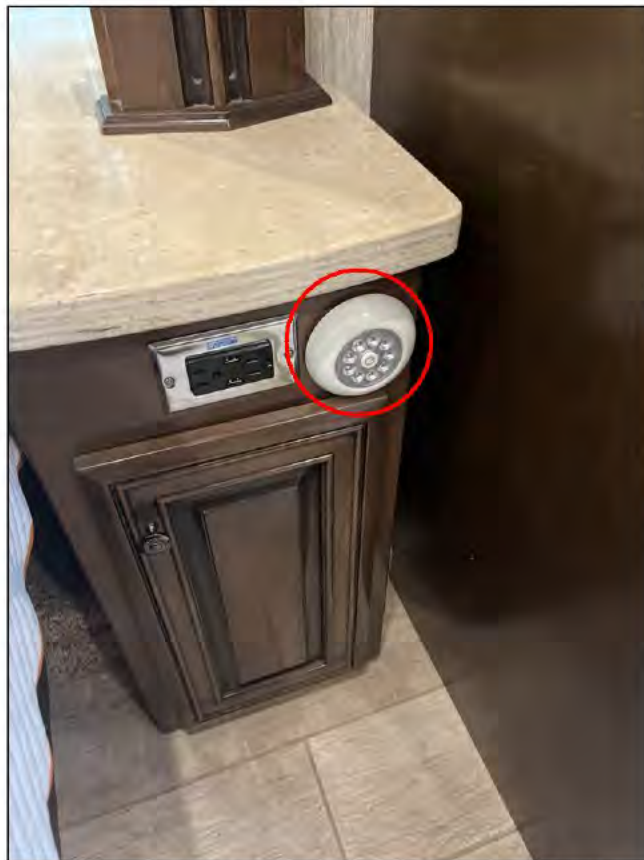
Inspector noted a white disc attached to the wall next to the forward main bed nightstand. Inspector also noted an aftermarket light in a similar location on the rear main bed nightstand.

White disc on the wall forward of the main bed nightstand

After market light on the rear master bed nightstand

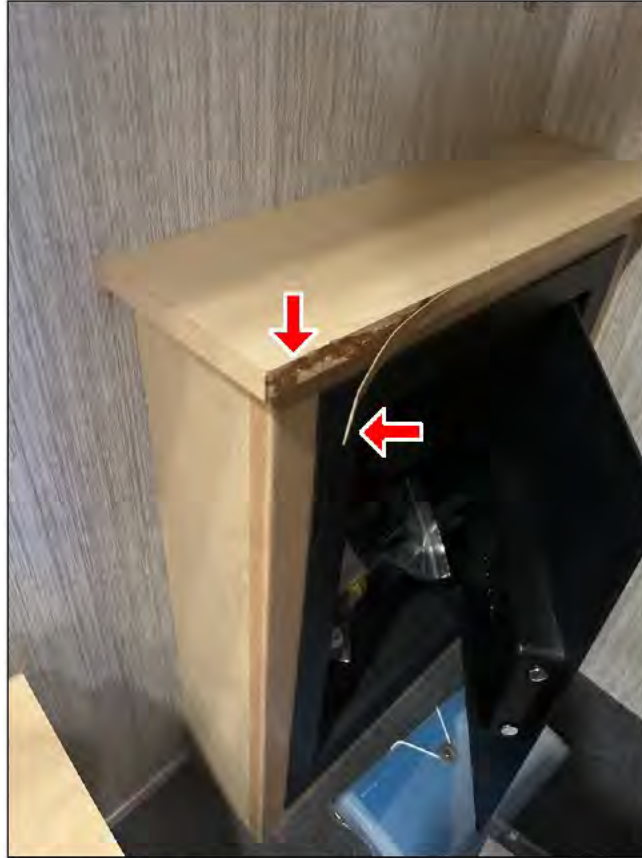
Inspector noted raised trim in the rear main bedroom closet on the streetside above the safe. It is recommended that this be repaired by a qualified RV technician.

Streetside rear, in master bathroom closet  
around safe

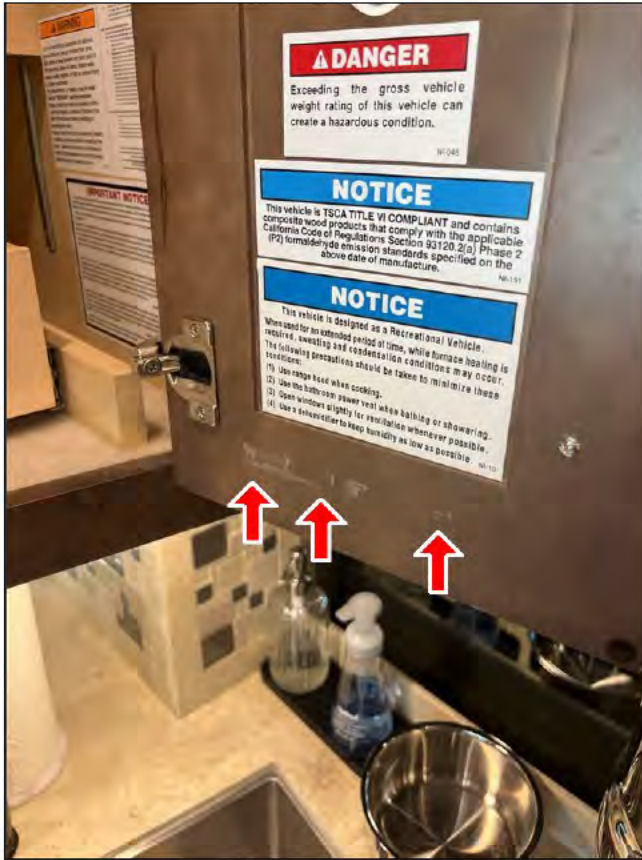
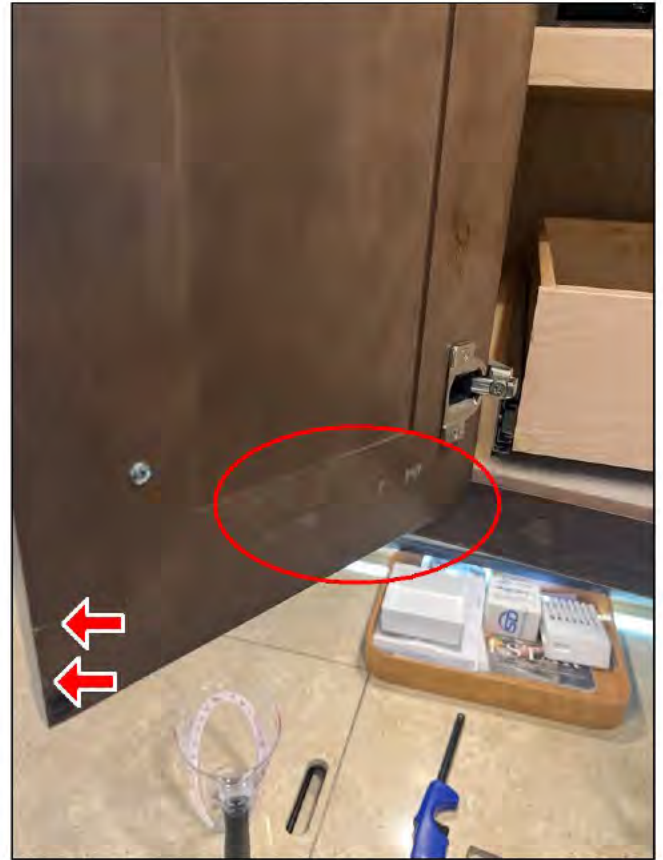
Inspector noted some discoloration on the bottom interior of the cabinet doors above the kitchen sink.

Rear curbside cabinet door above kitchen sink

Front curbside cabinet door above kitchen sink

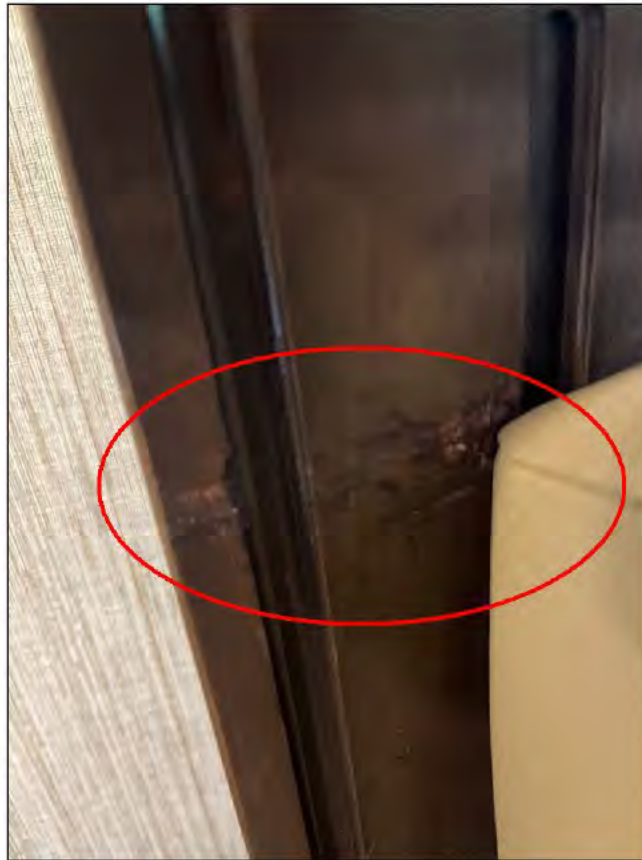
- (1) Inspector noted scraping on the streetside, middle window trim piece, forward of the dinette.

Streetside middle window trim forward of dinette

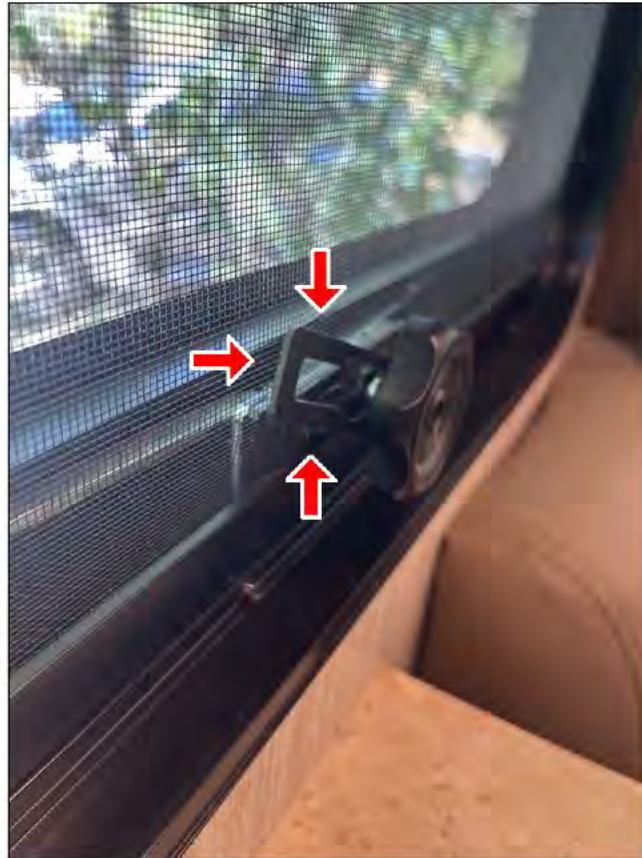
- (2) Inspector noted a loose piece of plastic around the window knob of the streetside forward dinette window. It is recommended that this be repaired by a qualified RV technician.

Streetside forward dinette window

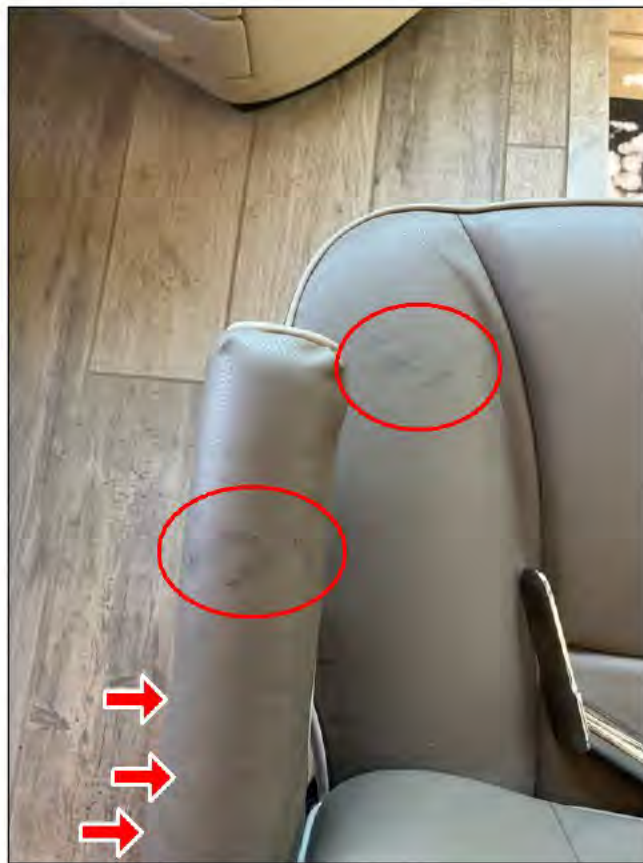
Inspector noted discoloration on the streetside of the passenger seat.

Discoloration on the streetside passenger seat
