RV Inspection Report

24 May 2024: 2024 Pleasure Way Plateau TS

5Js RV LLC

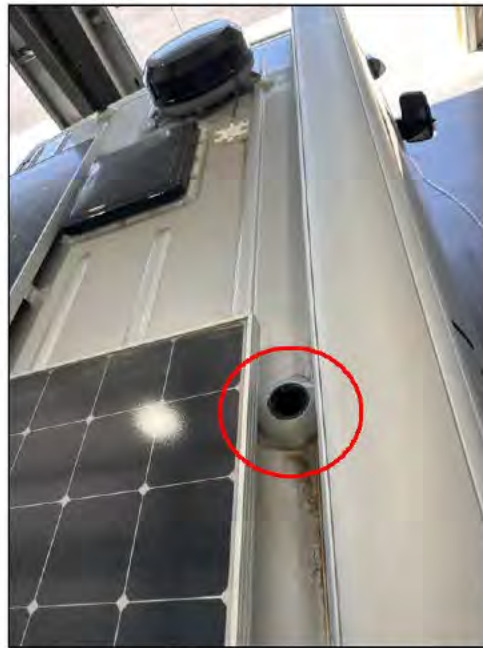
Curbside roof above sliding door

(1) Inspector noted a pipe coming through the curbside roof above the sliding door with no cover over it. It is recommended that a qualified RV technician repair to prevent possible future water intrusion.

\$ (1) Inspector noted a pipe coming through the curbside roof above the sliding door with no cover over it. It is recommended that a qualified RV technician repair to prevent possible future water intrusion.

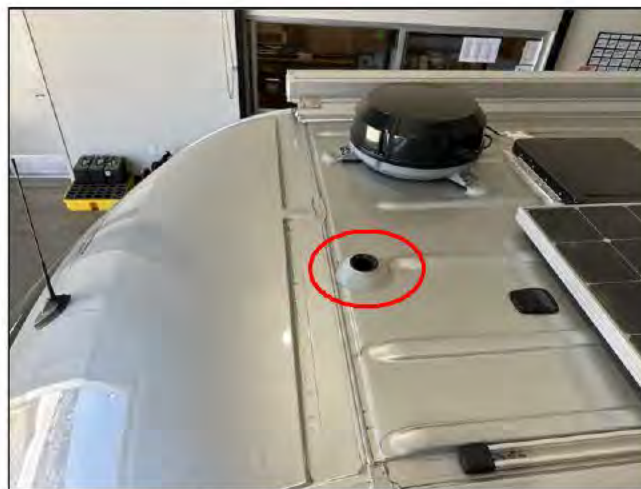
Front center of roof

(2) Inspector noted a pipe coming through the center front of the roof with no cover over it. It is recommended that a qualified RV technician repair to prevent possible future water intrusion.

\$ (2) Inspector noted a pipe coming through the center front of the roof with no cover over it. It is recommended that a qualified RV technician repair to prevent possible future water intrusion.

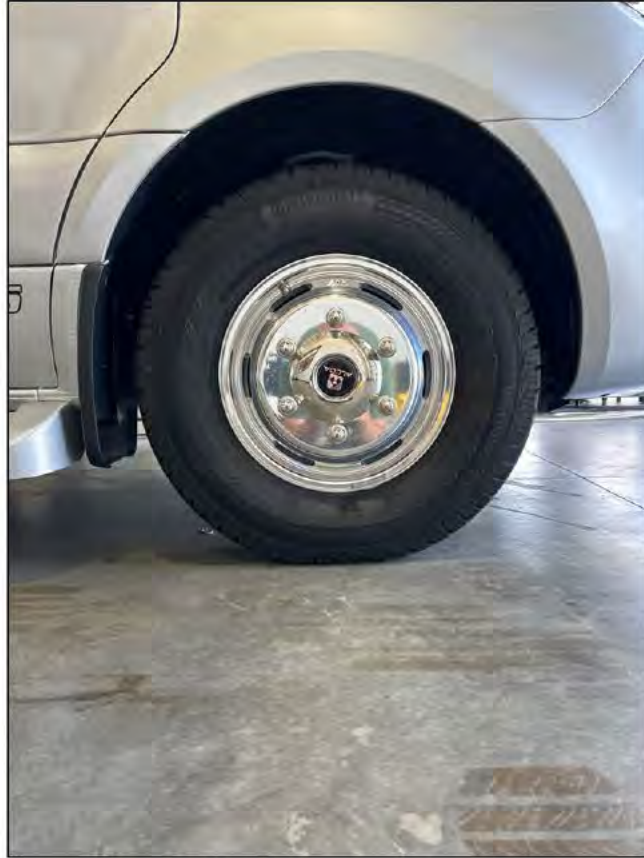
Front curbside wheel assembly

Inspector was unable to visually verify the DOT manufacture date on the front curbside tire due to the mounting direction of the tire. It is recommended that a qualified tire technician verify the DOT manufacture date before the RV is driven.

+ Inspector was unable to visually verify the DOT manufacture date on the front curbside tire due to the mounting direction of the tire. It is recommended that a qualified tire technician verify the DOT manufacture date before the RV is driven.

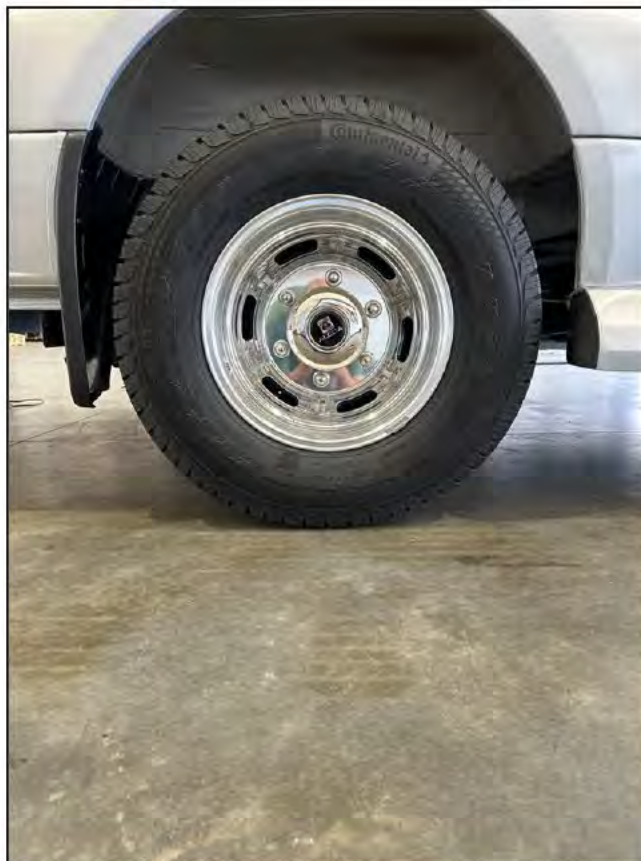
Rear curbside outside wheel assembly

Inspector was unable to visually verify the DOT manufacture date on the outside rear curbside tire due to the mounting direction of the tire. It is recommended that a qualified tire technician verify the DOT manufacture date before the RV is driven.

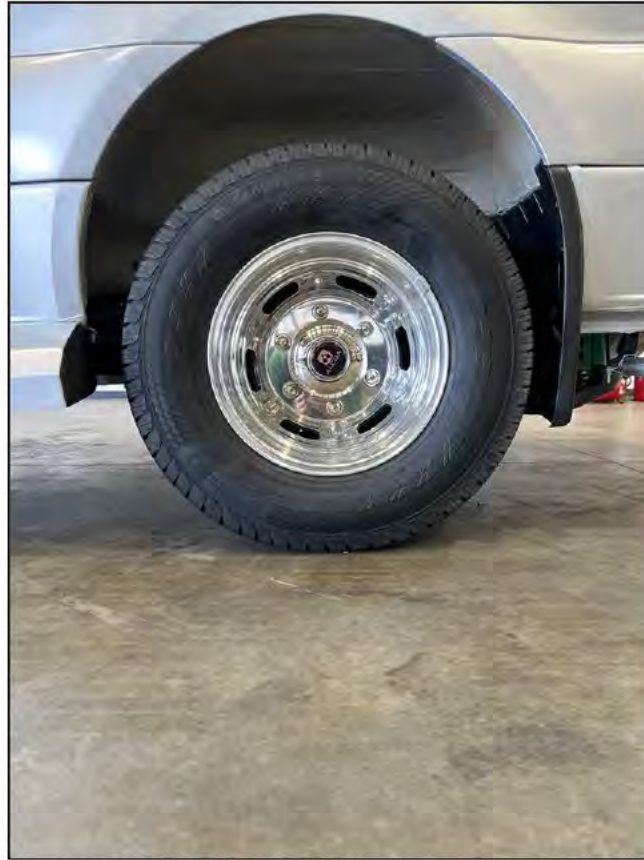
Rear streetside outside wheel assembly

Inspector was unable to visually verify the DOT manufacture date on the outside rear streetside tire due to the mounting direction of the tire. It is recommended that a qualified tire technician verify the DOT manufacture date before the RV is driven.

+ Inspector was unable to visually verify the DOT manufacture date on the outside rear streetside tire due to the mounting direction of the tire. It is recommended that a qualified tire technician verify the DOT manufacture date before the RV is driven.

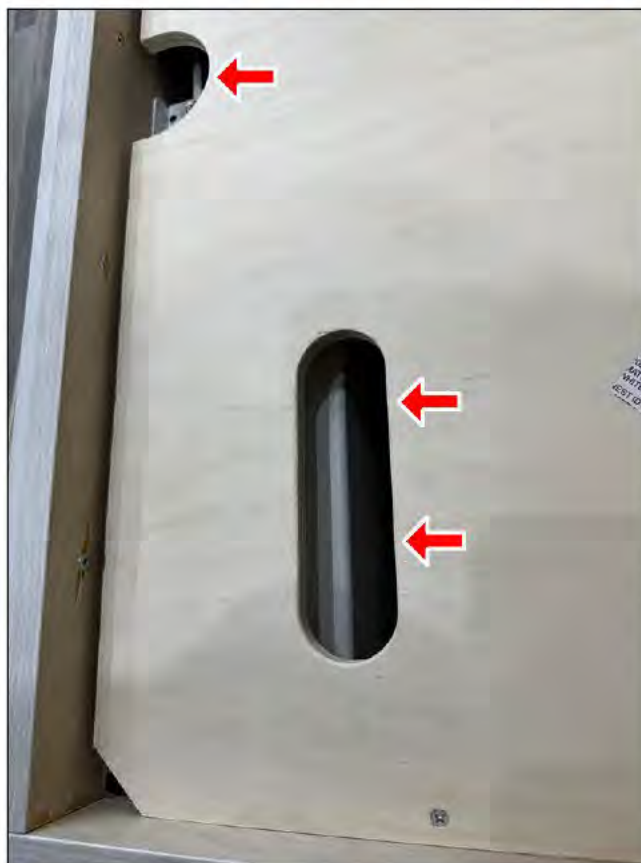
Inspector was unable to access the inverter to inspect the cables, wiring, and fuses.

Inverter under curbside rear chair with limited access

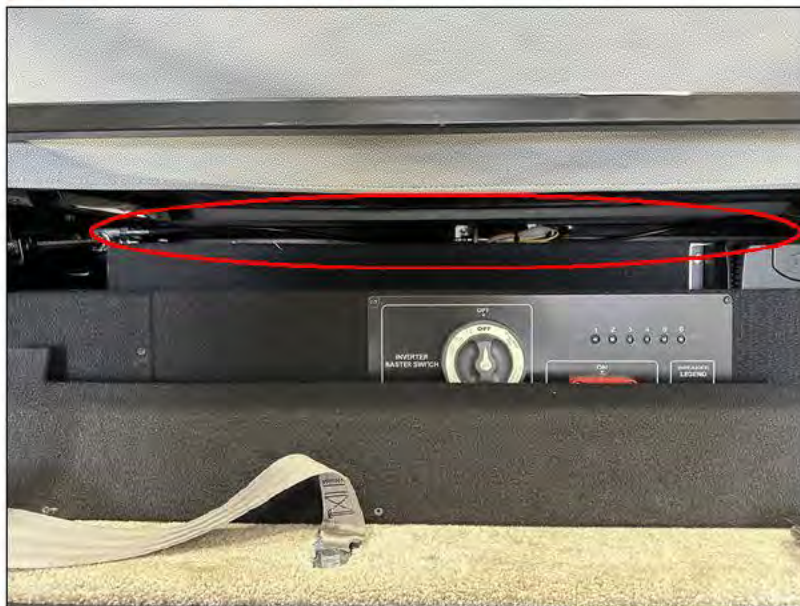
Inspector was unable to fully visualize the house batteries due to their location under the rear couch with inadequate clearance above them for access.

Battery access under the rear couch from rear

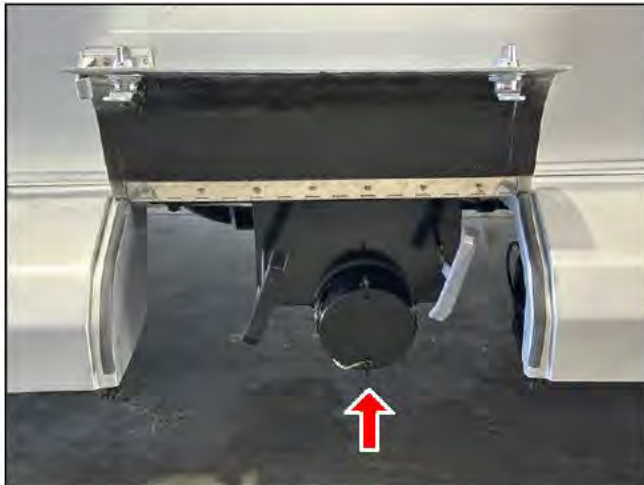
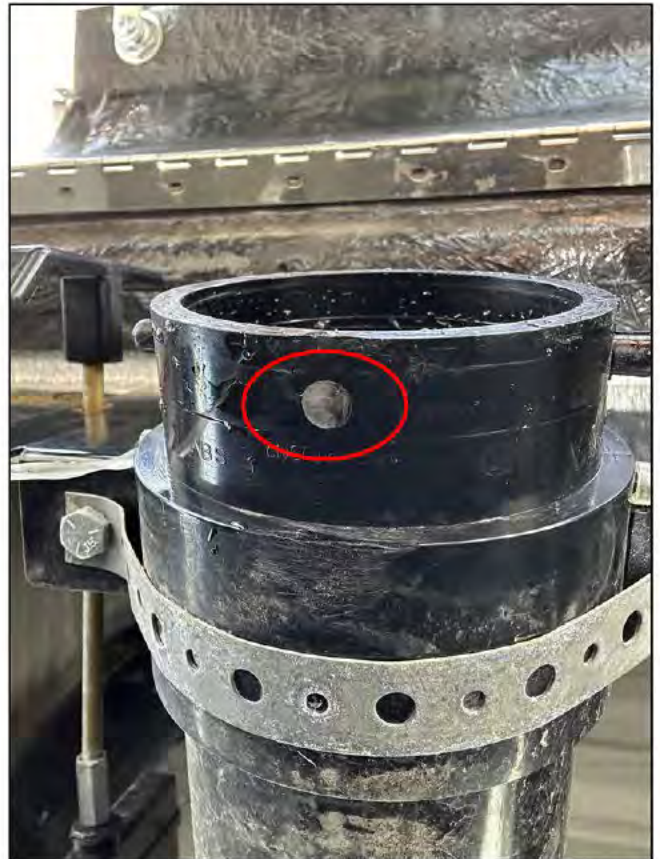
Inspector noted a missing lug "node" on the bottom of the sewer hose connection on the streetside. The bayonet fittings on the sewer hoses and the drain cap still fit tightly if attached with the bayonet openings at left and right position. If the bayonet openings are at the top and bottom, there is no lug for the bayonet to attach to at the bottom, making a poor seal. It is recommended that a qualified RV technician repair or replace the sewer hose connection to ensure a good seal and prevent possible leakage of black or gray water.

\$ Inspector noted a missing lug "node" on the bottom of the sewer hose connection on the streetside. The bayonet fittings on the sewer hoses and the drain cap still fit tightly if attached with the bayonet openings at left and right position. If the bayonet openings are at the top and bottom, there is no lug for the bayonet to attach to at the bottom, making a poor seal. It is recommended that a qualified RV technician repair or replace the sewer hose connection to ensure a good seal and prevent possible leakage of black or gray water.

Streetside sewer hose connection behind driver door

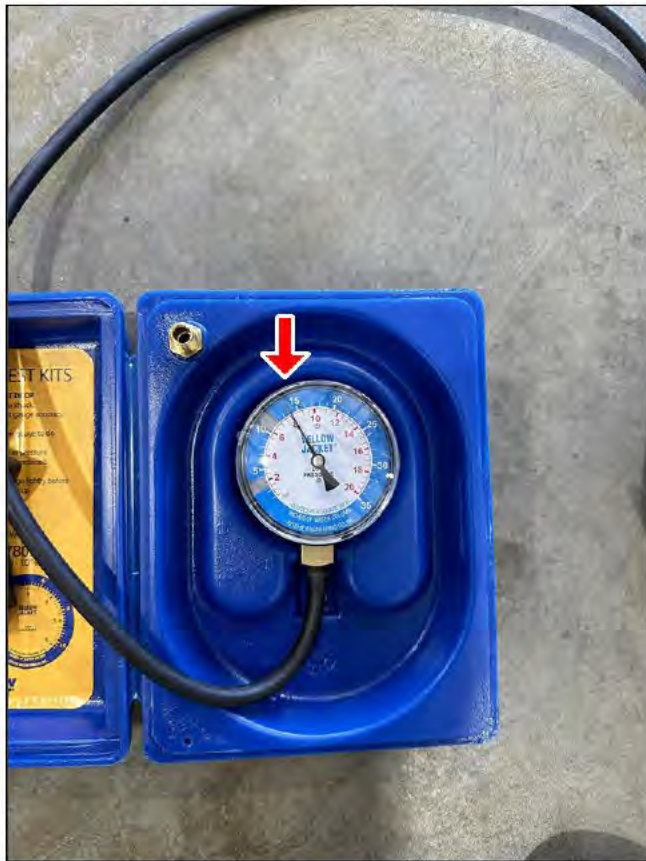
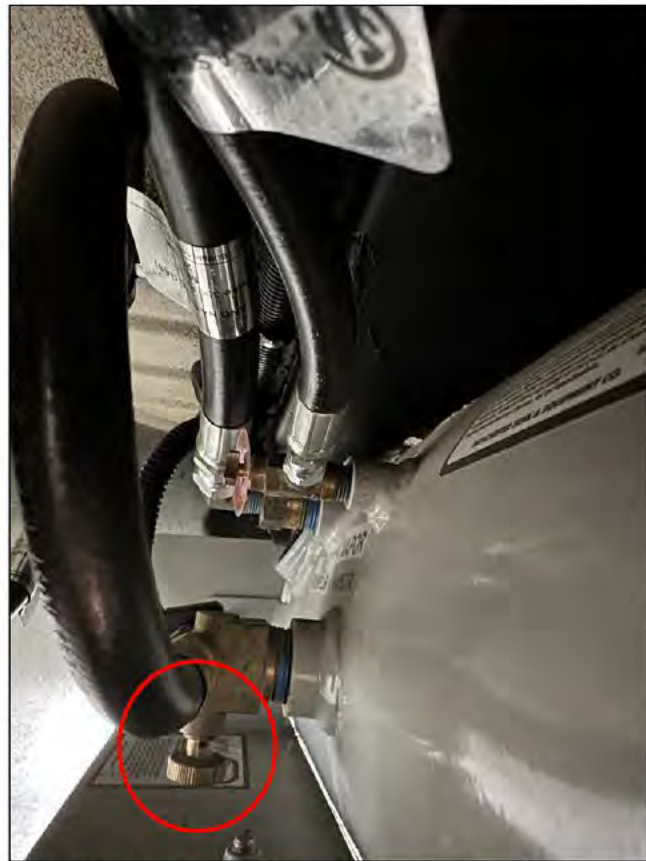
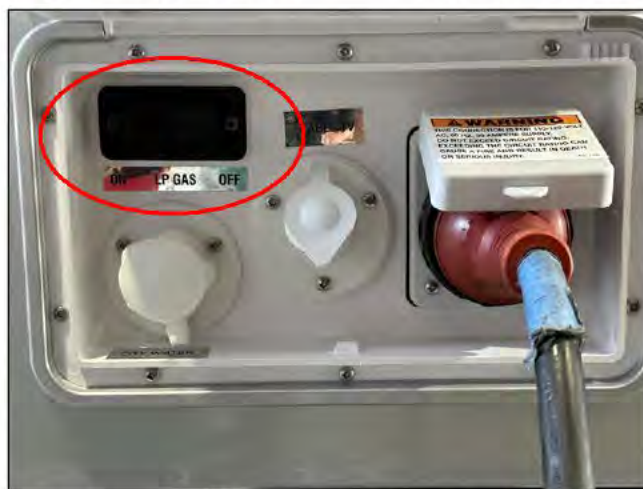
interior of the RV. Inspector turned the knob on the hose going to the regulator out of the tank, but that did not cut the LP pressure at the rear quick connect. Inspector discussed how to turn off the LP at the tank with the assistant RV service supervisor. He did not know and neither did another service tech inspector asked. They both pointed Inspector to the LP disconnect switch. When inspector showed them that the switch did not cut the LP to the quick connect, they suggested that there is no cutoff switch to the rear quick connect. It is recommended that a qualified RV technician determine how to shutoff the LP from the tank to all portions of the RV at one time.

+ Inspector attempted to conduct the LP pressure drop test at the rear external LP quick connect. Unfortunately, the LP disconnect switch did not turn off the LP at the rear quick connect, just at the interior of the RV. Inspector turned the knob on the hose going to the regulator out of the tank, but that did not cut the LP pressure at the rear quick connect. Inspector discussed how to turn off the LP at the tank with the assistant RV service supervisor. He did not know and neither did another service tech inspector asked. They both pointed Inspector to the LP disconnect switch. When inspector showed them that the switch did not cut the LP to the quick connect, they suggested that there is no cutoff switch to the rear quick connect. It is recommended that a qualified RV technician determine how to shutoff the LP from the tank to all portions of the RV at one time.

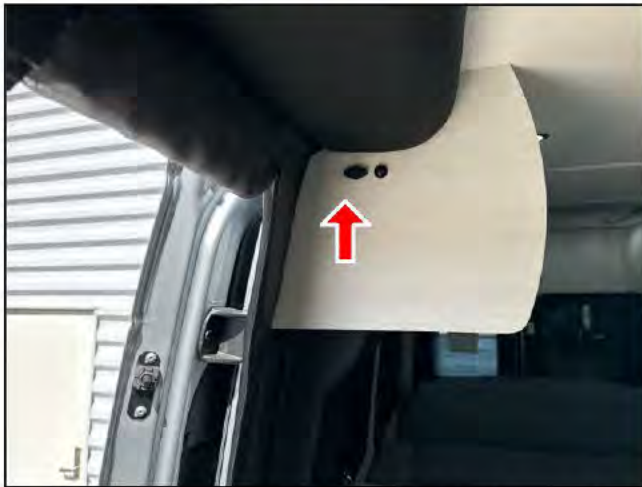
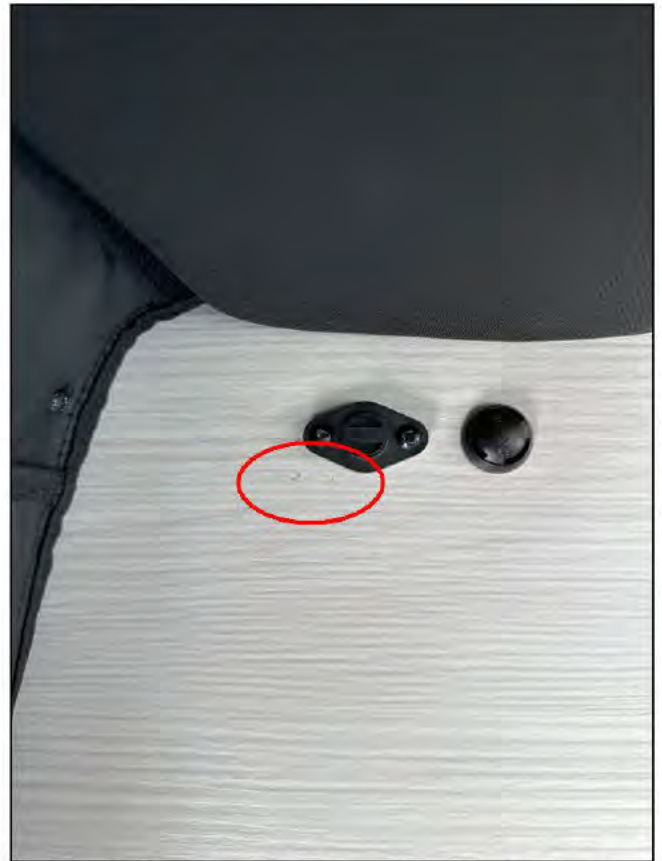
Front side of curbside cabinet just rear of sliding door

(1) Inspector noted black marks under the air conditioner temperature sensor on the front side of the curbside cabinet just rear of the sliding door.

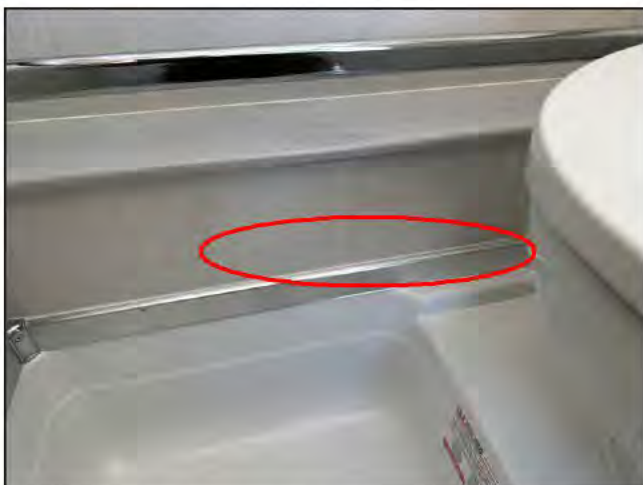
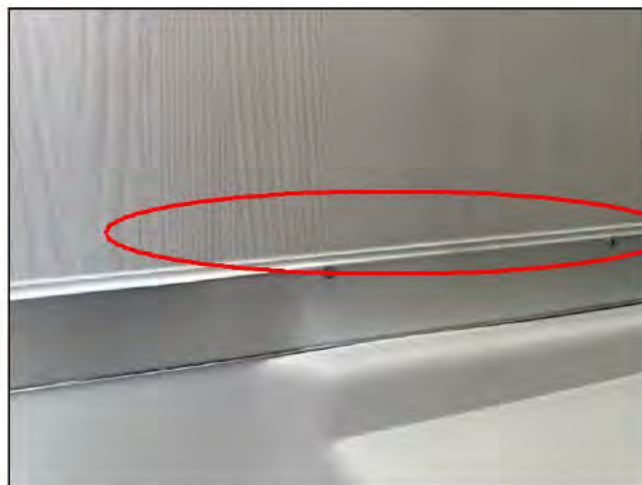
Streetside wall at bottom of bathroom

(2) Inspector noted bumps or scrapes in a line just above the bottom trim rail on the streetside bathroom wall.
