# RV Inspection Report

Inspection Date / RV Model:  
**22 Apr 2024: 2024 Dynamax Isata 3 24FW**

5Js RV LLC

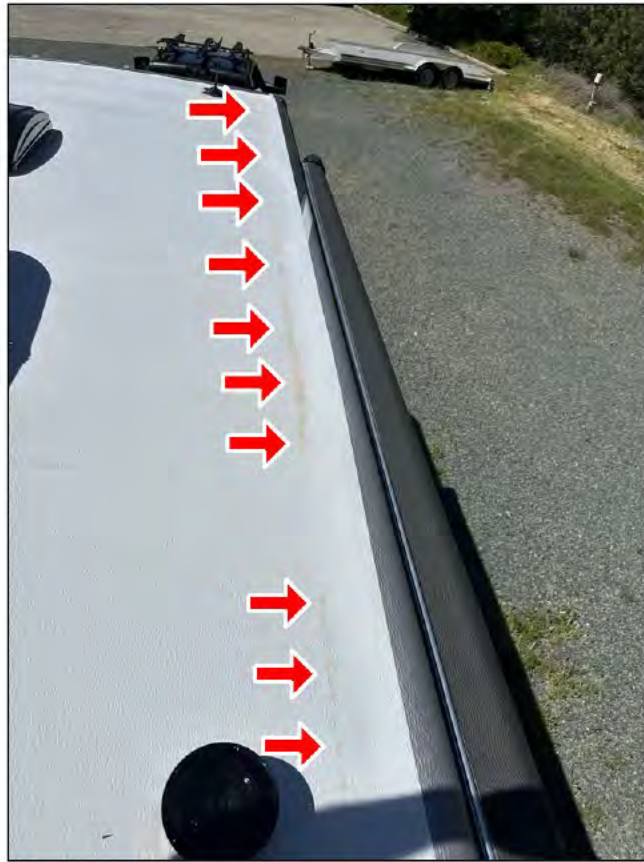
🔍 Inspector noted yellowish stains along both the streetside and curbside edges of the roof.

Curbside edge of roof from rear to front

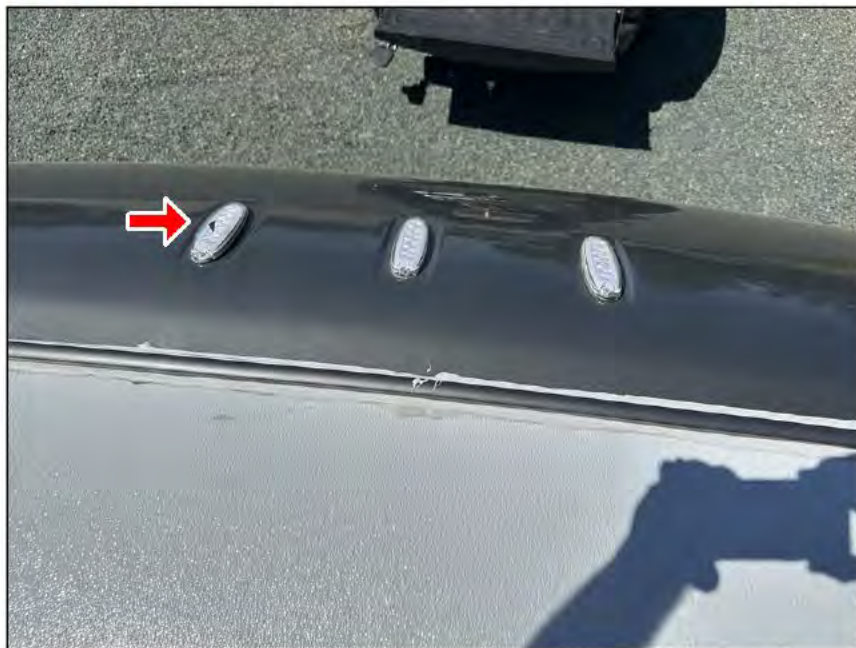
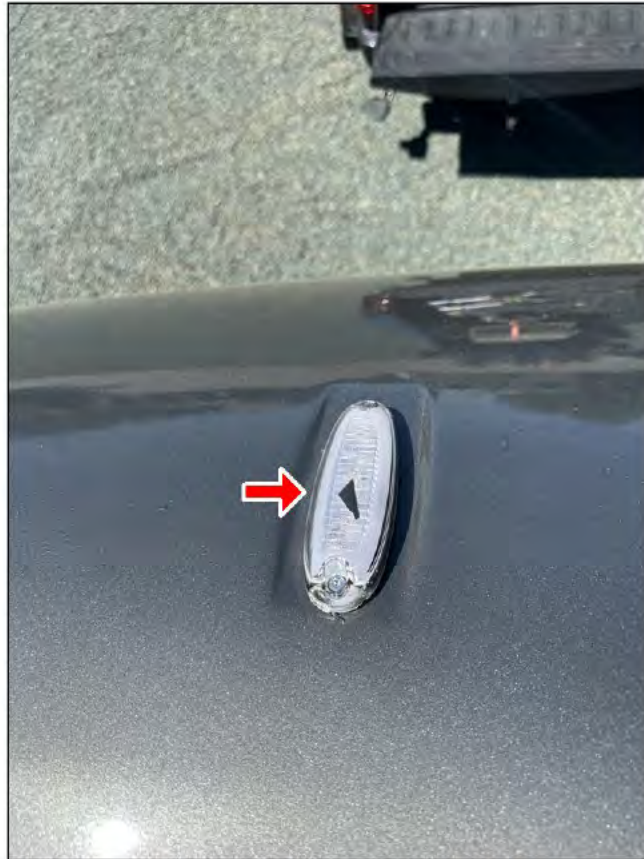
🔍 (1) Inspector noted that there was a triangular substance on the streetside-most light of the center three top marker lights on the front cap.

Three center marker lights on front cap (from top rear)

Close up of streetside-most light of the center three front marker lights (from top rear)

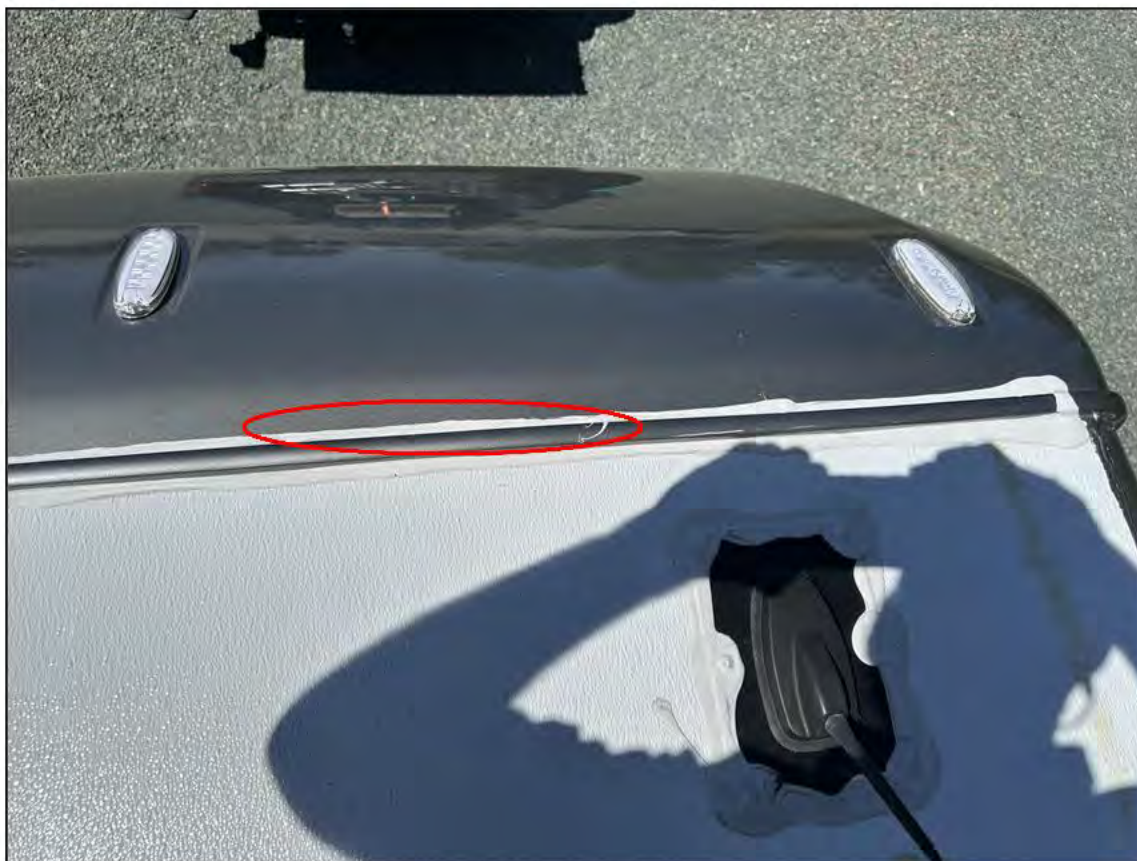
(2) Inspector noted gaps in the sealant along the front cap seam toward the curbside. It is recommended that a qualified RV technician repair to prevent possible future water intrusion.

Front cap seam toward curbside

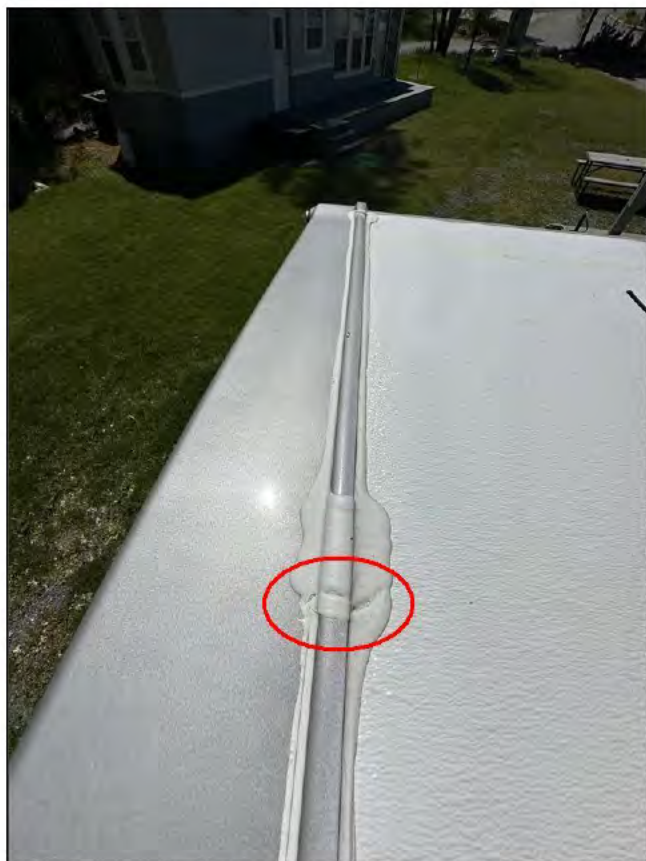
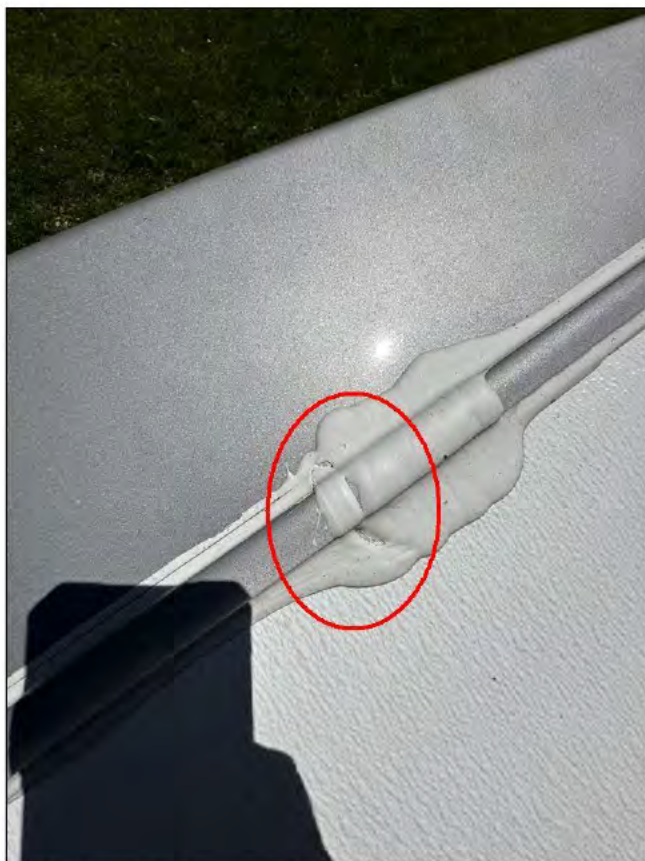
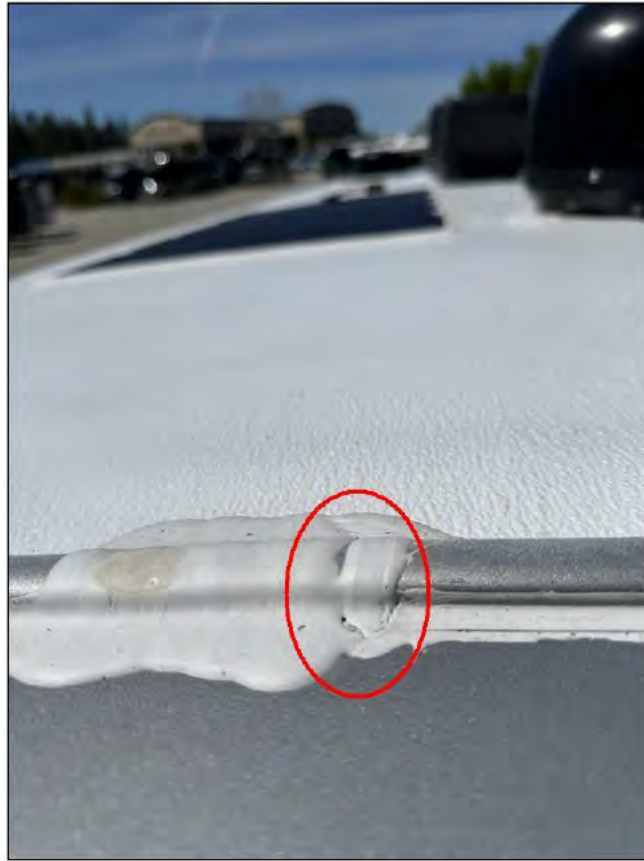
- (1) Inspector noted gaps in the sealant at the middle of the rear cap seam. It is recommended that a qualified RV technician repair to prevent possible future water intrusion.

Middle of rear cap seam from curbside

Middle of rear cap seam from front curbside

Middle of rear cap seam from rear

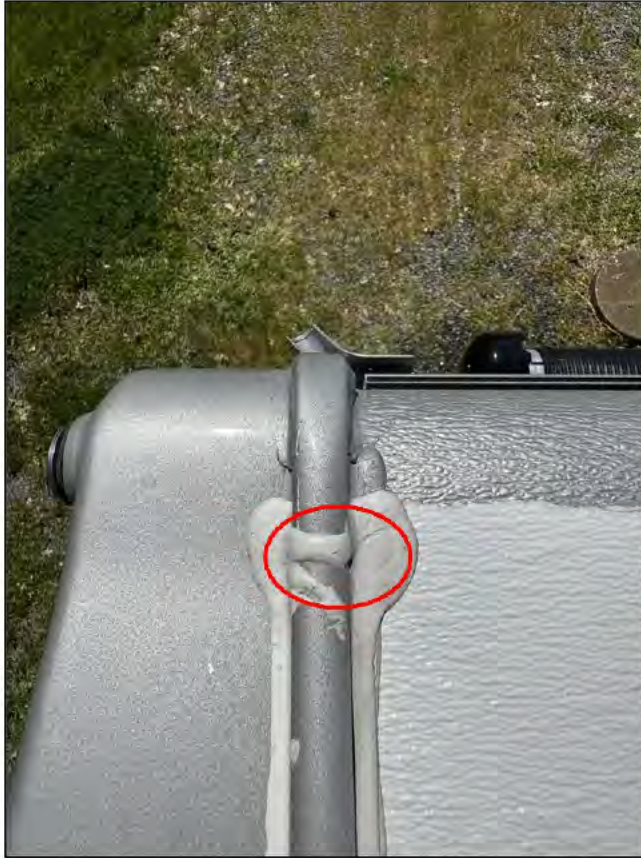
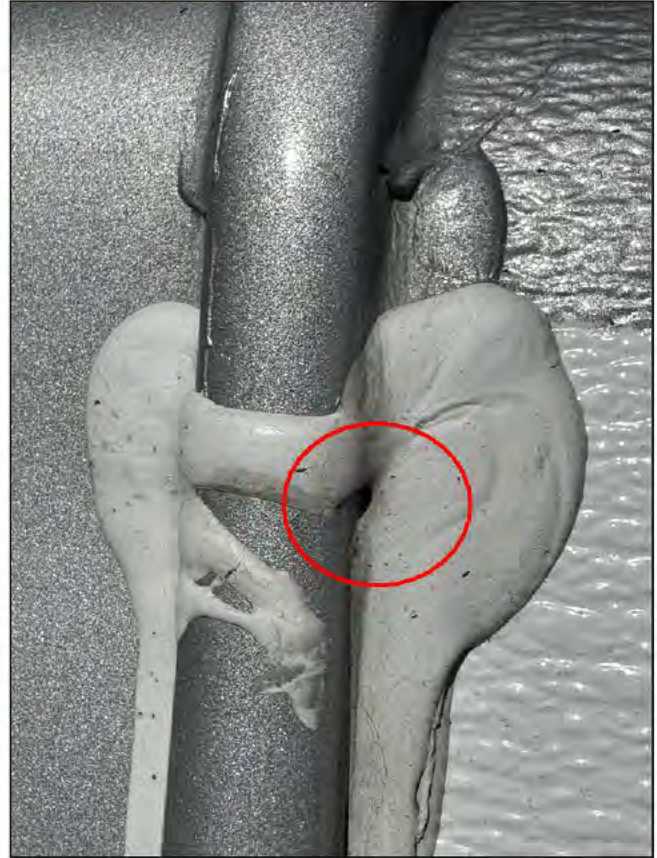
- (2) Inspector noted a gap in the sealant of the rear cap on the streetside rear edge. It is recommended that a qualified RV technician repair to prevent possible future water intrusion.

Streetside edge of rear cap seal

Closeup of streetside edge of rear cap seal (curbside to streetside)

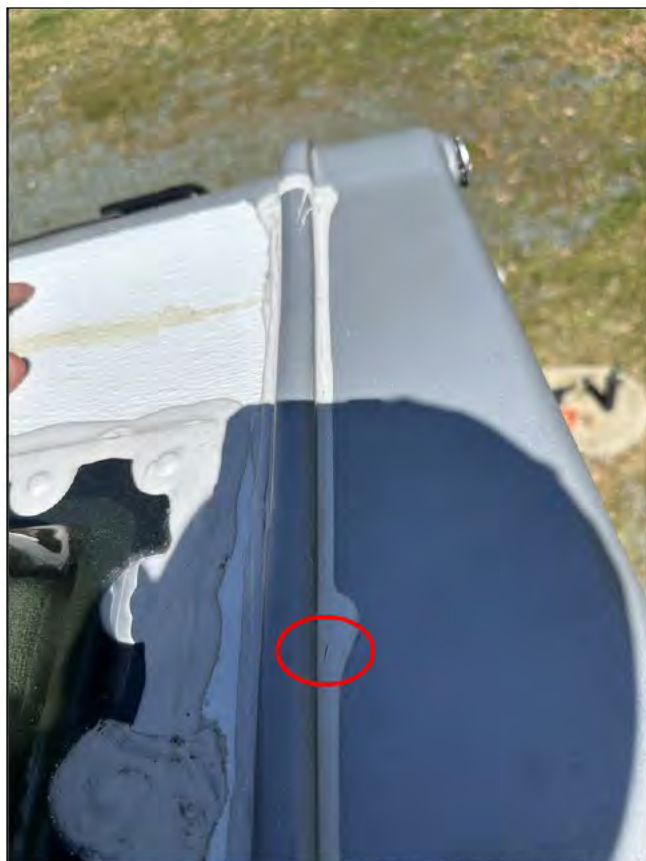
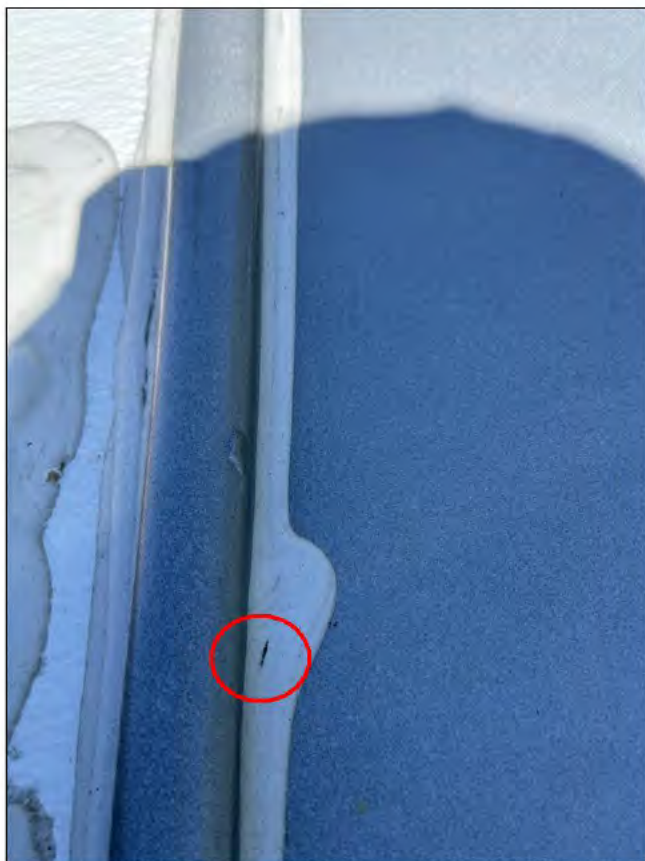
(3) Inspector noted a gap/bubble in the sealant of the rear cap toward the middle. It is recommended that a qualified RV technician repair to prevent possible future water intrusion.

Rear cap seal at middle (from streetside)

Close up of rear cap seal at middle (from streetside)

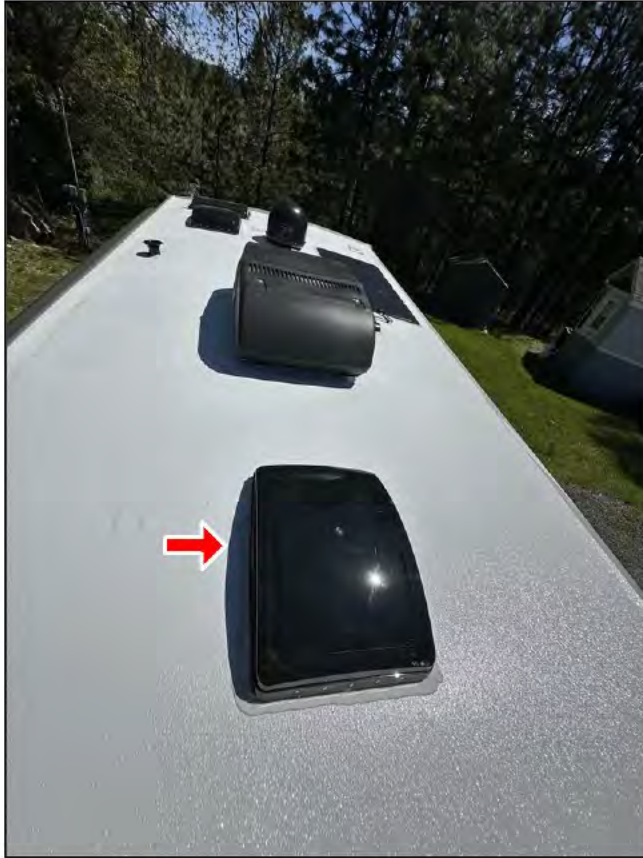
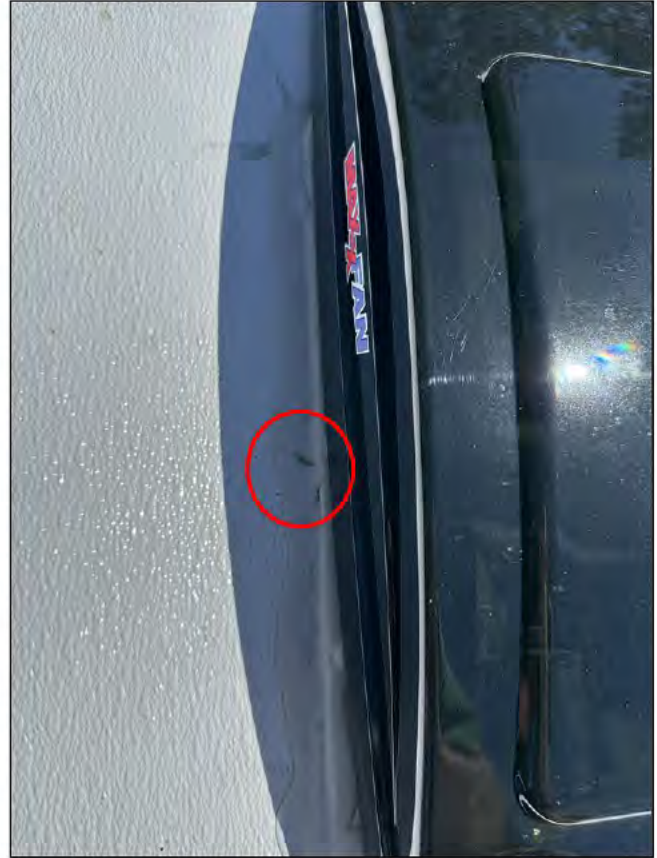
Inspector noted a gap/cut in the sealant of the forward powered vent on the curbside edge. It is recommended that a qualified RV technician repair to prevent possible future water intrusion.

Forward powered vent (from front)

Curbside of the forward powered vent

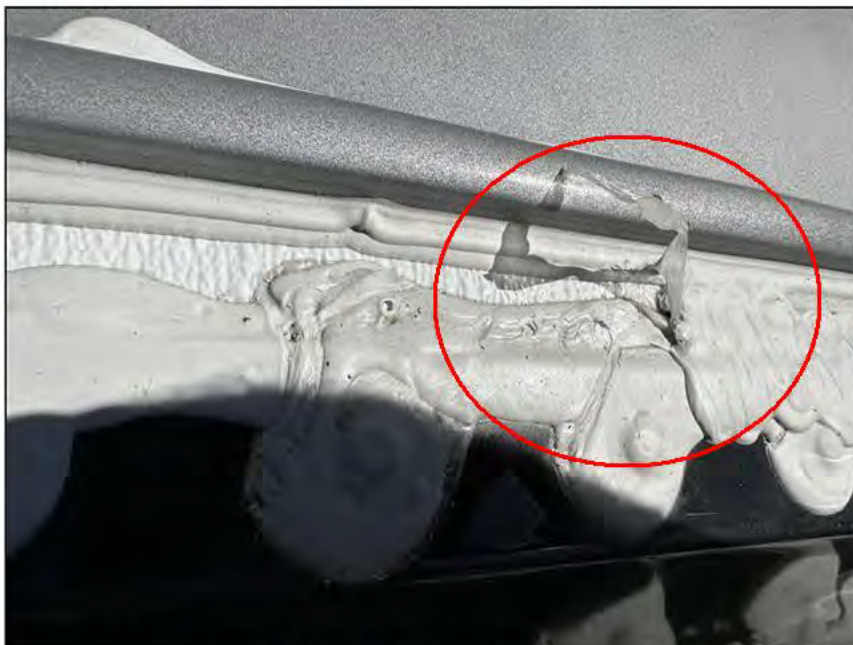
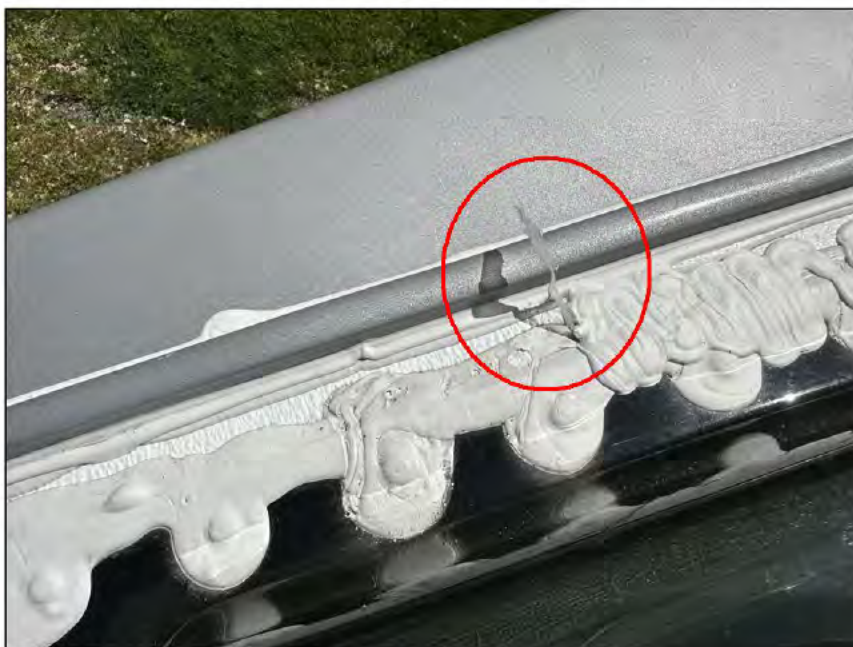
- (1) Inspector noted a piece of plastic under the sealant at the rear edge of the rear skylight that prevents the sealant from forming a tight seal with the roof. It is recommended that a qualified RV technician repair to prevent possible future water intrusion.

Rear edge of rear skylight from curbside front

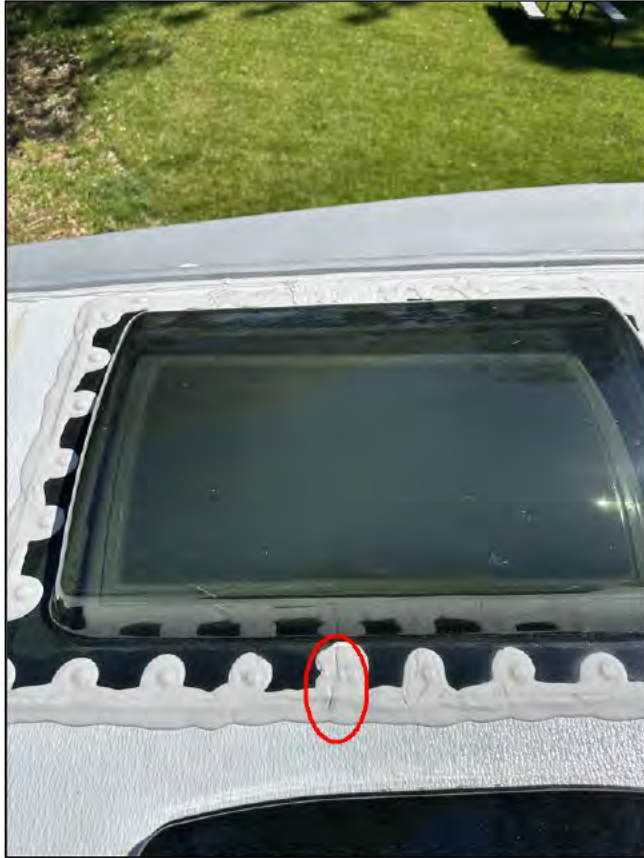
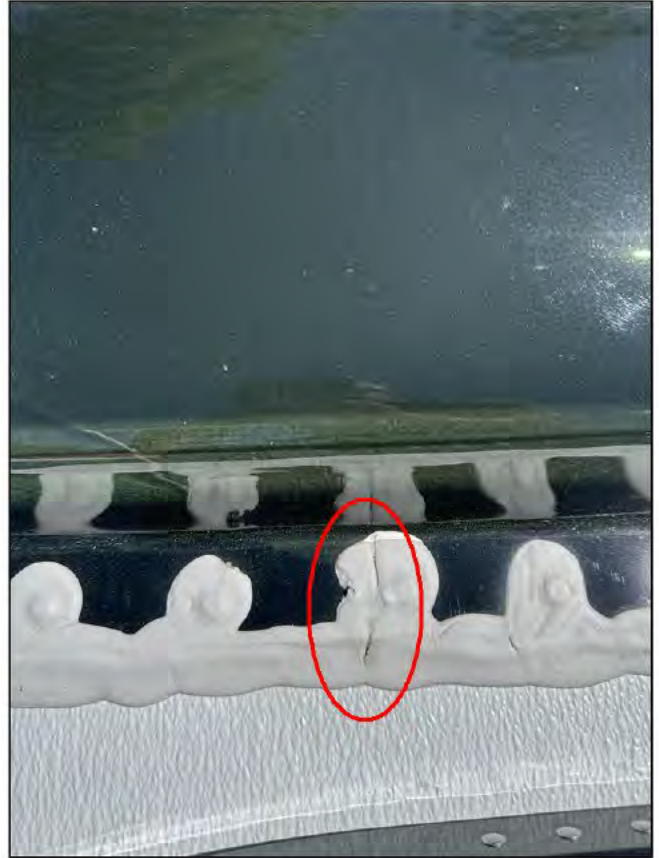
- (2) Inspector noted a gap/cut in the sealant in the middle of the front edge of the rear skylight. It is recommended that a qualified RV technician repair to prevent possible future water intrusion.

Front edge of rear skylight (front to rear)

Close up of front edge of rear skylight (front to rear)

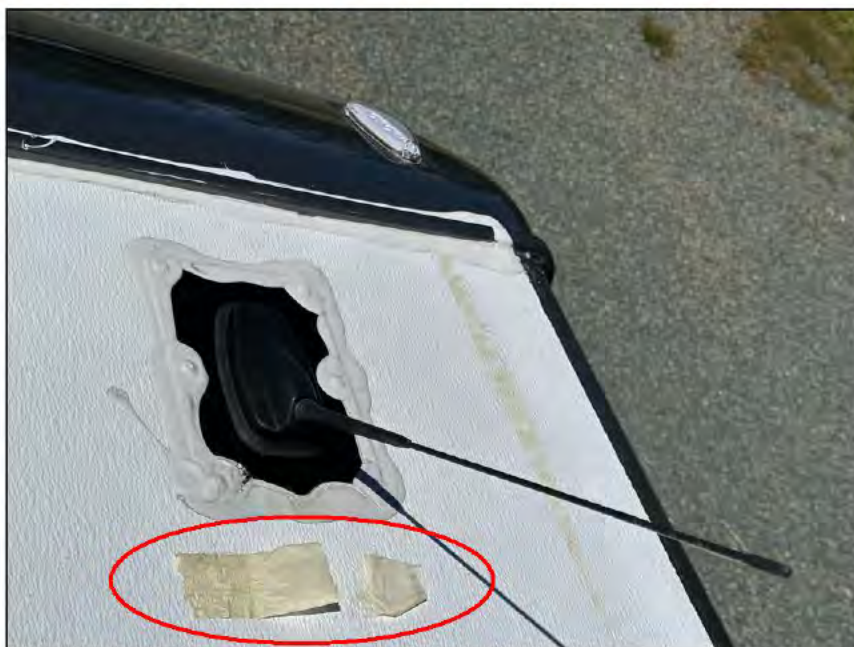
🔍 Inspector noted tape on the roof behind the antenna on the front curbside portion of the roof.

Antenna at front curbside on roof

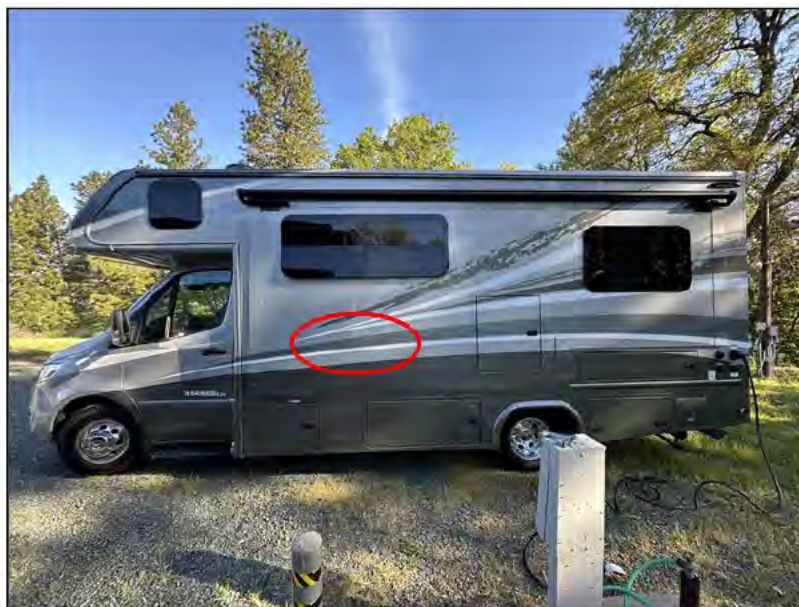
- Inspector noted slight bulging of the streetside sidewall under the forward-most slide window just above the black paint. Inspector could not determine a cause for the slight bulge as there did not seem to be any water intrusion from the roof of the slide or the window.

Streetside wall

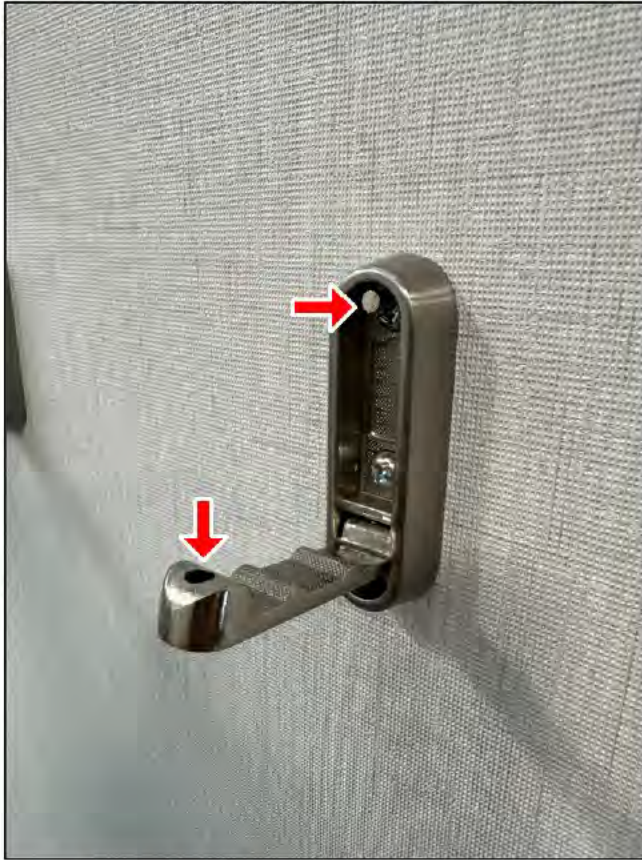
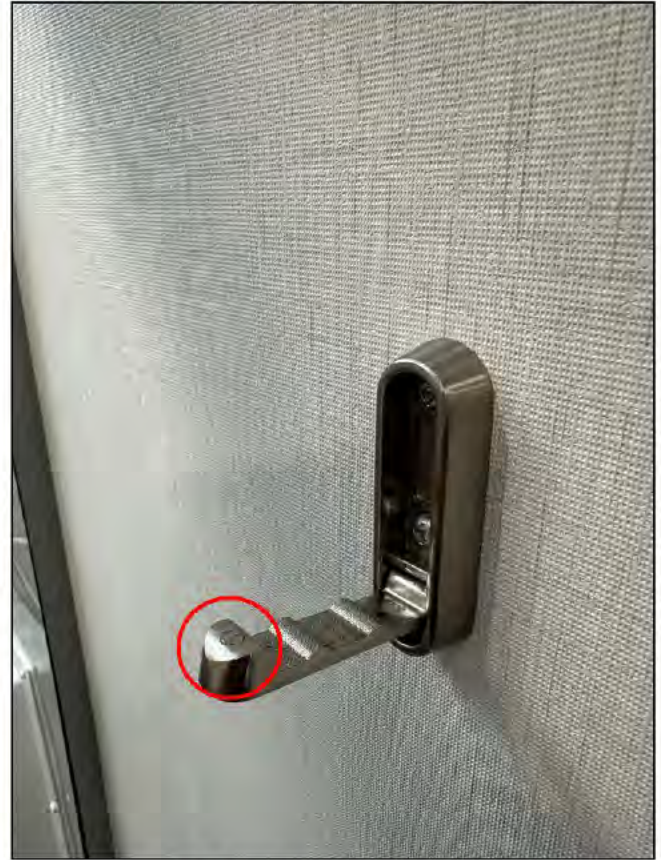
- Inspector noted that the forward most towel hook in the bathroom has a magnet that will not stay in its hole, preventing the hook from closing. It is recommended a qualified RV technician repair the hook. (See the image of the rear-most towel hook to see where the magnet should be.)

Forward most towel hook in bathroom

Rear most towel hook in bathroom (for comparison)

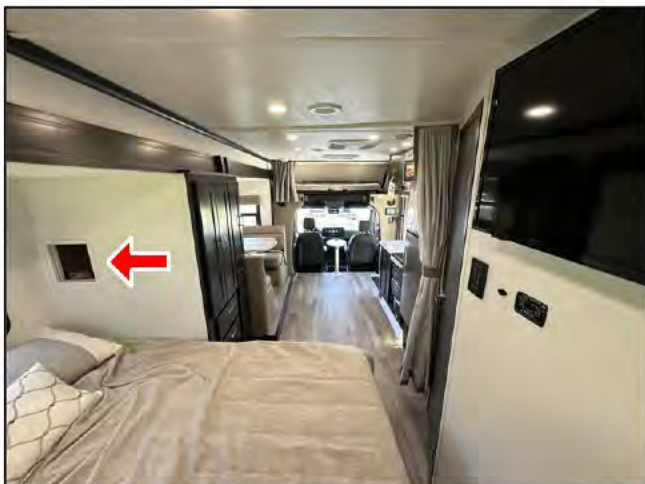
- Inspector noted a square hole in the wall separating the bedroom from the living area on the streetside. The hole has a groove in the inside frame making it seem as if glass or some type of panel is supposed to be in this hole.

Rear to front view of the rig with bedroom in foreground

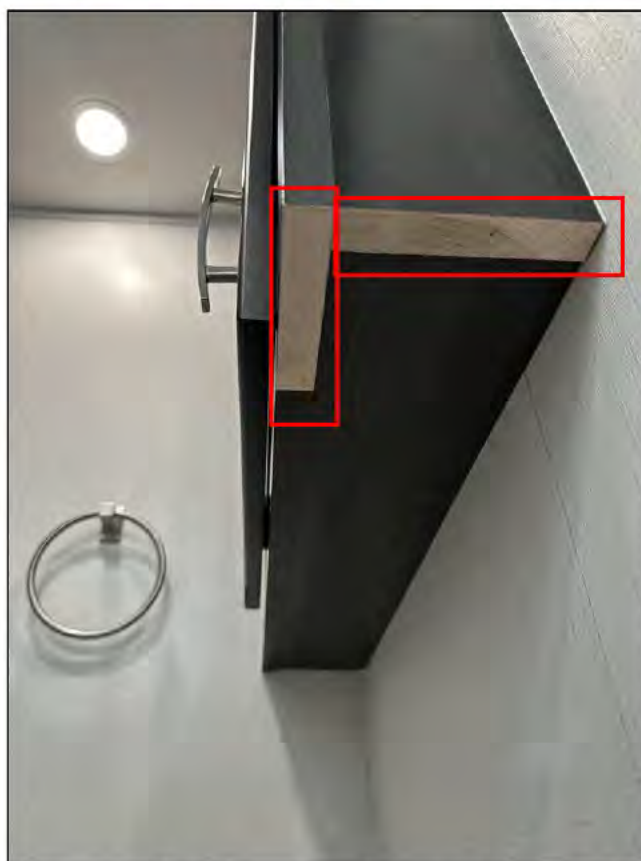
- Inspector noted that the bottom edges of two of the board framing the medicine cabinet are not finished on the bottom. It is recommended that a qualified RV technician seal these edges to prevent steam or other water from being absorbed into the wood.

Bottom of bathroom medicine cabinet (from shower side)

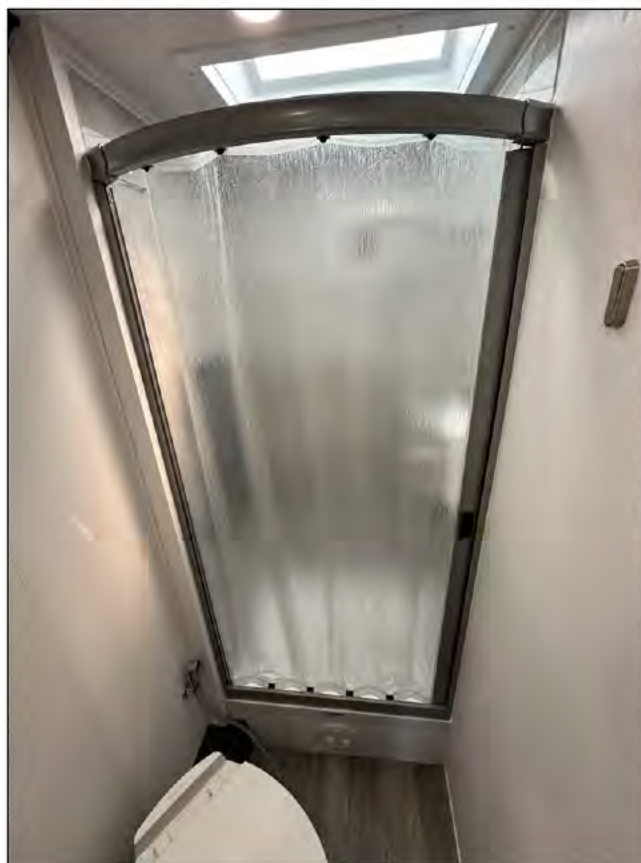
Inspector noted that the shower enclosure is a sliding door with a plastic sheet.

Shower with curtain closed

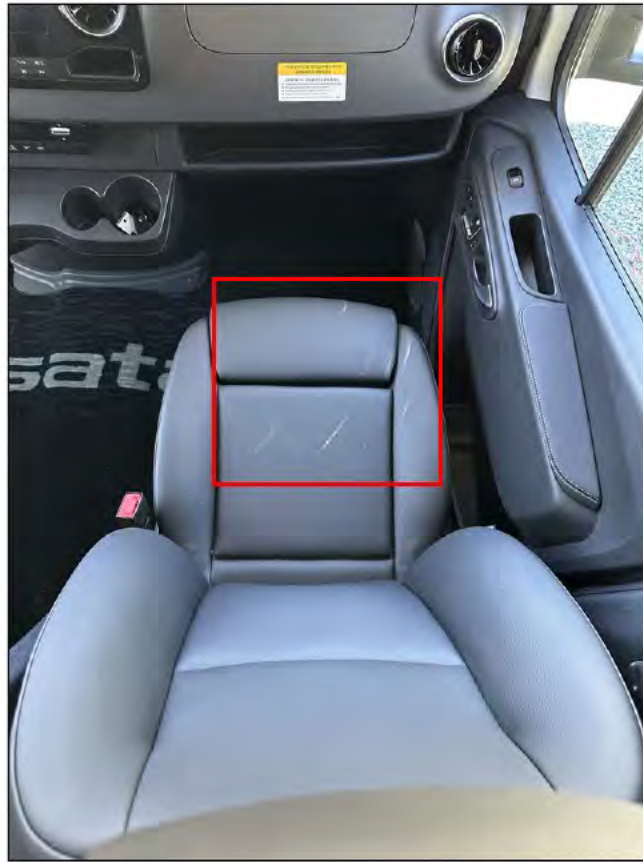
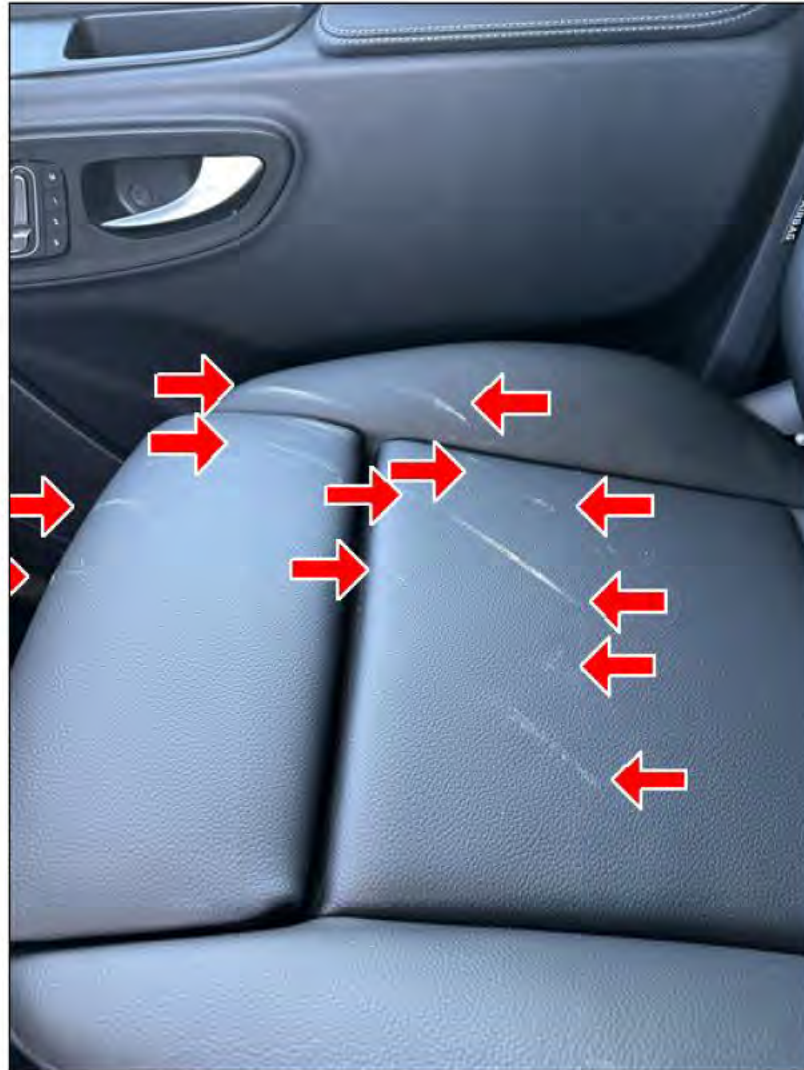
Inspector noted white marks on the front passenger seat.

Front passenger seat from above rear

Front passenger seat from driver's side

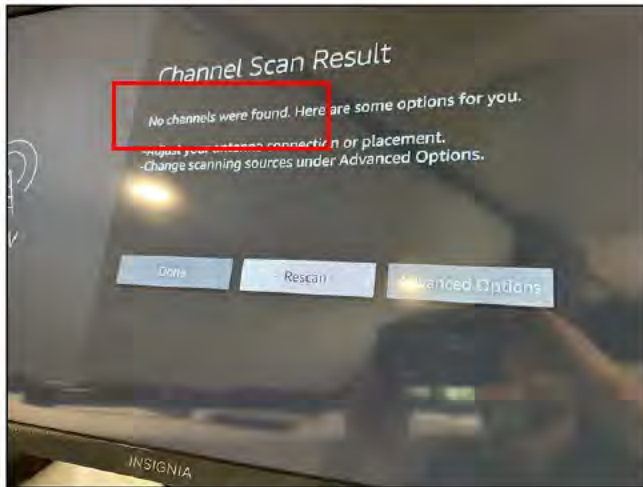
TV operates but does not pick up local channels. Inspector noted that the co-axial cable was not connected to the rear of the TV. It is recommended that a qualified RV technician properly connect the TV, retest, and repair as necessary.

Kitchen TV (front)
