RV Inspection Report

2021 Airstream International 25FB

**Inspection Date / RV Model:
7 June 24: 2021 Airstream 25FB International**

5Js RV LLC

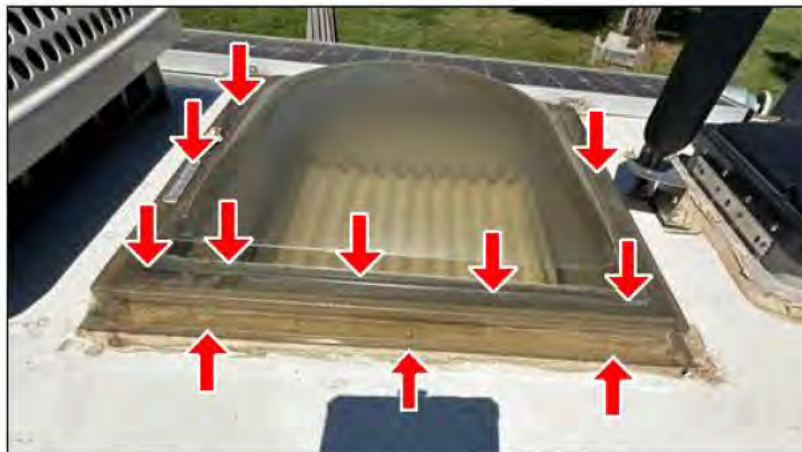
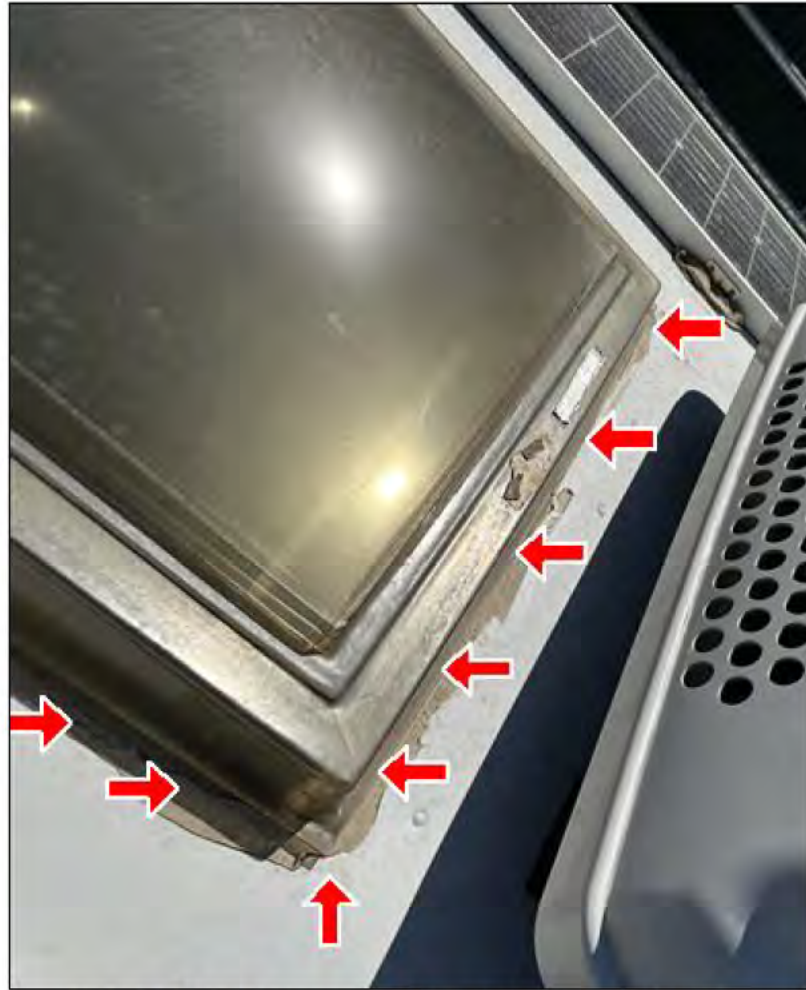
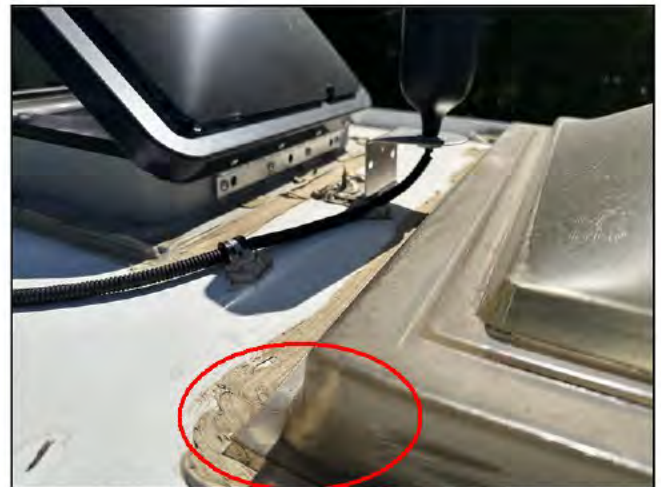
\$ Inspector noted that the skylight does not have a trim ring around it and holes are present in the edges of the skylight and the edges of the skylight are not flush with the roof. It is recommended that a qualified RV technician determine whether the trim ring is required to keep water out of the skylight and replace or repair the skylight as necessary to prevent possible future water intrusion.

Skylight on rear end of roof from streetside

Curbside front corner and front edge of skylight (from curbside)

Curbside rear corner of the skylight

Inspector noted that the skylight does not have a trim ring around it and holes are present in the edges of the skylight and the edges of the skylight are not flush with the roof. It is recommended that a qualified RV technician determine whether the trim ring is required to keep water out of the skylight and replace or repair the skylight as necessary to prevent possible future water intrusion.

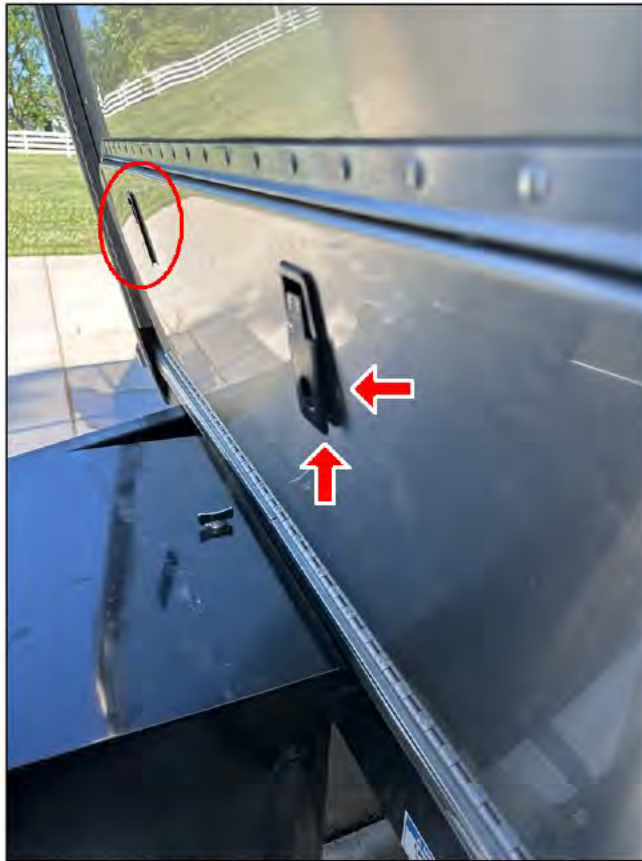
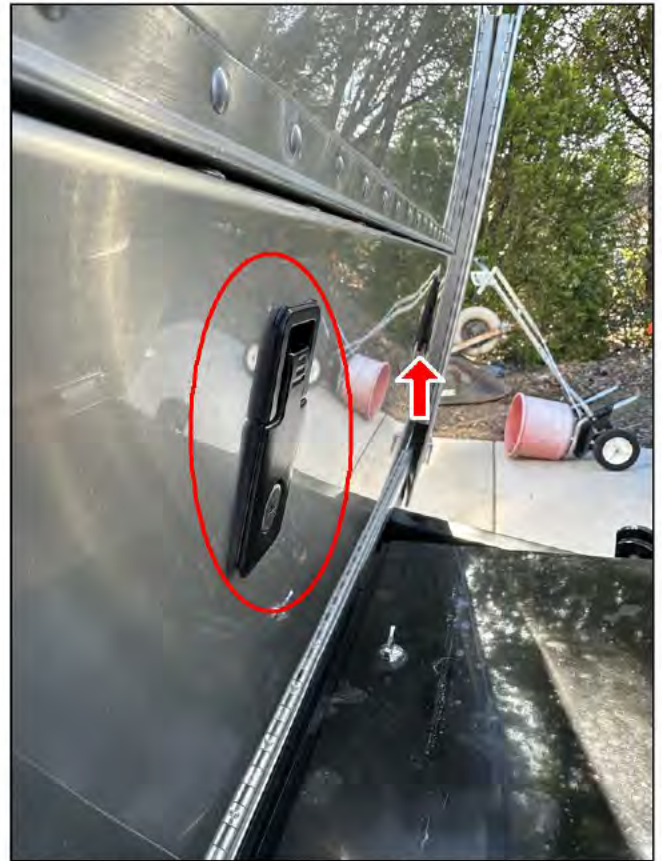
Inspector noted that the streetside latch on the front cargo bay door would not fully seat when latched and pushed down. The photo shows the curbside latch fully seated and nearly flush with the door whereas the streetside latch does not sit as close to the door. It is recommended that a qualified RV technician repair or replace the latch.

Front cargo bay door from streetside

Front cargo bay door from curbside

- 🔧 Inspector noted that the streetside latch on the front cargo bay door would not fully seat when latched and pushed down. The photo shows the curbside latch fully seated and nearly flush with the door whereas the streetside latch does not sit as close to the door. It is recommended that a qualified RV technician repair or replace the latch.

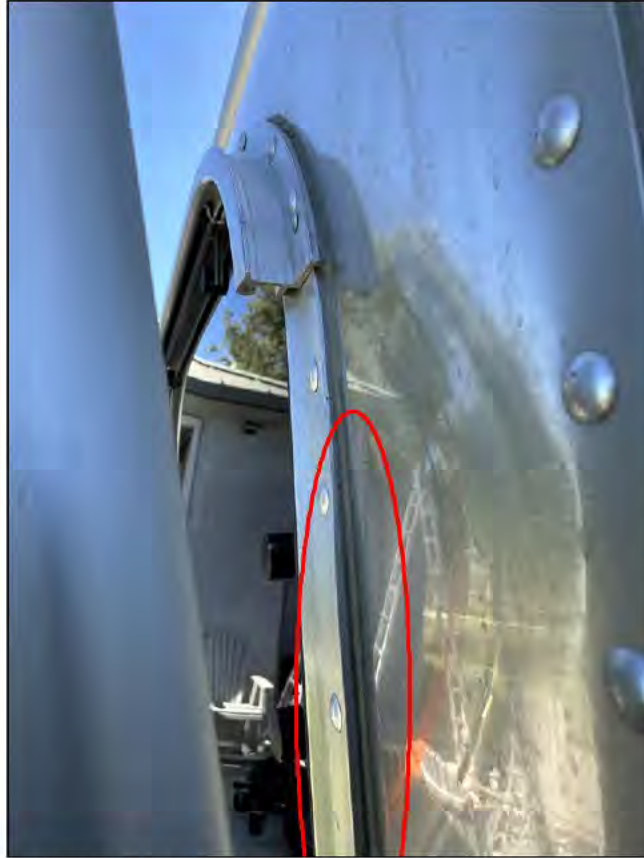
Inspector noted gaps in sealant along front edge of the curbside window just rear of the front awning arm. It is recommended that a qualified RV technician repair the sealant to prevent possible future water intrusion.

Curbside front window just rear of front awning arm

- 🔧 Inspector noted gaps in sealant along front edge of the curbside window just rear of the front awning arm. It is recommended that a qualified RV technician repair the sealant to prevent possible future water intrusion.

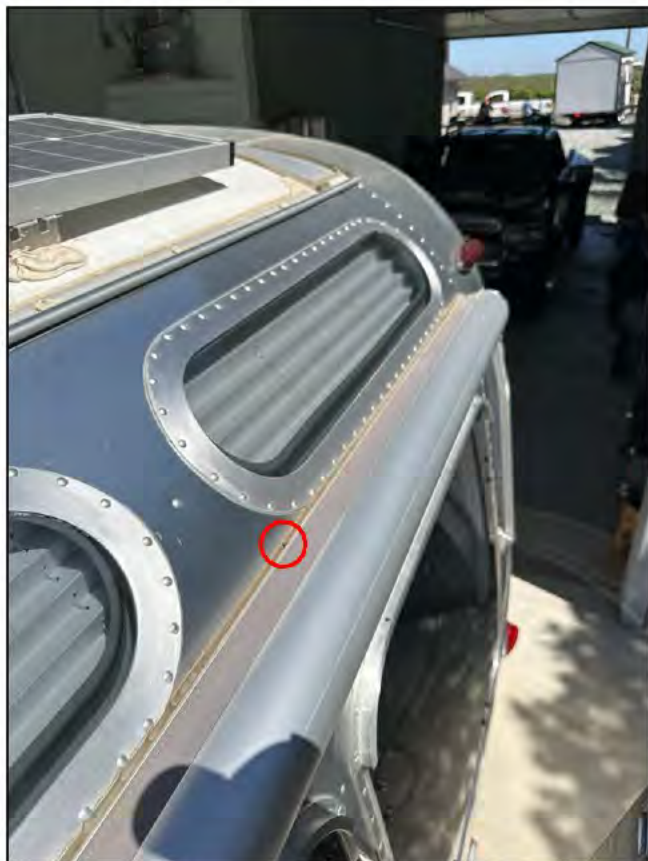
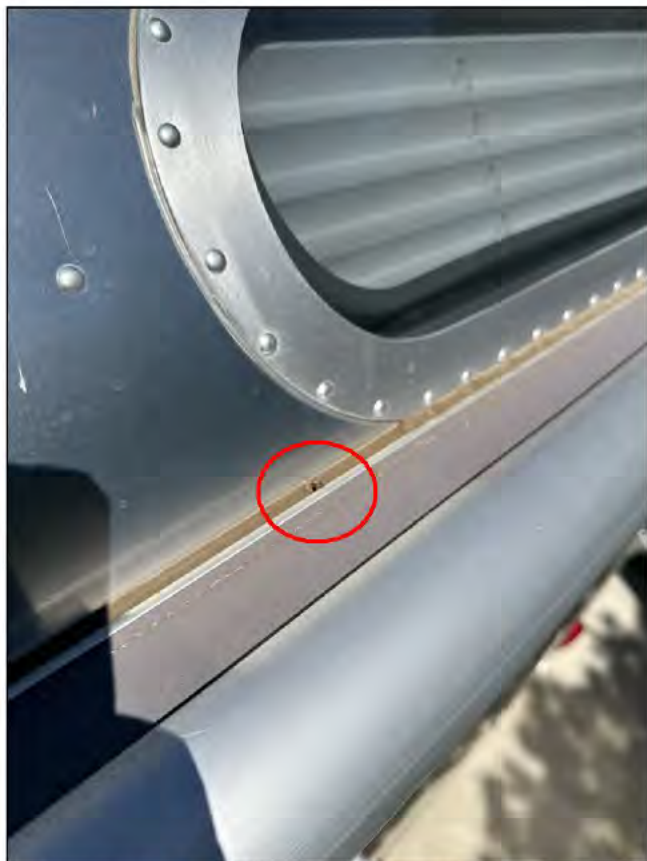
- (1) Inspector noted hole in sealant on the streetside trim rail over the awning under the front edge of the rear upper window. It is recommended that a qualified RV technician repair the sealant to prevent possible future water intrusion.

Streetside trim rail over awning under front edge of rear upper window

Streetside trim rail over awning under front edge of rear upper window (close up)

- 🔧 (1) Inspector noted hole in sealant on the streetside trim rail over the awning under the front edge of the rear upper window. It is recommended that a qualified RV technician repair the sealant to prevent possible future water intrusion.
- 🔧 (2) Inspector noted that the top and top rear edges of the exterior furnace cover on the streetside sidewall were not tight against the sidewall. It is recommended that a qualified RV technician repair the seal to prevent possible future water intrusion.

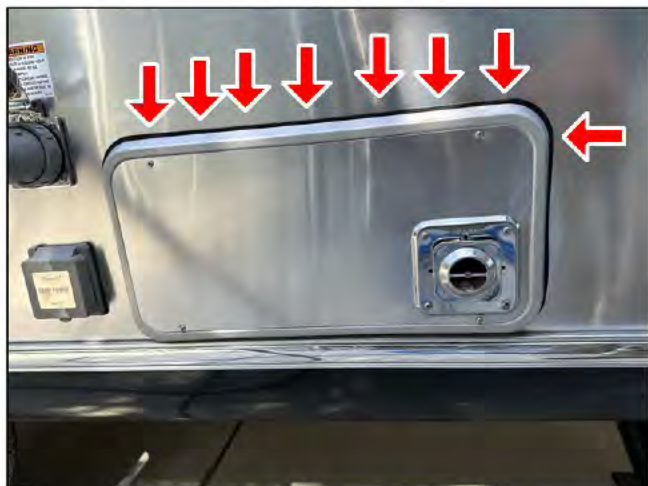
- (2) Inspector noted that the top and top rear edges of the exterior furnace cover on the streetside sidewall were not tight against the sidewall. It is recommended that a qualified RV technician repair the seal to prevent possible future water intrusion.

Furnace on streetside sidewall

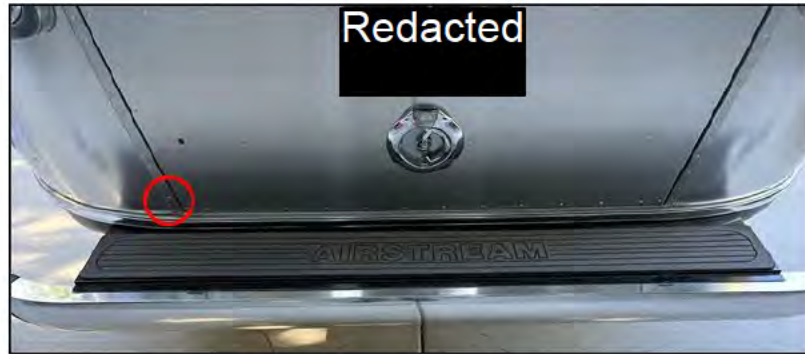
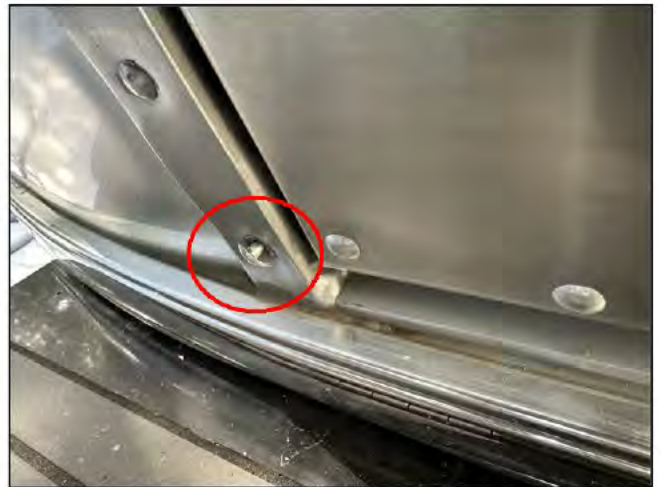
- (1) Inspector noted that the bottom rivet on the streetside bottom edge of the rear door surround was loose. It is recommended that a qualified RV technician repair or replace the rivet to prevent possible future water intrusion.

Rear bottom view of rear cap

Rear bottom view of rear cap streetside (close up from curbside)

- 🐿 (1) Inspector noted that the bottom rivet on the streetside bottom edge of the rear door surround was loose. It is recommended that a qualified RV technician repair or replace the rivet to prevent possible future water intrusion.

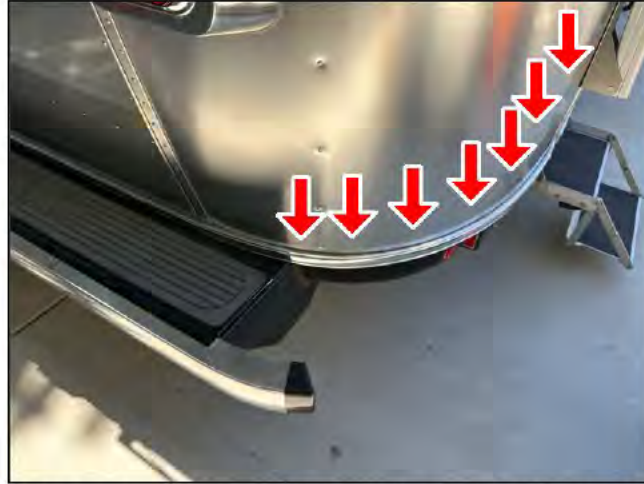
- (2) Inspector noted gaps in sealant on the curbside bottom trim rail at the rear of the curbside wall curving into the rear wall. It is recommended that a qualified RV technician repair the sealant to prevent possible future water intrusion.

Rear corner of curbside wall curving into the rear wall

Rear/curbside wall at curve toward rear (closer to door)

- 🐿 (2) Inspector noted gaps in sealant on the curbside bottom trim rail at the rear of the curbside wall curving into the rear wall. It is recommended that a qualified RV technician repair the sealant to prevent possible future water intrusion.

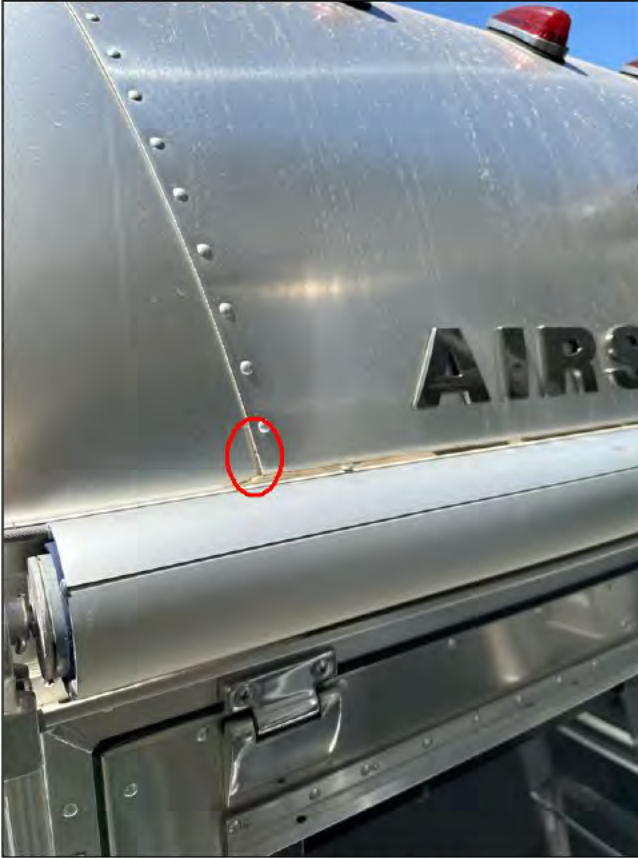
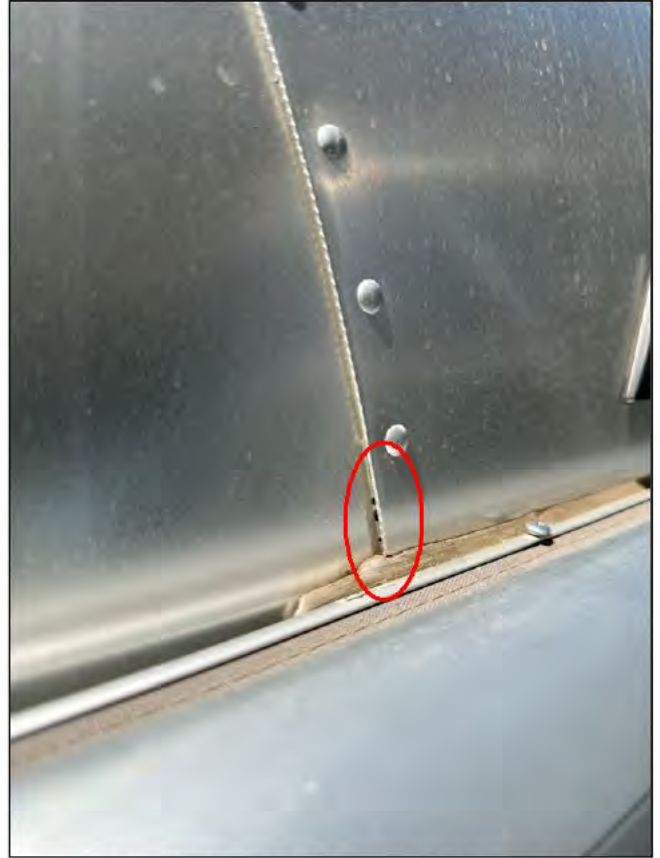
- (3) Inspector noted holes in sealant on the rear upper trim over the awning to the streetside of the AIRSTREAM name. It is recommended that a qualified RV technician repair the sealant to prevent possible future water intrusion.

Top rear streetside seal

Top rear streetside seal (close up)

- 🐿 (3) Inspector noted holes in sealant on the rear upper trim over the awning to the streetside of the AIRSTREAM name. It is recommended that a qualified RV technician repair the sealant to prevent possible future water intrusion.

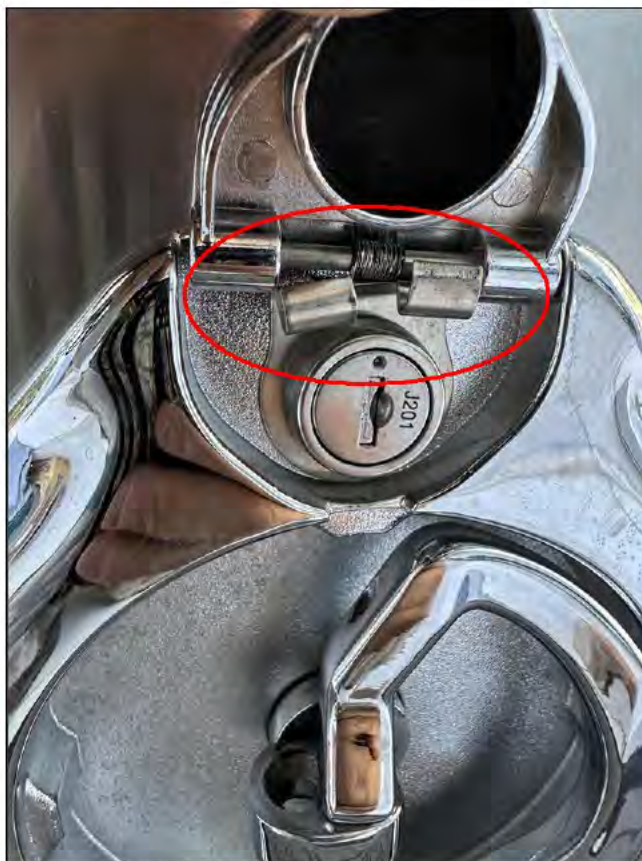
- (4) Inspector noted the lock cover on the rear door latch is not fully seated and the hooks for the cover are bent. It is recommended that a qualified RV technician repair or replace the lock cover.

Rear door lock cover

- 🐿 (4) Inspector noted the lock cover on the rear door latch is not fully seated and the hooks for the cover are bent. It is recommended that a qualified RV technician repair or replace the lock cover.

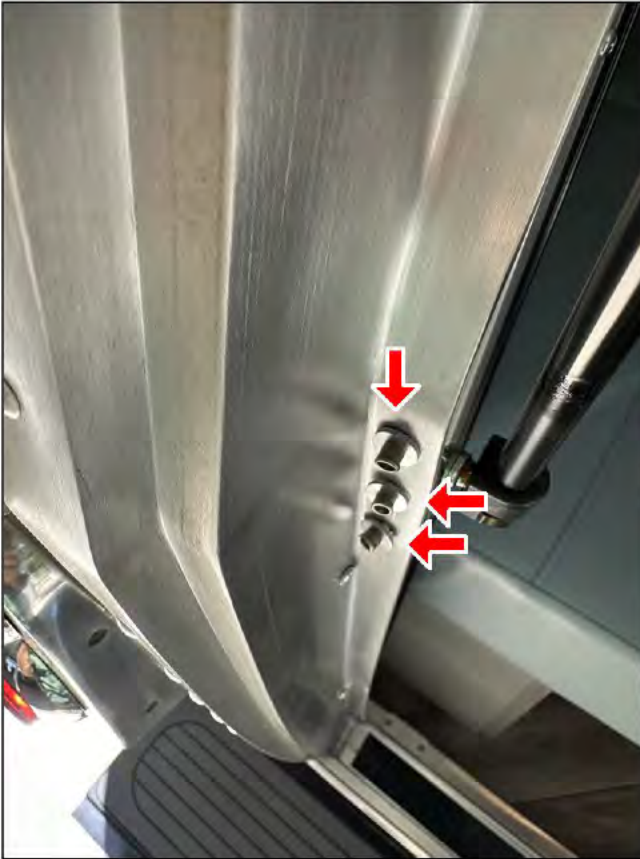
Inspector noted the rivets holding on the struts onto the frame for the rear door on both curbside and streetside are not fully seated. The rear door operates correctly and the rivets do not seem loose. It is recommended to keep an eye on the rivets and if they become loose, a qualified RV technician should repair or replace to prevent damage and maintain proper function.

Streetside rear door strut (bottom)

Streetside rear door strut (bottom) (from curbside)

Curbside rear door strut (bottom) (from streetside)

- Inspector noted the rivets holding on the struts onto the frame for the rear door on both curbside and streetside are not fully seated. The rear door operates correctly and the rivets do not seem loose. It is recommended to keep an eye on the rivets and if they become loose, a qualified RV technician should repair or replace to prevent damage and maintain proper function.

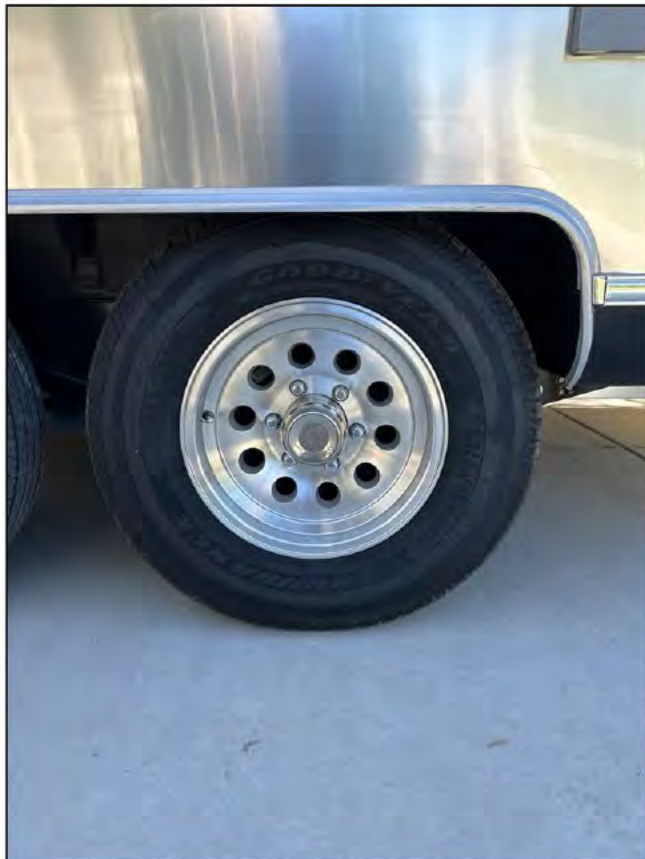
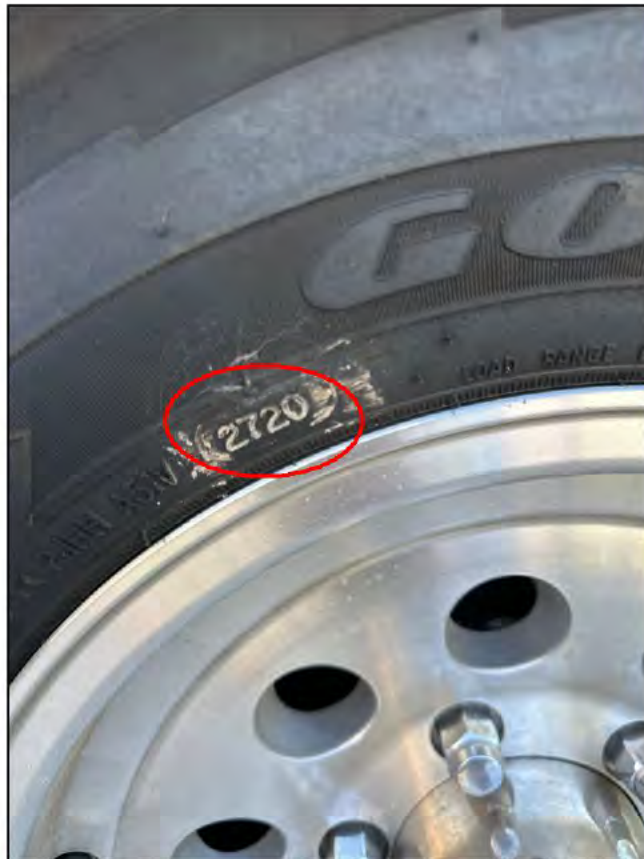
+ Inspector noted that the curbside front wheel was under-inflated by approximately 14 PSI. It is recommended that the tire be inflated to the recommended manufacturer inflation level of 80 PSI before the rig is driven.

Curbside front tire and wheel

Inspector noted that the curbside front wheel was under-inflated by approximately 14 PSI. It is recommended that the tire be inflated to the recommended manufacturer inflation level of 80 PSI before the rig is driven.

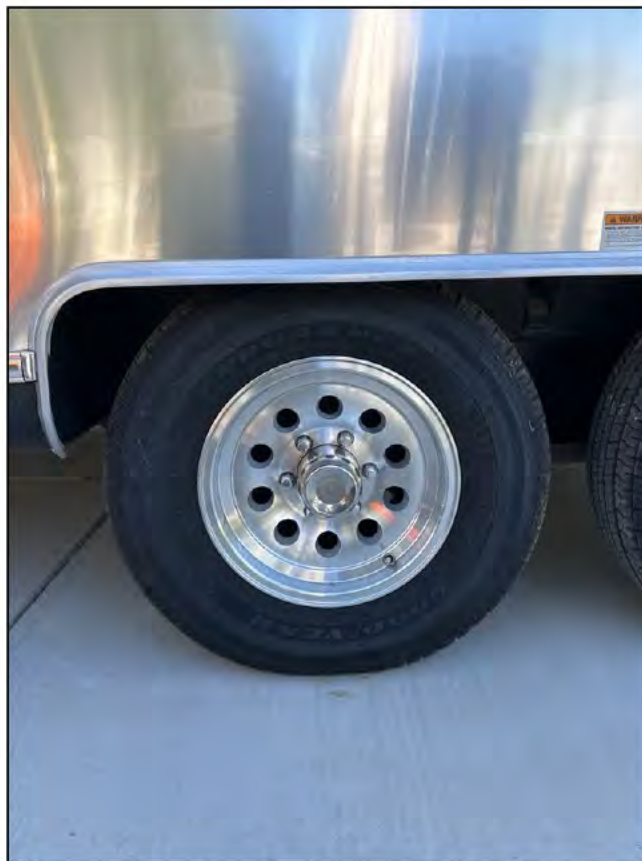
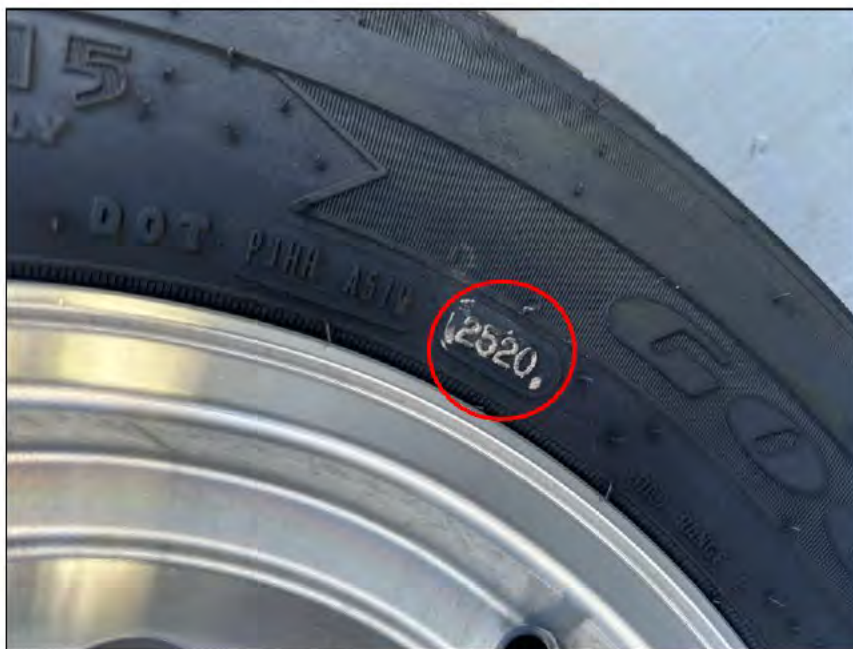
+ Inspector noted that the curbside rear wheel was under-inflated by approximately 13 PSI. It is recommended that the tire be inflated to the recommended manufacturer inflation level of 80 PSI before the rig is driven.

Curbside rear tire and wheel

Inspector noted that the curbside rear wheel was under-inflated by approximately 13 PSI. It is recommended that the tire be inflated to the recommended manufacturer inflation level of 80 PSI before the rig is driven.

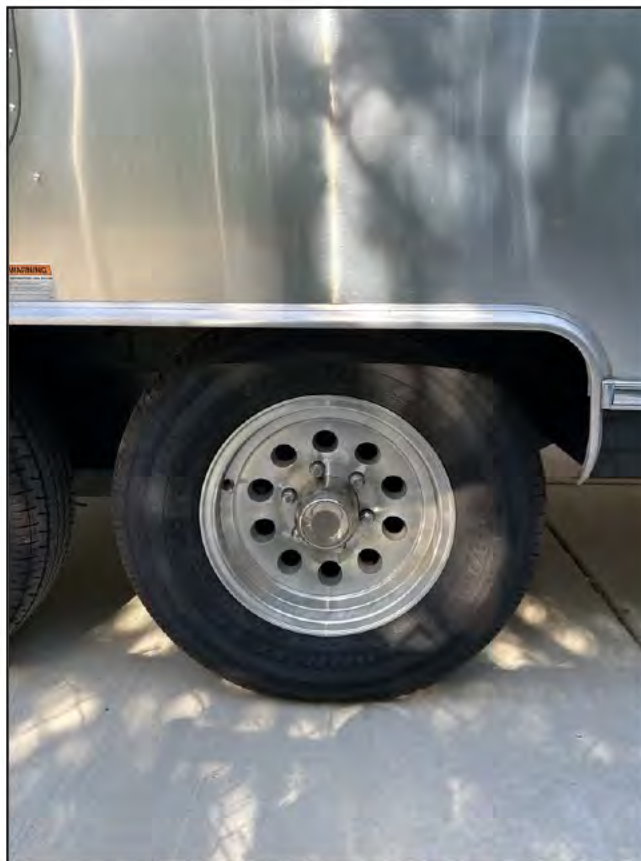
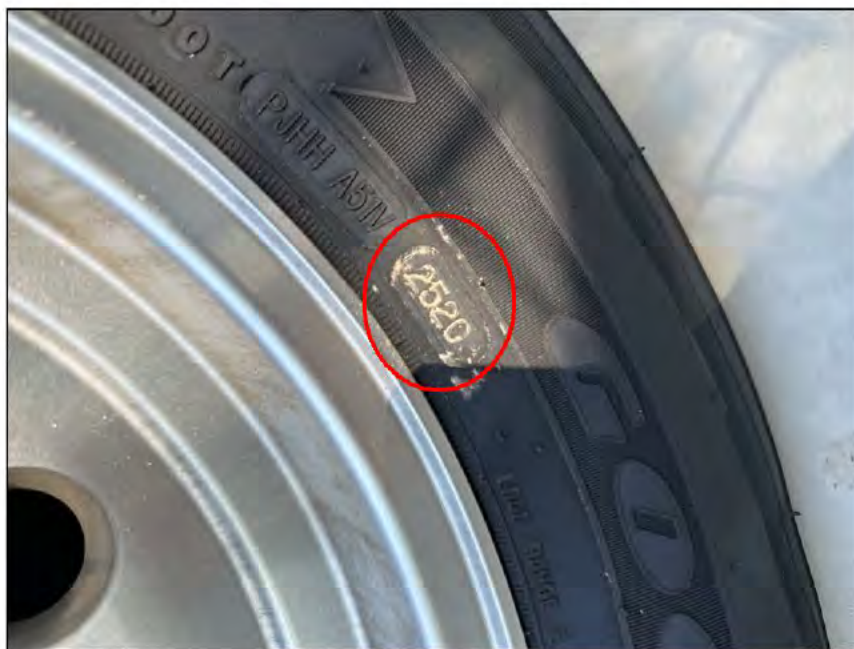
+ Inspector noted that the streetside rear wheel was under-inflated by approximately 16 PSI. It is recommended that the tire be inflated to the recommended manufacturer inflation level of 80 PSI before the rig is driven.

Streetside rear tire and wheel

Inspector noted that the streetside rear wheel was under-inflated by approximately 16 PSI. It is recommended that the tire be inflated to the recommended manufacturer inflation level of 80 PSI before the rig is driven.

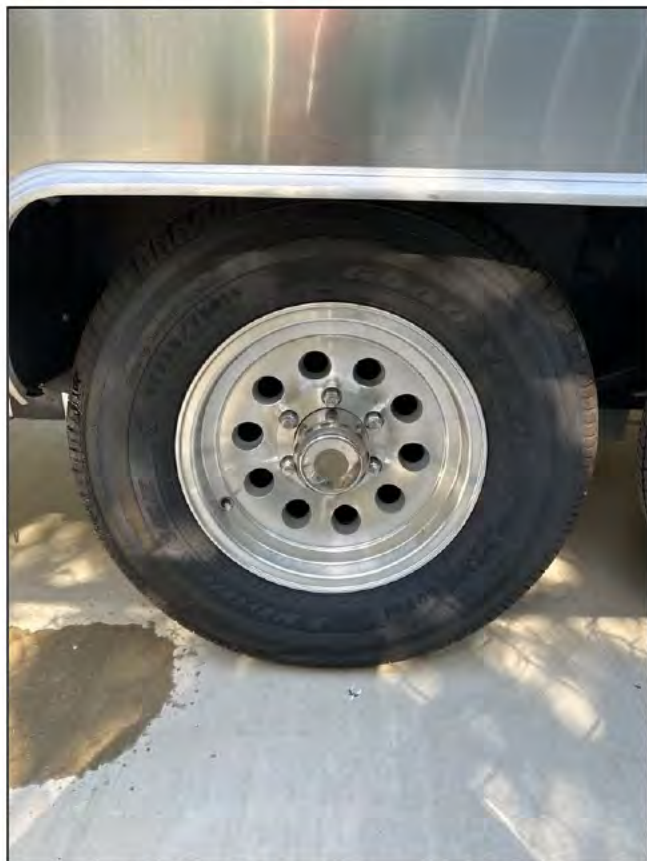
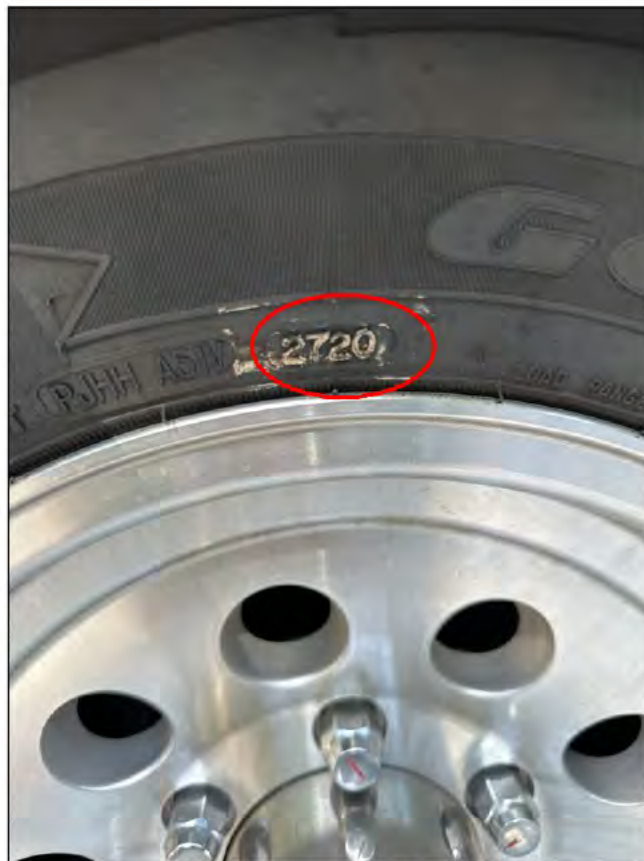
Inspector noted that the streetside front wheel was under-inflated by approximately 16 PSI. It is recommended that the tire be inflated to the recommended manufacturer inflation level of 80 PSI before the rig is driven.

Streetside front tire and wheel

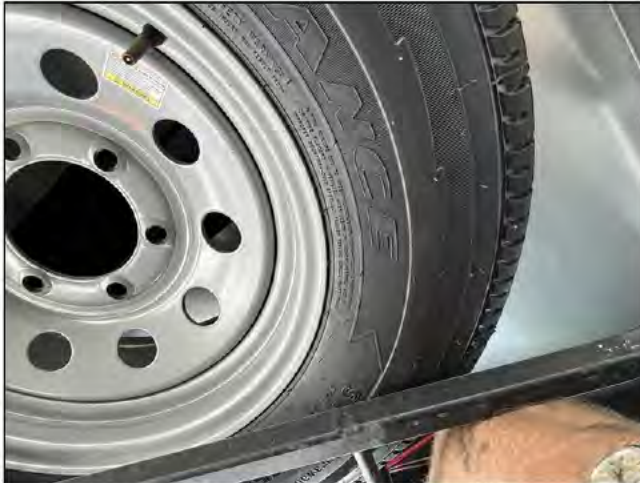
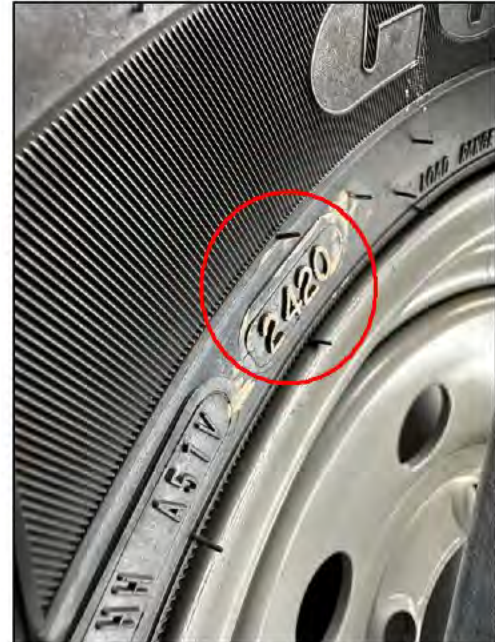
+ Inspector noted that the spare tire was under-inflated by approximately 28 PSI. It is recommended that the tire be inflated to the recommended manufacturer inflation level of 80 PSI before the rig is driven.

Spare tire under rear of rig

Inspector noted that the spare tire was under-inflated by approximately 28 PSI. It is recommended that the tire be inflated to the recommended manufacturer inflation level of 80 PSI before the rig is

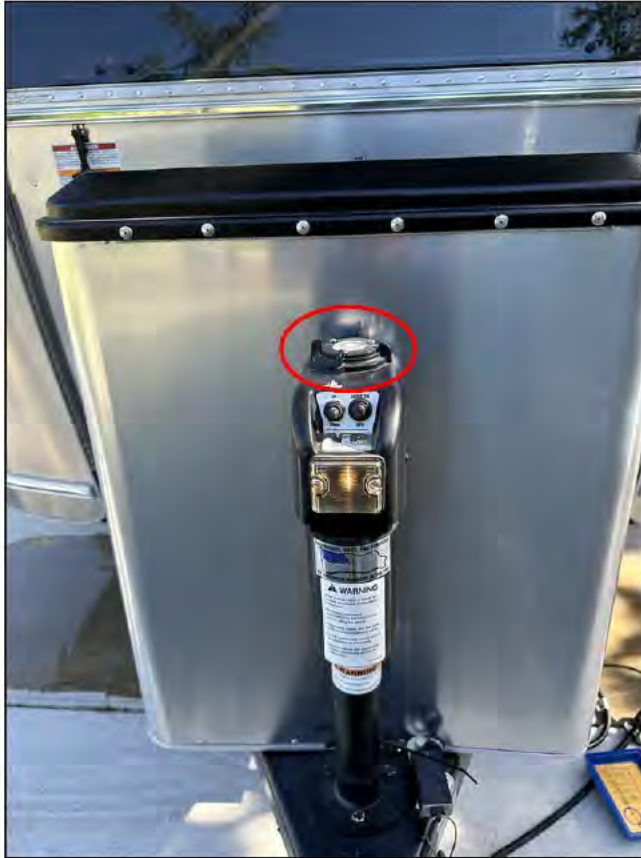
- Inspector noted that the level on top of the tongue jack was loose. It is recommended that a qualified RV technician repair the level.

Level on top of trailer tongue jack

- 🐿 Inspector noted that the level on top of the tongue jack was loose. It is recommended that a qualified RV technician repair the level.

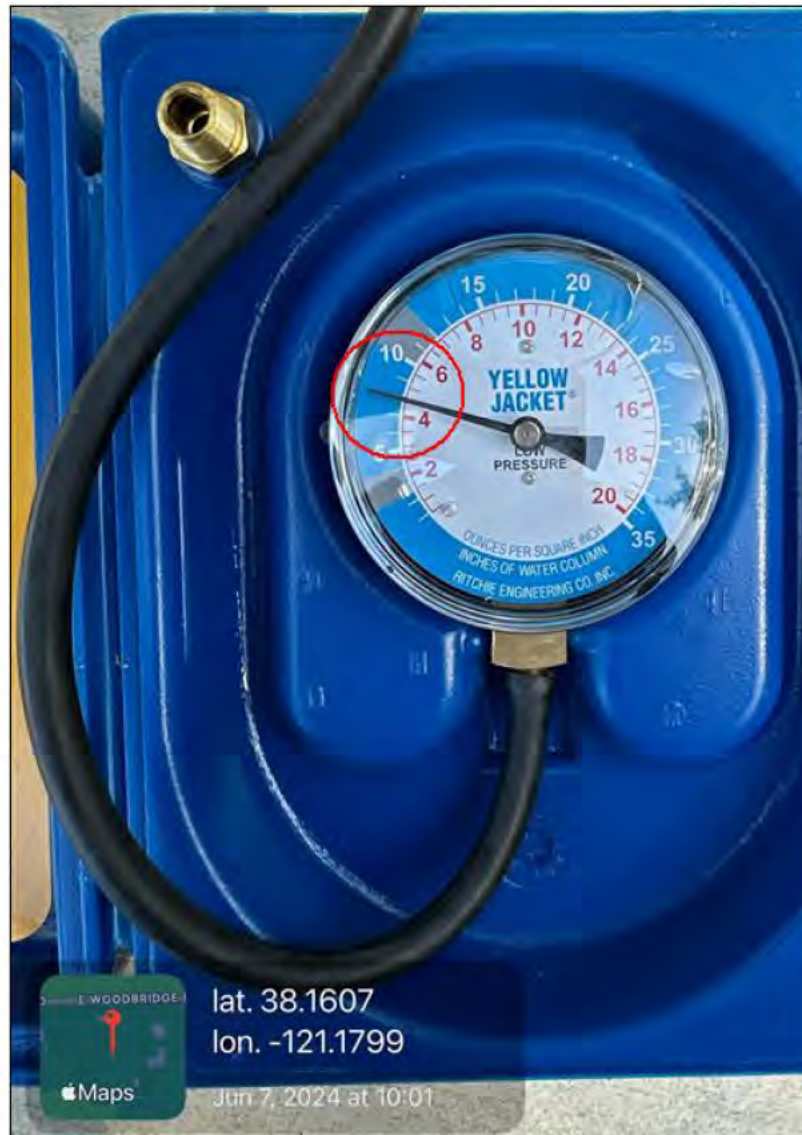
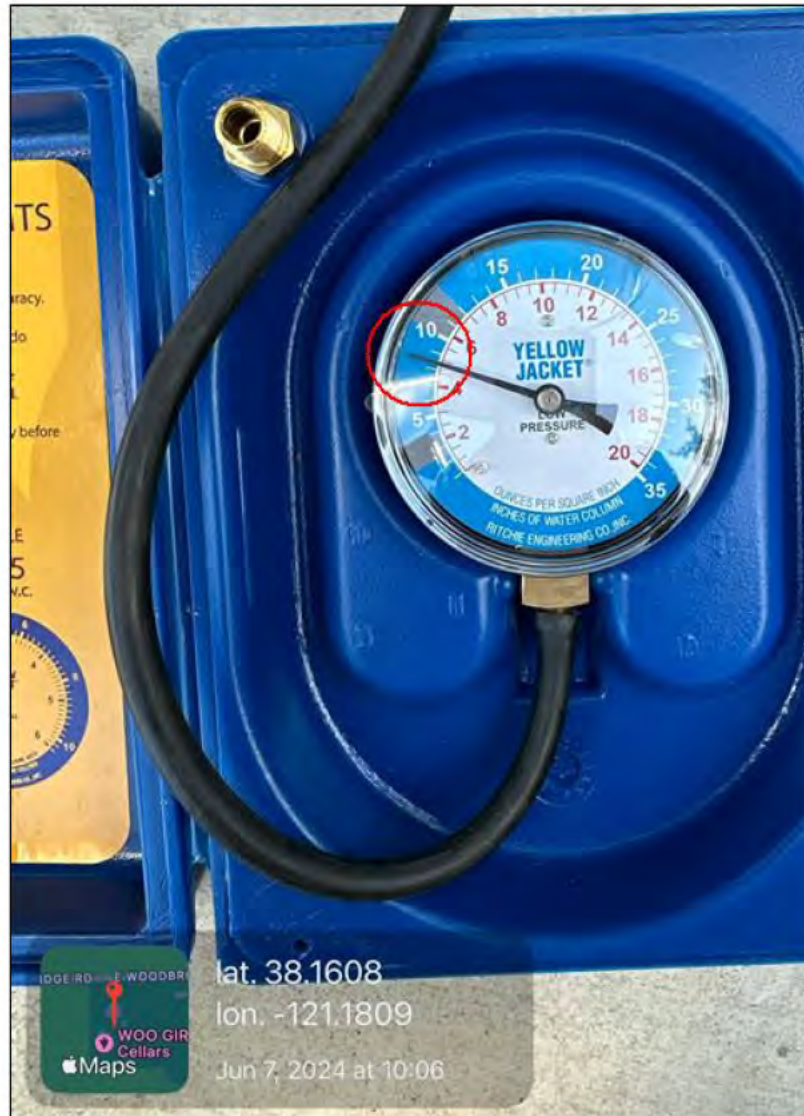
- +** Inspector conducted the LP drop test at the rear external LP connecting port. Inspector conducted the test **nine** times. Each time, the pressure in the LP system rose. Although the pressure did not drop, the pressure should not have changed at all. Before the RV is occupied, it is recommended that a qualified RV technician repair or replace LP components to prevent any change in LP pressure during the drop test.

Start of LP drop test at 1001 PDT (8 WCI)

End of drop test at 1006 PDT (8.5 WCI)

Inspector conducted the LP drop test at the rear external LP connecting port. Inspector conducted the test **nine** times. Each time, the pressure in the LP system rose. Although the pressure did not drop, the pressure should not have changed at all. Before the RV is occupied, it is recommended that a qualified RV technician repair or replace LP components to prevent any change in LP pressure during the drop test.

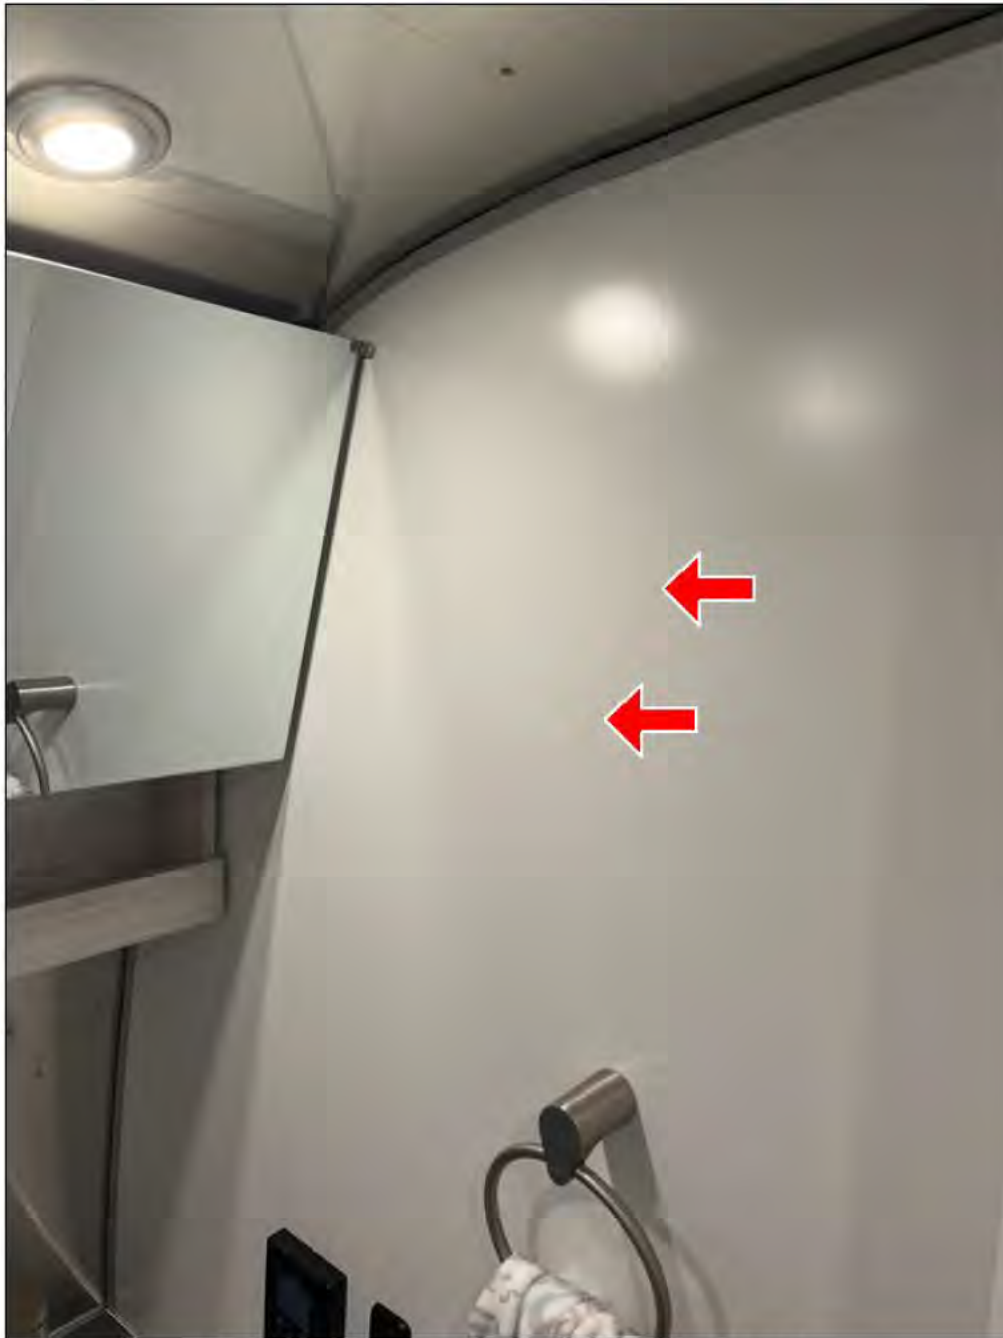
Inspector noted some discoloration on the rear bathroom wall above the hand towel holder.

Rear bathroom wall above hand towel holder

- Inspector noted some discoloration on the rear bathroom wall above the hand towel holder.

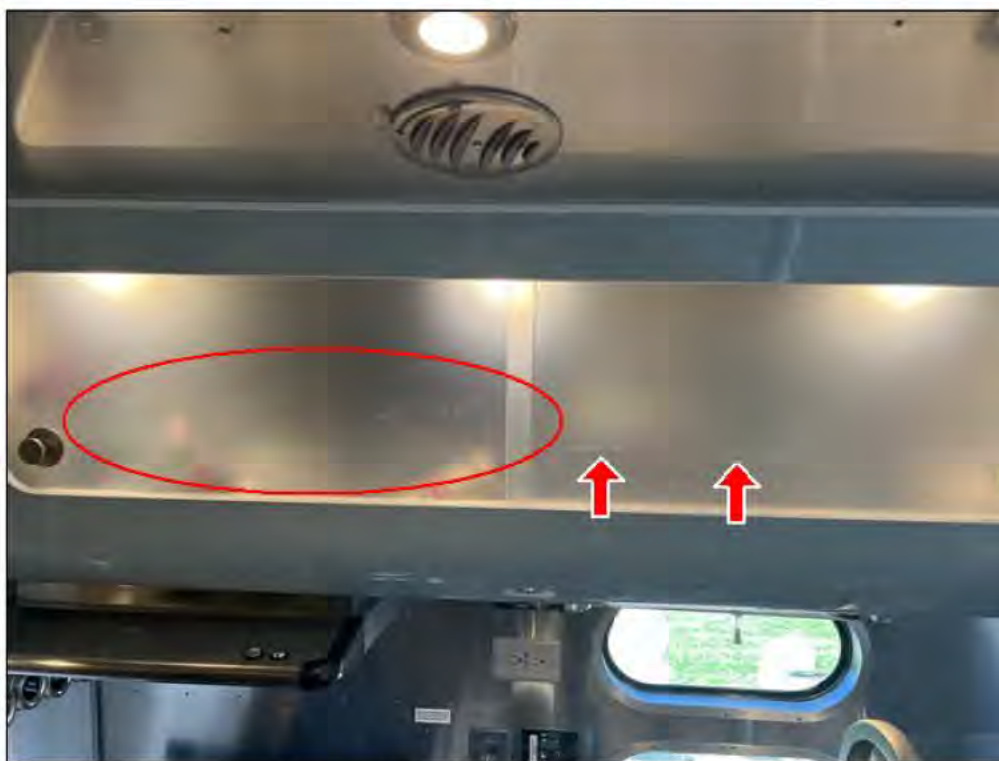
Inspector noted scratches on the interior of the cupboard above the kitchen area on the curbside wall.

Cupboard above kitchen - curbside

- Inspector noted scratches on the interior of the cupboard above the kitchen area on the curbside wall.
