RV Inspection Report

Inspection Date / RV Model:
18 Apr 2024: 2022 Grand Design Reflection 367BHS

5Js RV LLC

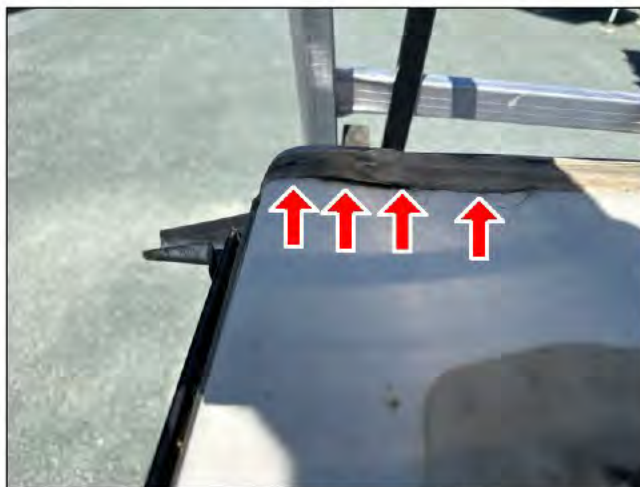
\$ (1) Inspector noted gaps in sealant at the top corner of the rear curbside cap seal. It is recommended that a qualified RV technician repair to prevent possible future water intrusion.

Top curbside rear cap corner seal (from front)

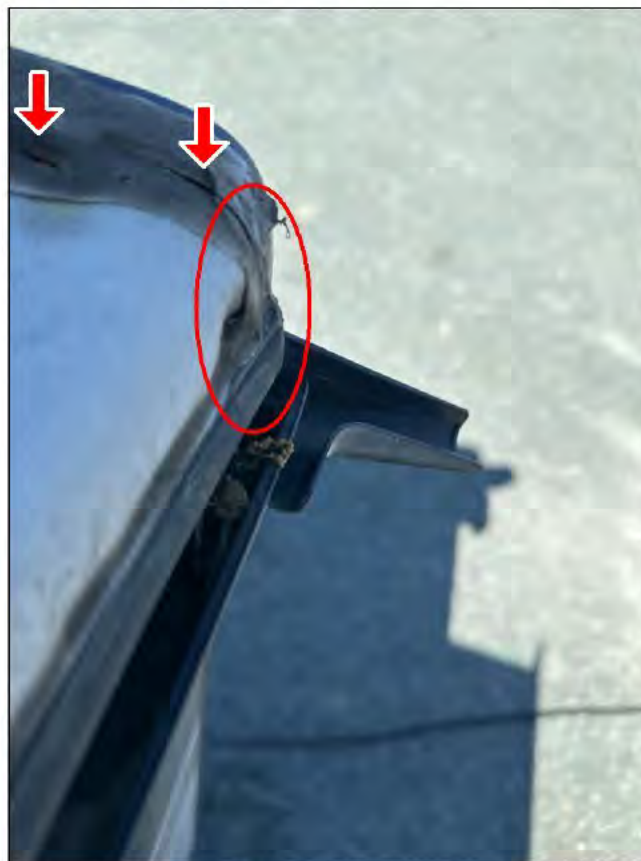
Top streetside rear cap corner seal (from front side)

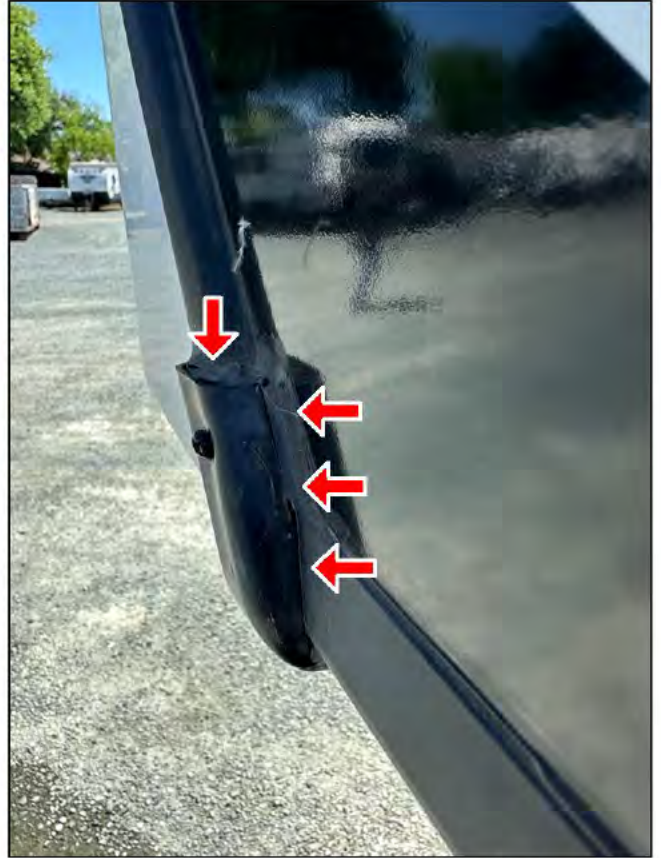
- (2) Inspector noted gaps in sealant along the streetside front cap seam, including the bottom front corner and the upper rear edge. It is recommended that a qualified RV technician repair to prevent possible future water intrusion.

Streetside Front Cap Bottom Corner (Rear to Front)

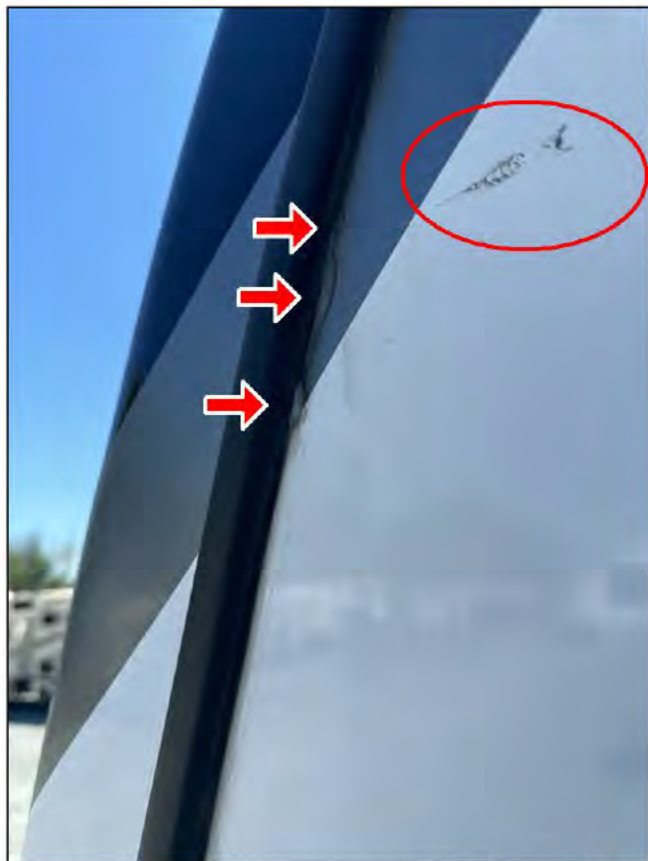
Streetside Front Cap Seam Rear Bottom to Front Top

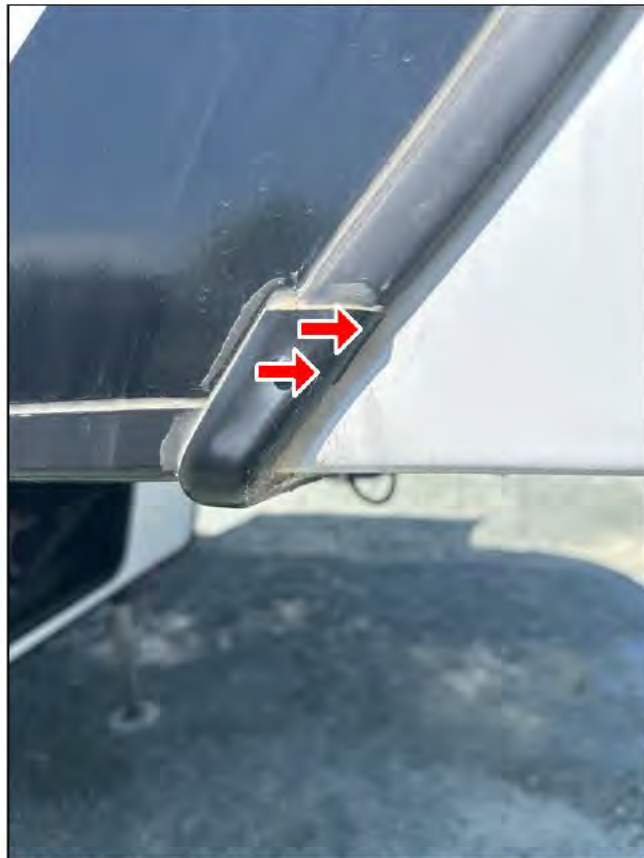
Curbside Front Cap Bottom Corner (Slightly from Front)

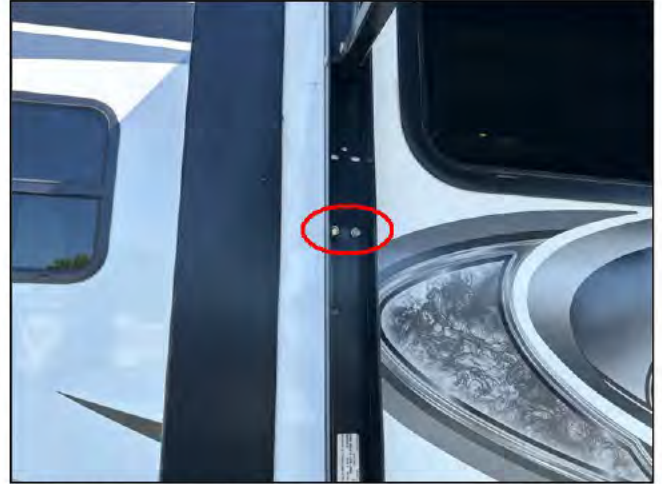
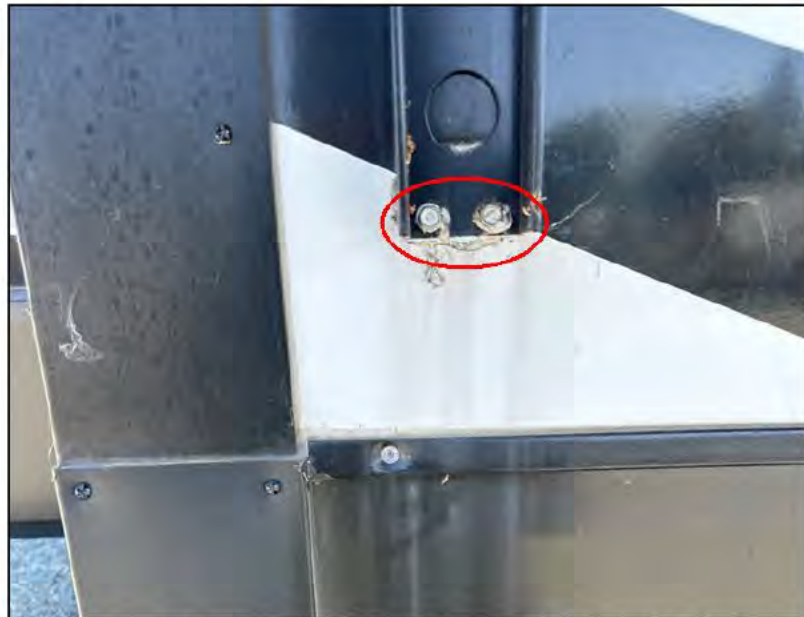
Bottom Rear Awning Arm on Curbside Slide
(Close Up Top)

Bottom Rear Awning Arm on Curbside Slide (Close Up Bottom)

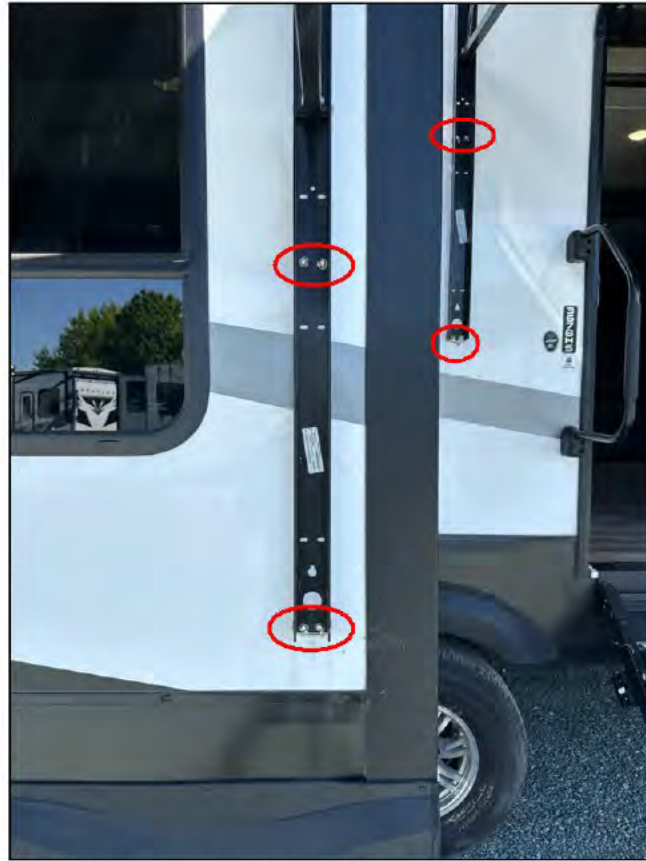
(1) Inspector noted that the rear arm of the front curbside awning did not fully close upon retracting the awning. Note the circle in the bottom left of the photo with the daylight showing versus the top right of the photo with a fully closed awning arm. It is recommended that a qualified RV technician repair before the rig is driven.

Rear Awning (Front Arm) and Front Awning (Rear Arm)

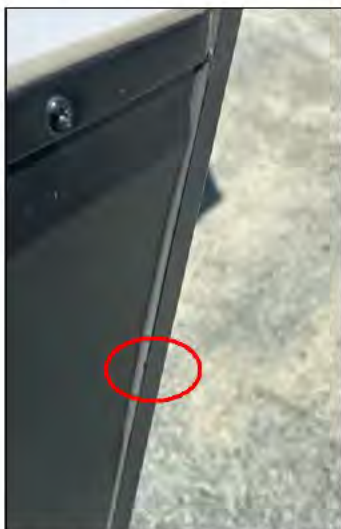
(3) Inspector noted gaps in the sealant along the bottom front edge of the curbside sidewall. It is recommended that a qualified RV technician repair to prevent possible future water intrusion.

Curbside Sidewall Front
Bottom Edge

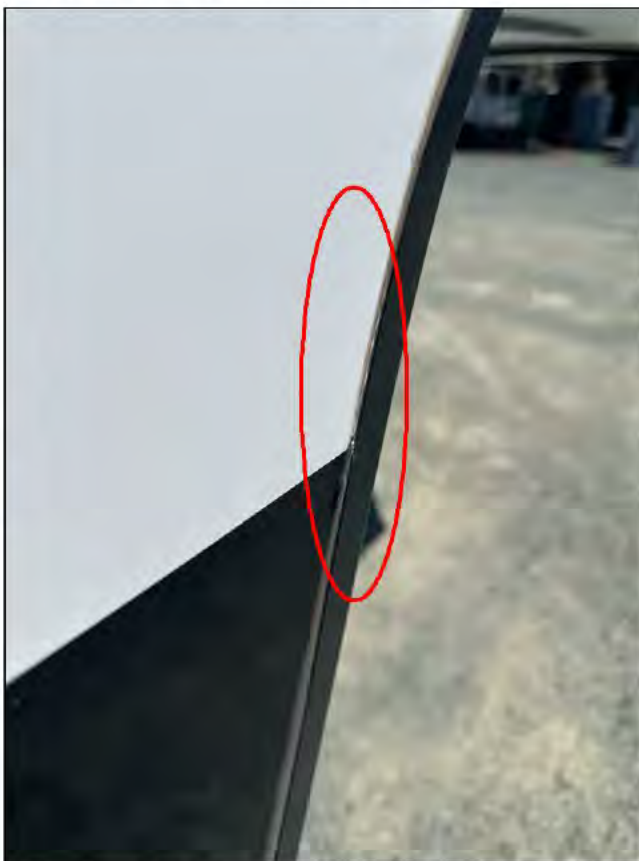
Curbside Sidewall Front Bottom Edge (Higher
Up)

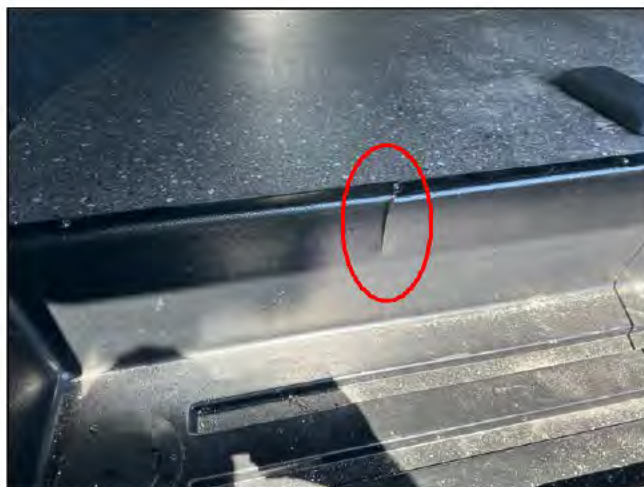
- (1) Inspector noted that there was a crack in the plastic insert inside the middle cargo bay on the curbside toward the rear of the bay.

Middle Cargo Bay Interior Curbside

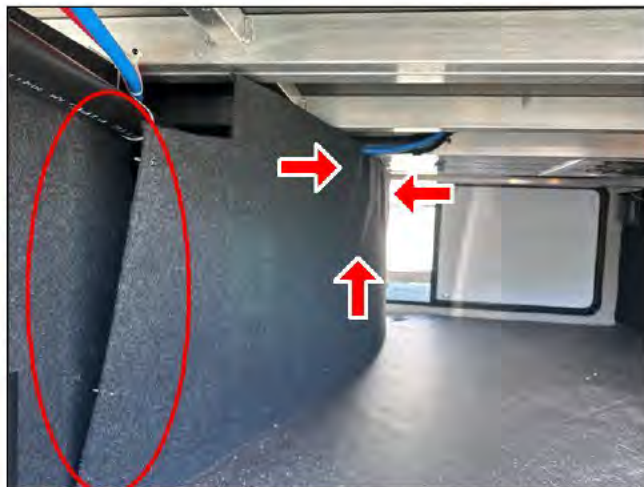
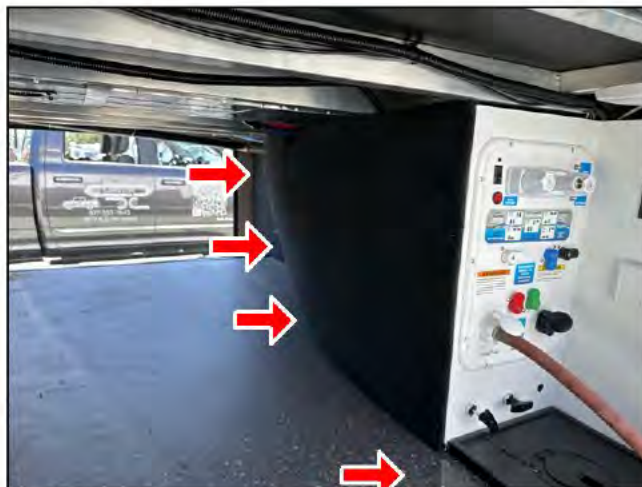
- (2) Inspector noted that the rear wall of the middle cargo bay (pass through) is unscrewed and has puckered carpeting on it toward the streetside. It is recommended that a qualified RV technician repair.

Middle Cargo Bay (Rear Wall) from Curbside

Middle Cargo Bay (Rear Wall) from Streetside

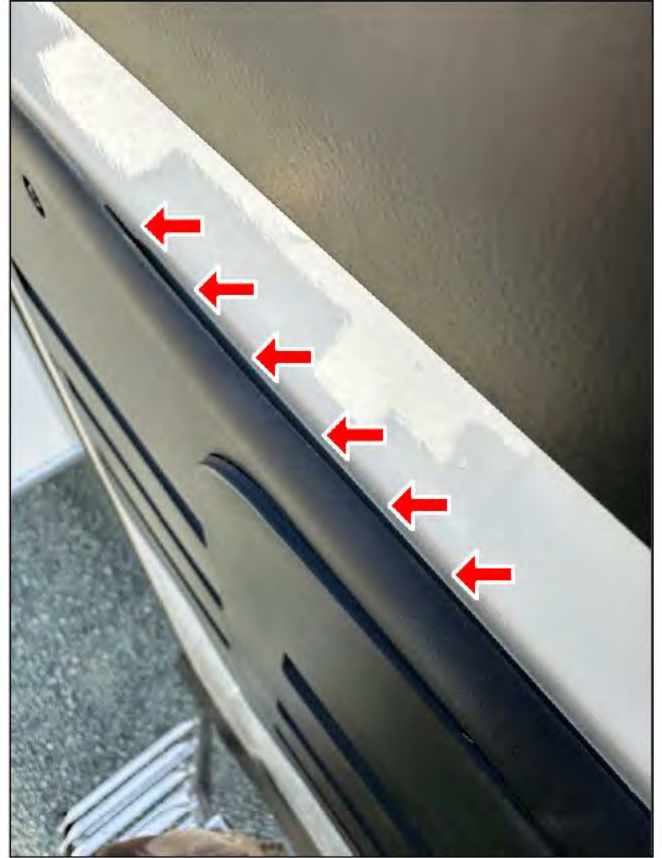
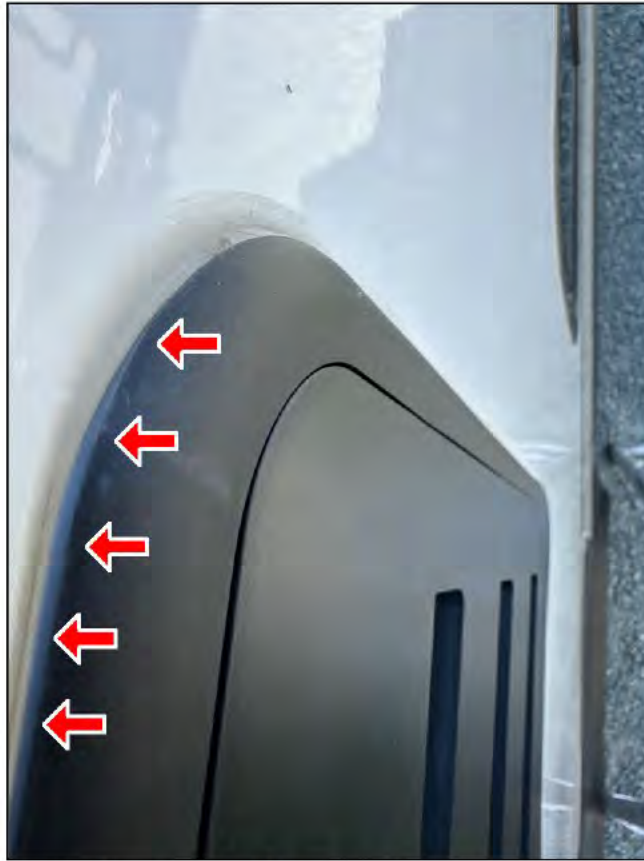
(5) Inspector noted gaps in sealant on the top of the upper refrigerator vent on the rear streetside slide. It is recommended that a qualified RV technician repair to prevent possible future water intrusion.

Top middle of upper refrigerator vent on streetside

Rear top corner of upper refrigerator vent on streetside

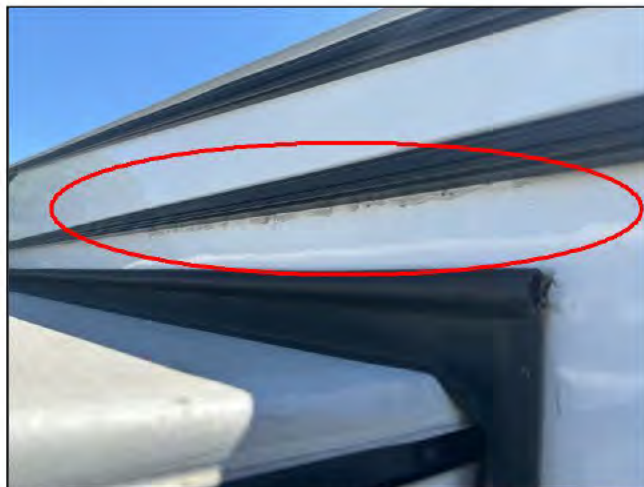
(6) Inspector noted sealant dripping out from under the gutter over the streetside rear slide. This may indicate a previous repair.

Gutter over streetside rear slide (rear to front)

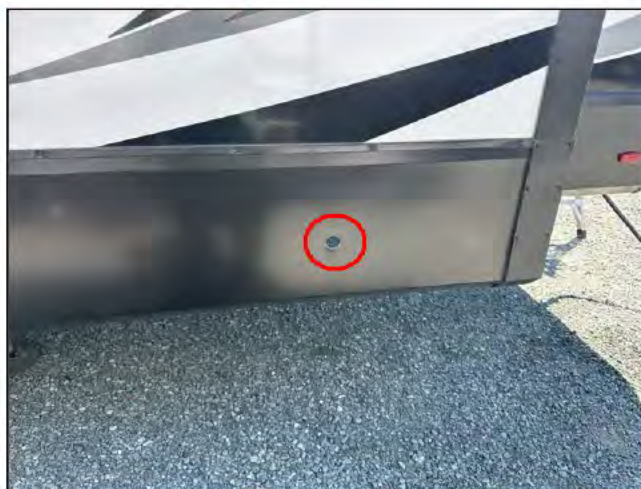
🔍 (7) Inspector noted that a grommet is missing from the streetside slide rear bottom.

Bottom rear of streetside rear slide

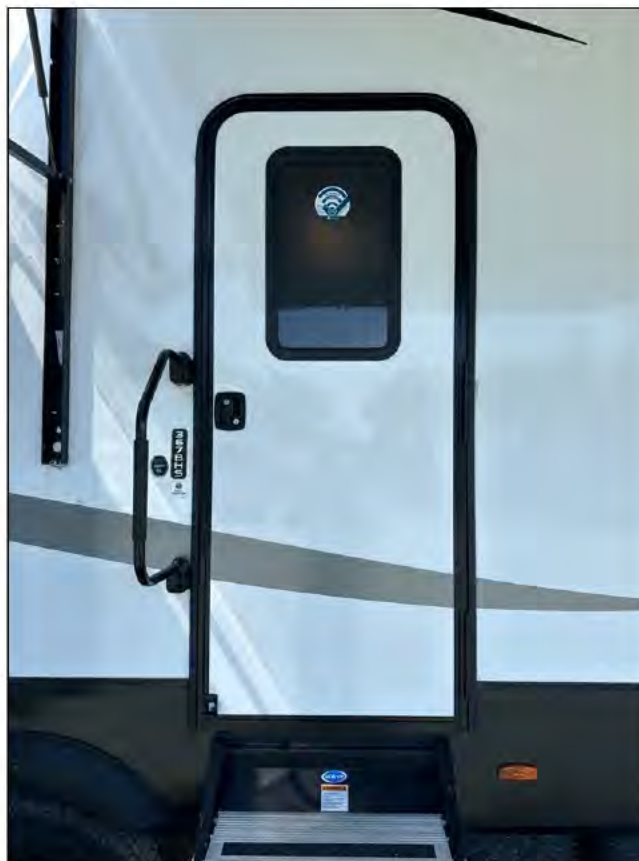
4. Main Entry Door

(1) Inspector observed small gashes on the lower interior frame of screen door.

(2) Inspector noted that the main door required a fair amount of force to close and latch. This was especially noticed when closing the door from the inside due to only having a little piece of plastic to pull on to close the door. It is recommended that qualified RV technician repair the door to allow for easier and more sure closing and latching to prevent possible future water intrusion.

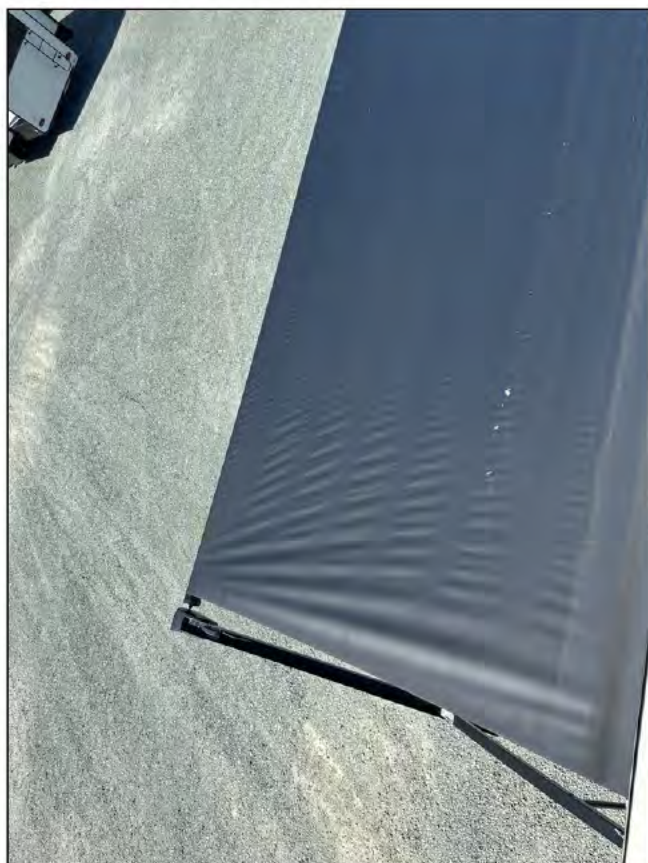
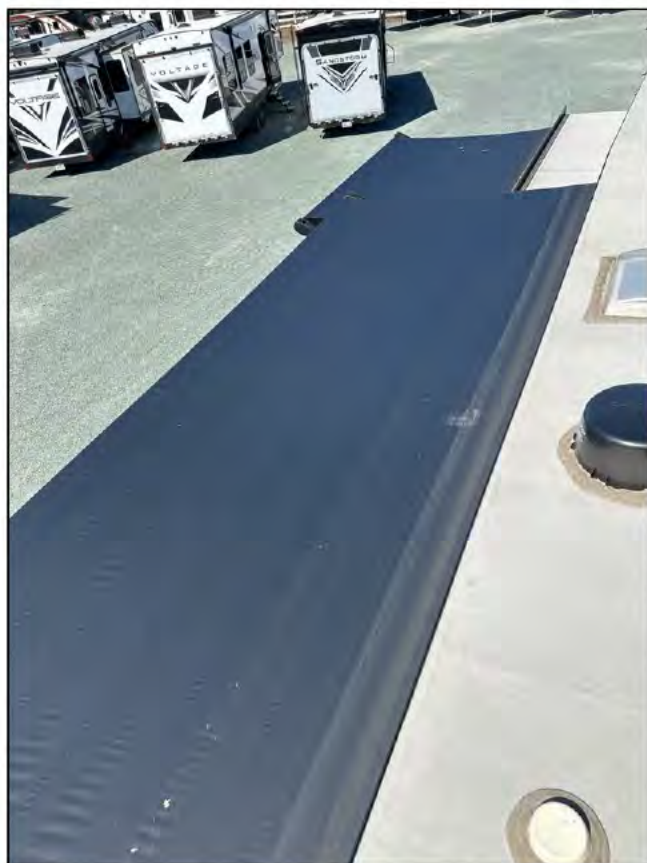
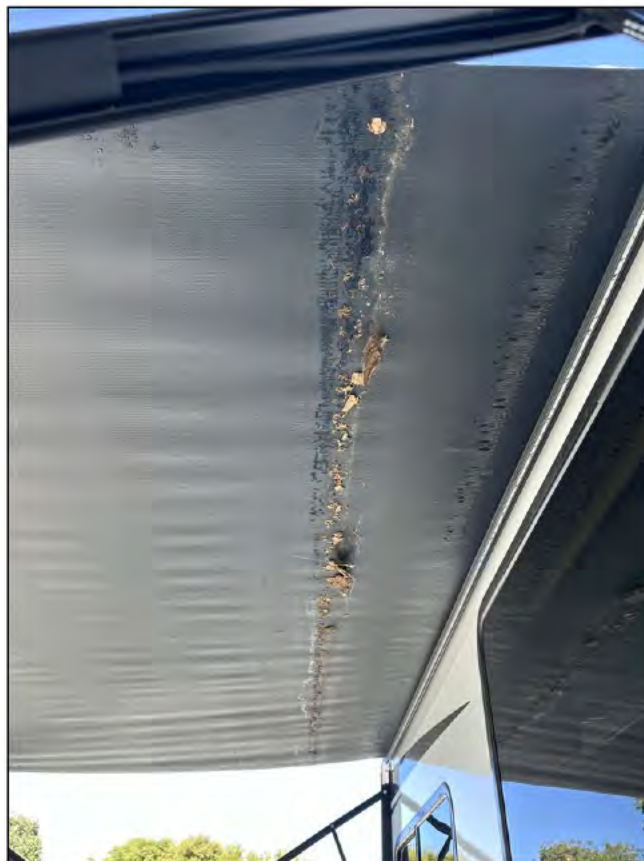
Front Curbside Awning

5.2.A Awning Operation
Comments: Poor

\$ (1) Inspector noted that the rear arm of the front curbside awning did not fully close upon retracting the awning. Note the circle in the bottom left of the photo with the daylight showing versus the top right of the photo with a fully closed awning arm. It is recommended that a qualified RV technician repair before the rig is driven.

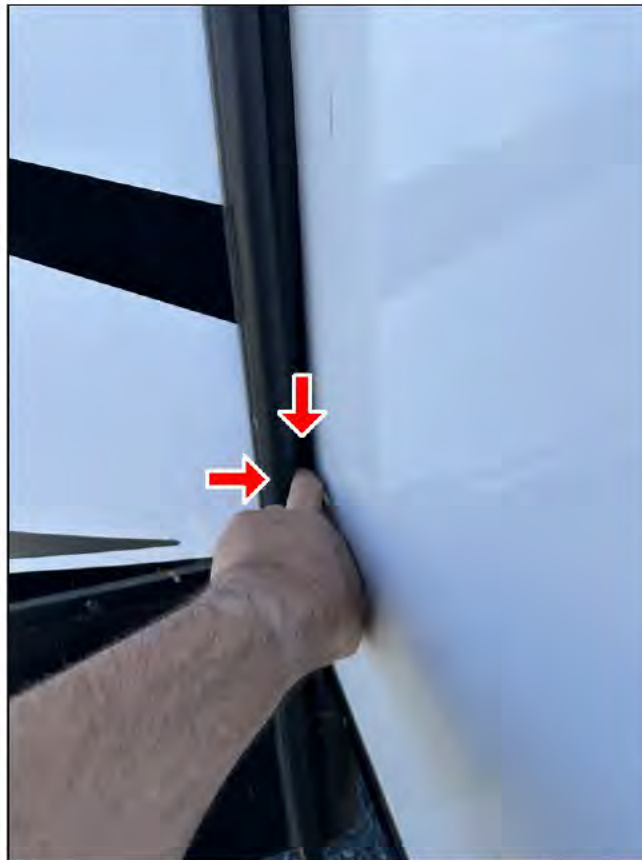
\$ Inspector noted that front side of curbside rear slide has a larger gap than the rear of the curbside slide indicating possible misalignment of slide. It is recommended that a qualified RV technician repair.

Rear bottom seal of curbside rear slide

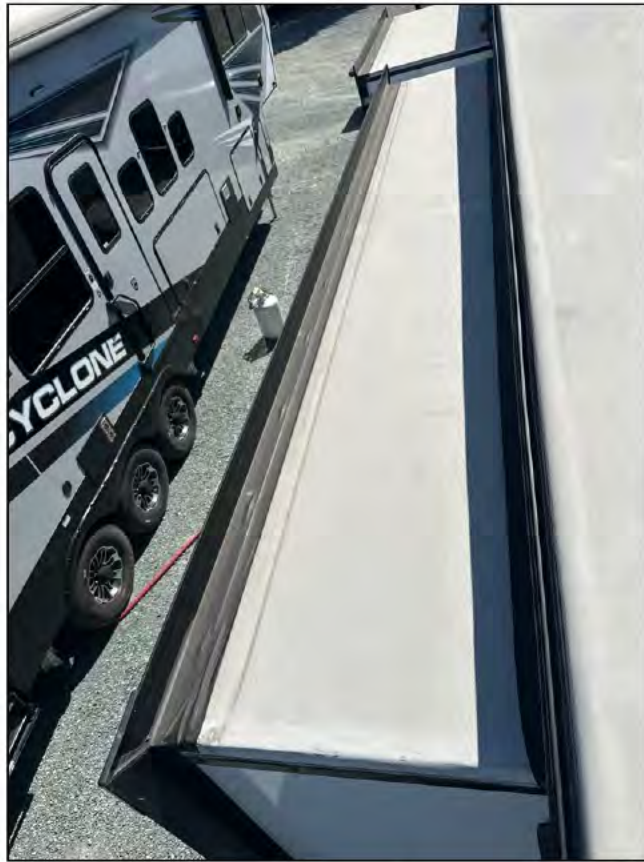
Streetside Rear Slide Roof

Streetside rear slide roof (rear to front)

🔍 Inspector noted that the J-wrap on the rear bottom corner of the streetside rear slide was bent.

Inspector noted that the top rear blade seal on the streetside rear slide did not flip fully to the outside upon slide extension. If this continues, it is recommended that a qualified RV technician replace or repair the blade seal to prevent possible future water intrusion.

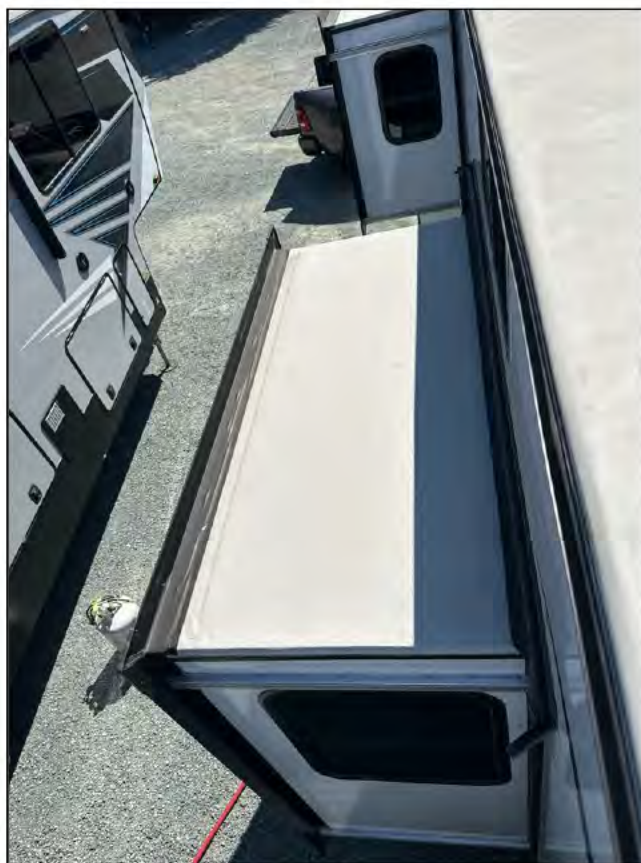
Roof of Streetside Center Slide

Streetside center slide roof from top rear

Inspector noted that the top front T-molding corner of the streetside center slide has a gap at the bottom. It is recommended that a qualified RV technician repair to prevent possible future water intrusion.

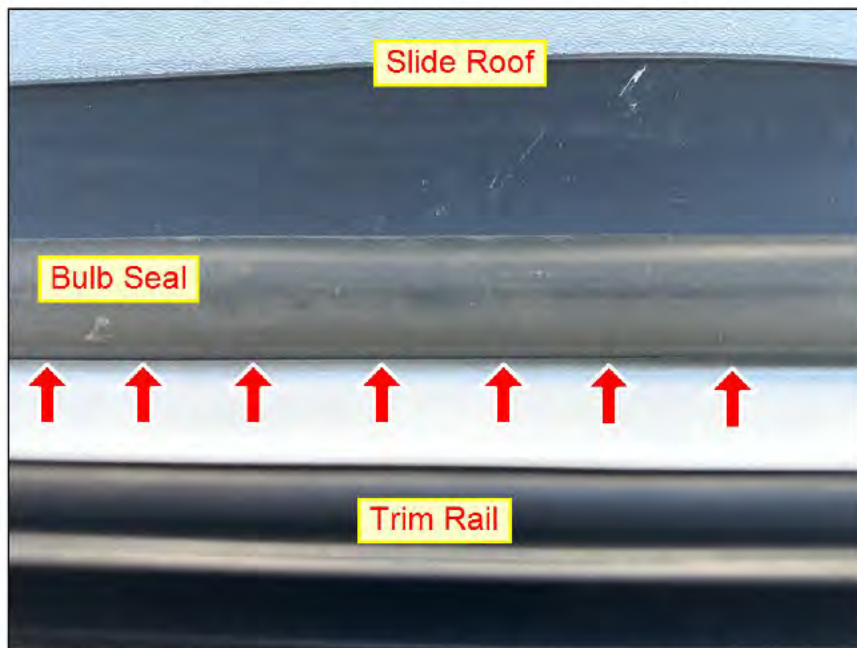
Inspector noted a fine separation between the bulb seal and the streetside sidewall above the streetside front slideout. The photo shows the small crack/break in the seal in a representative portion of the seal from the top down. It is recommended that a qualified RV technician repair to prevent possible future water intrusion.

Streetside front slideout bulb seal close up (top down)

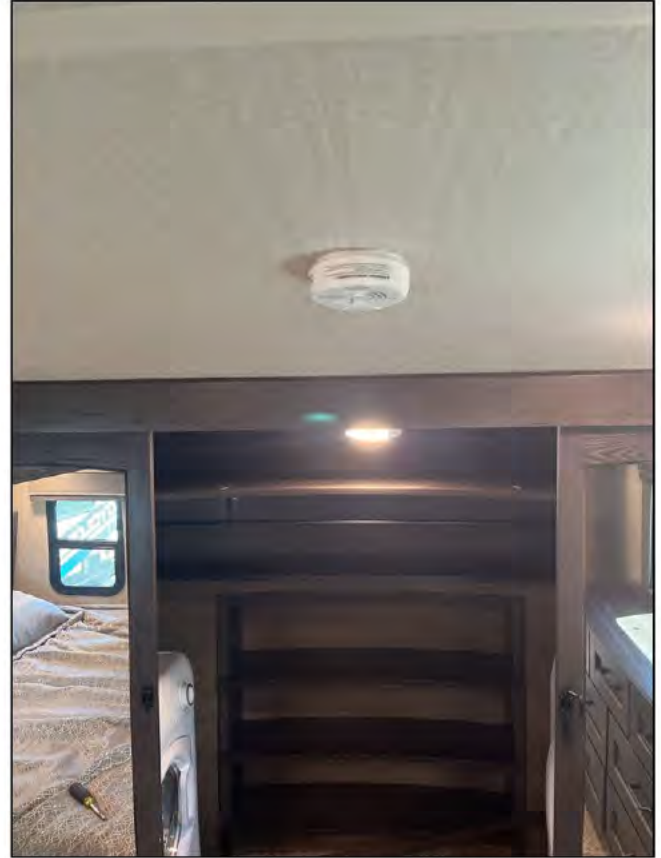
- +** Inspector noted while inspecting the unit, the master bedroom carbon monoxide detector was signaling low battery. Inspector recommends this be repaired by a qualified RV technician before the unit is occupied.

Carbon monoxide detector located in master bedroom

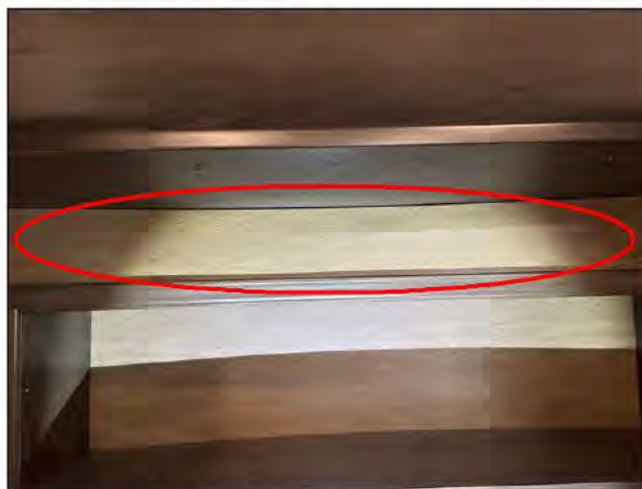
🔍 (2) In the master bedroom closet, inspector noted a missing trim piece (the piece was on the closet floor). Inspector recommends this be repaired by a qualified RV technician.

Master bedroom closet, front
