# RV Inspection Report

**Inspection Date / RV Model:**  
**29 May 2024: 2019 Newmar Dutch Star 4369**

5Js RV LLC

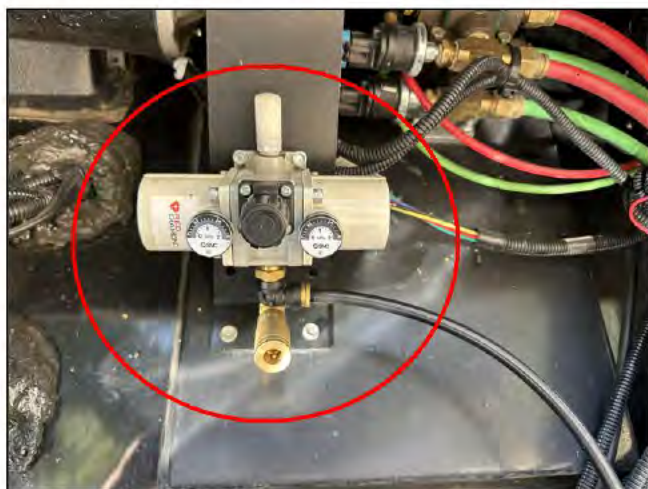
1. Owner stated he installed a high pressure air compressor hookup for use in inflating the front coach tires.
2. Owner stated he put chrome on the streetside rear radiator grill and the rear side wall.
3. Owner stated that he did not use the ice maker and just used ice trays to produce ice and did

Top inside streetside of front compartment

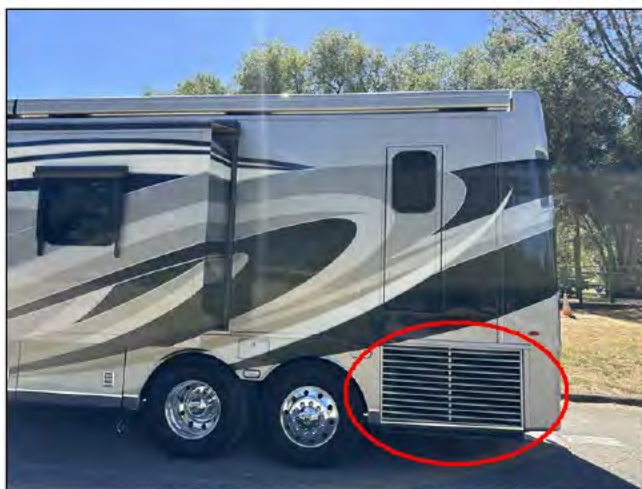
Streetside rear radiator grill

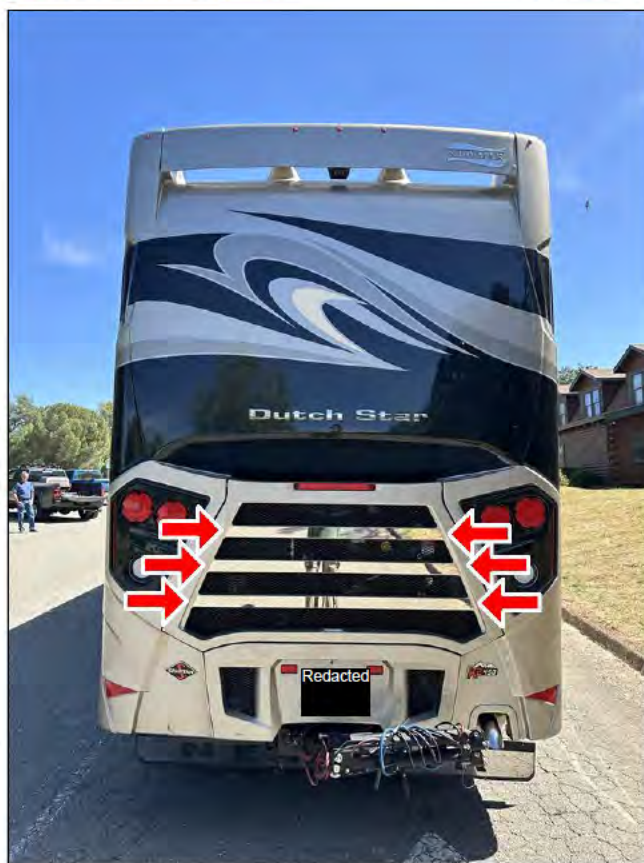
Rear side wall

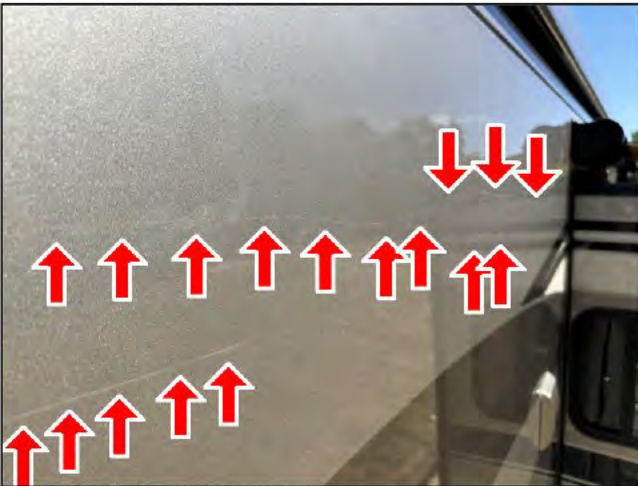
- Inspector noted scratches in the clear coat and/or paint on the upper curbside side wall to the rear of the slide.

Upper curbside side wall forward of rear wall

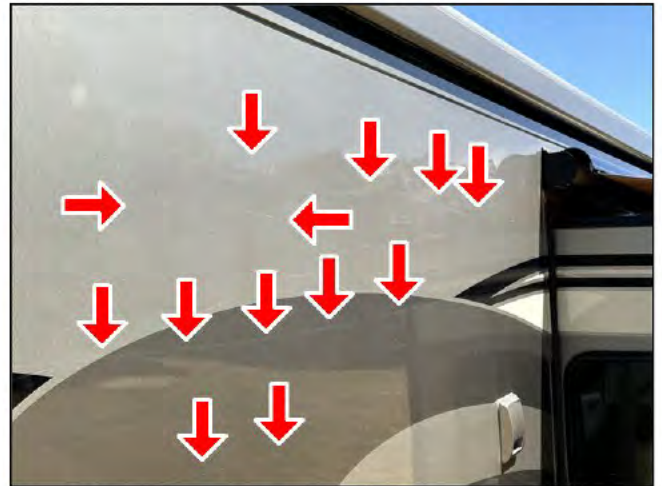
Another view of upper curbside side wall forward of rear wall

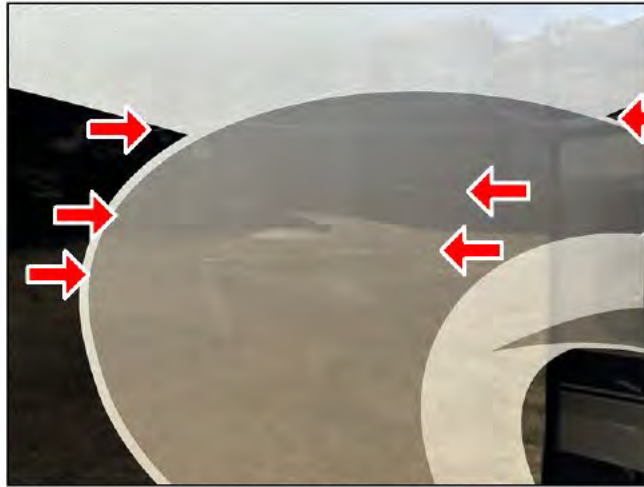
Close up of upper curbside side wall forward of rear wall

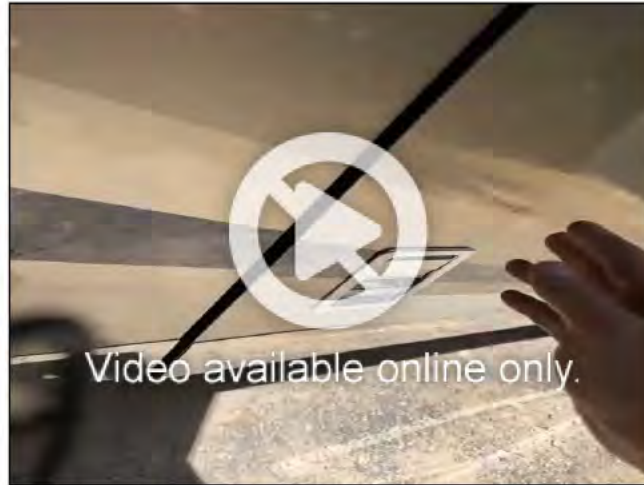
- (1) Inspector noted that the curbside cargo door 3rd to rear from front tire would latch but would have play in it when pressed. Seller indicates that the door has been that way from day one.

Play in latched curbside cargo bay door 3rd behind front tire

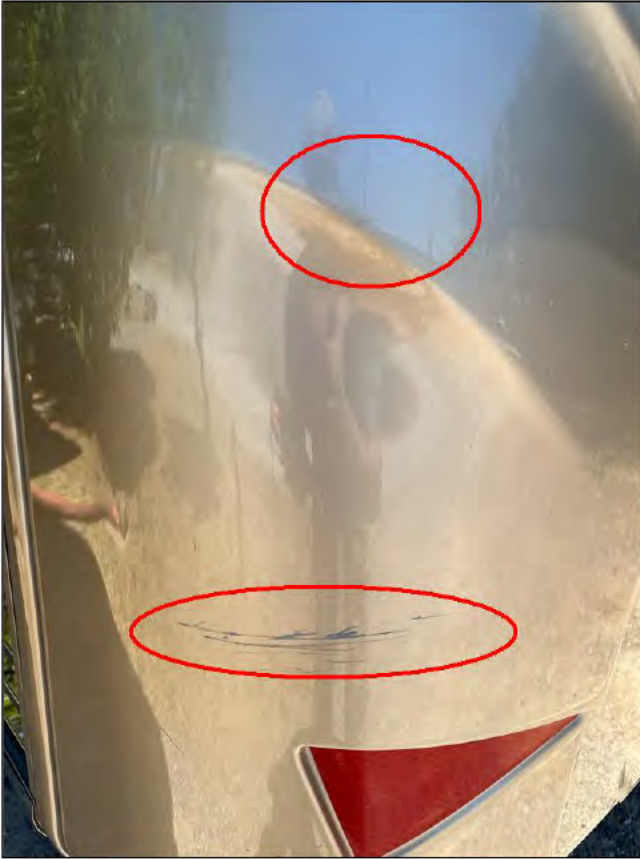
- Inspector noted scrapes and cracks along the rear cap wall from the mid-line to the streetside.

Close up of bottom streetside rear cap wall

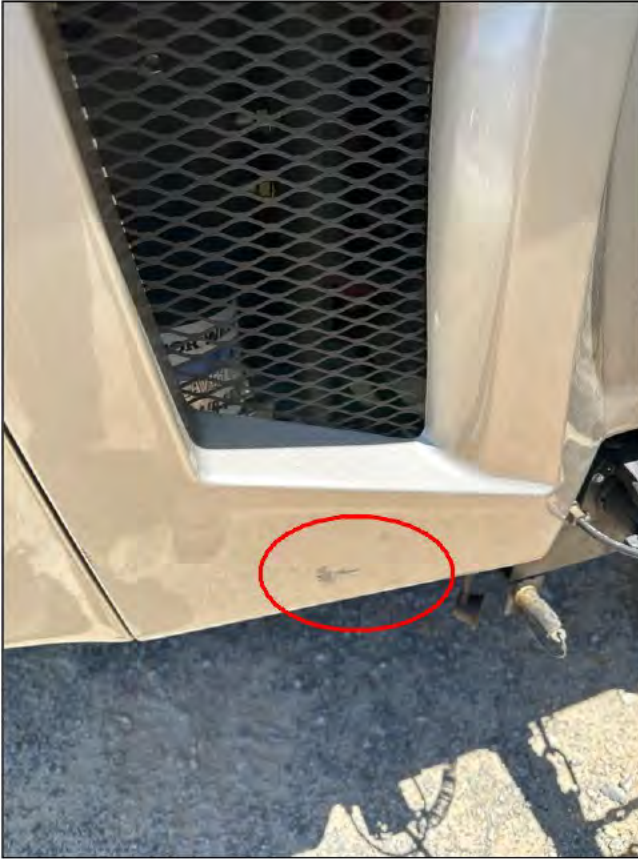
Streetside rear bottom of rear cap wall just streetside of hitch

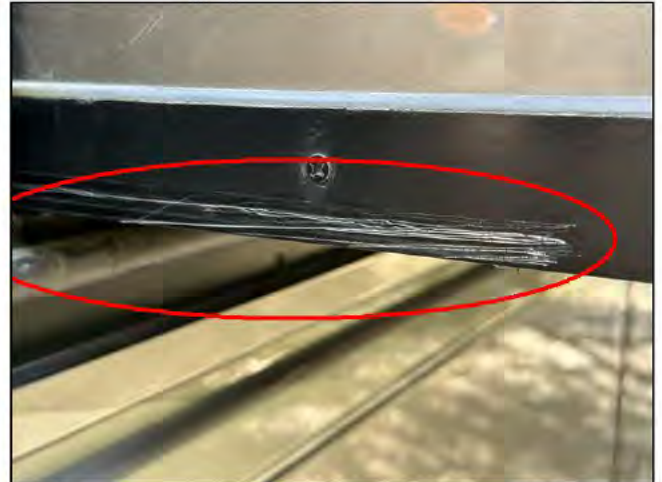
Inspector noted scratches along the bottom rear bracket of the front curbside slide. It is recommended that a qualified RV technician ensure there is no on-going scraping occurring and repair as needed.

Rear bottom bracket of front curbside slide (close-up)

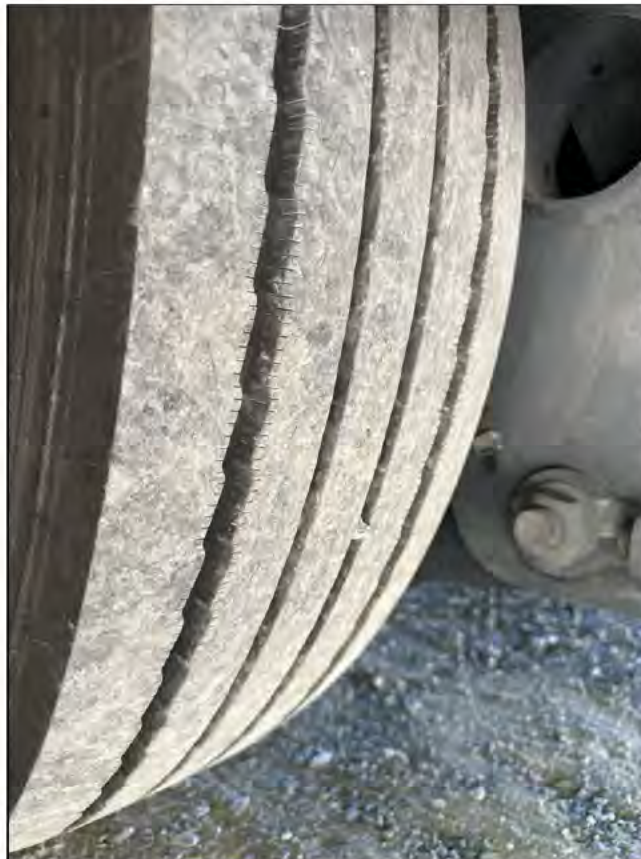
Curbside Drive Axle Inside Tread

Inspector was unable to inspect the wheel/tire condition of the curbside inside drive axle tire due to the low clearance and the tire being mounted inside another tire. Due to not being able to inspect the tire, inspector was unable to determine the DOT date of manufacture. It is recommended that a qualified tire technician determine whether the condition of the tire and wheel is suitable for use before the RV is driven.

Curbside drive axle inside tread

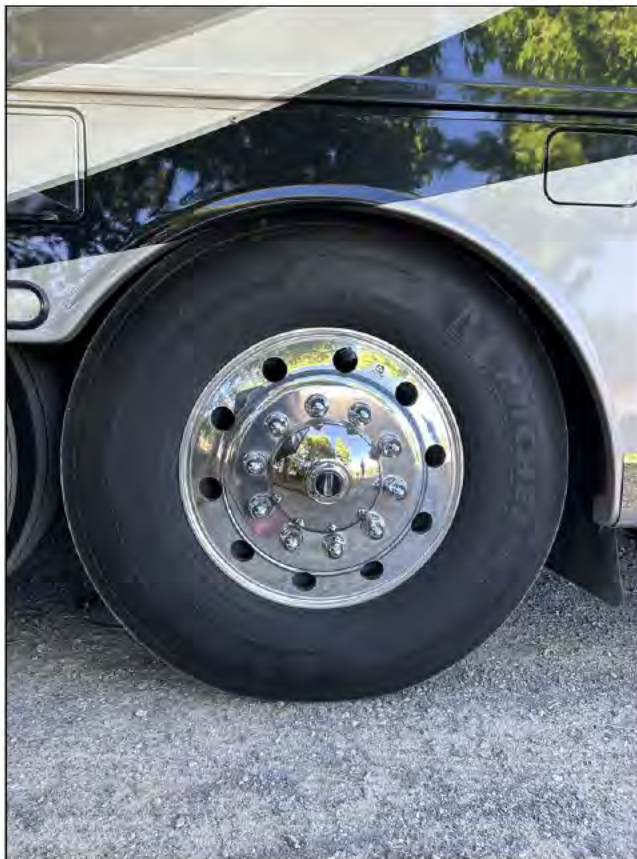
Curbside drive axle outside tire and wheel

Inspector was unable to determine the DOT date of manufacture of the drive axle outside curbside tire due to direction tire is mounted. It is recommended that a qualified tire technician determine whether the condition of the tire and wheel is suitable for use before the RV is driven.

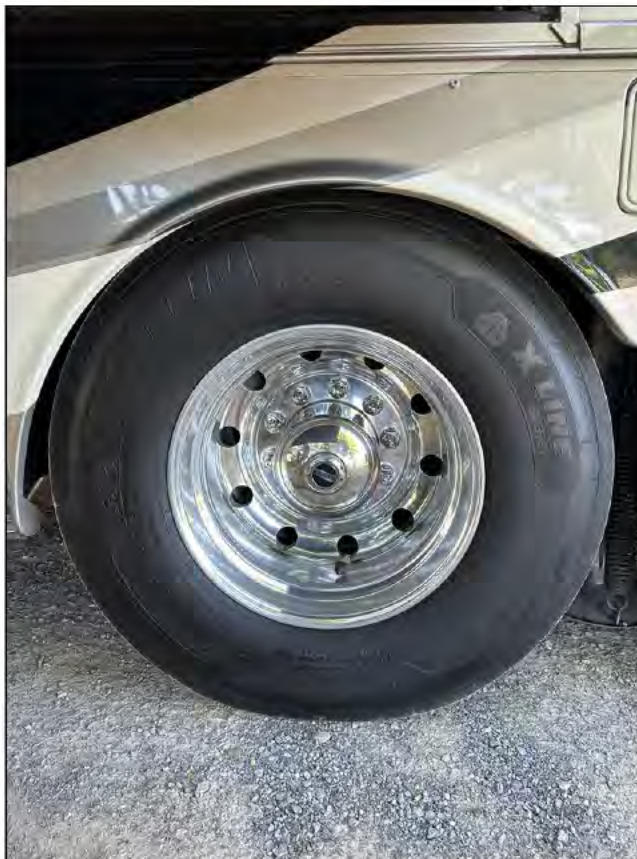
Curbside tag axle tire and wheel

Inspector noted that the curbside tag tire was manufactured in 2018, making it almost 6 years old.

The National Transportation Safety Board (NTSB) and some tire manufacturers are recommending that all tires older than six years should be replaced, regardless of their condition.

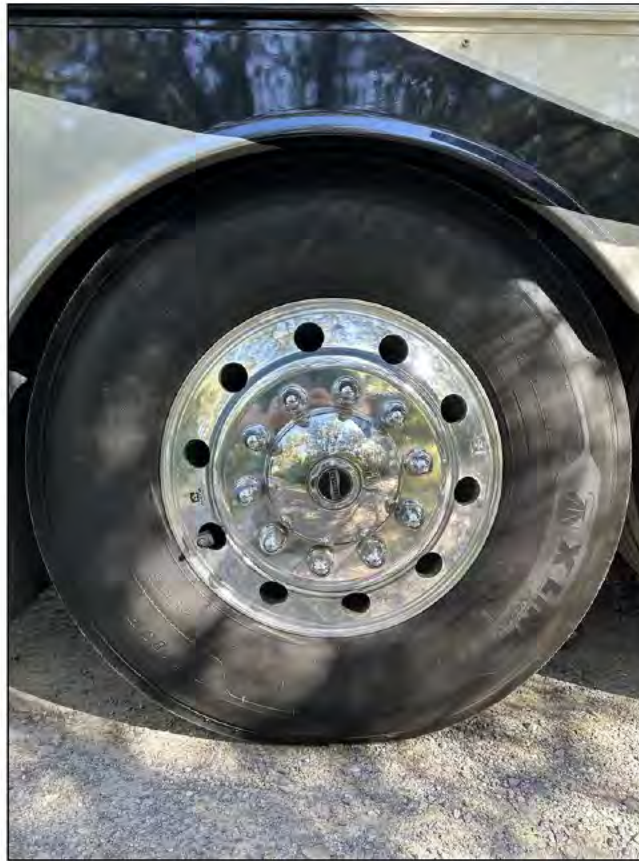
Streetside tag axle tire and wheel

**\$** Inspector noted that the streetside tag tire was manufactured in 2018, making it almost 6 years old. The National Transportation Safety Board (NTSB) and some tire manufacturers are recommending that all tires older than six years should be replaced, regardless of their condition.

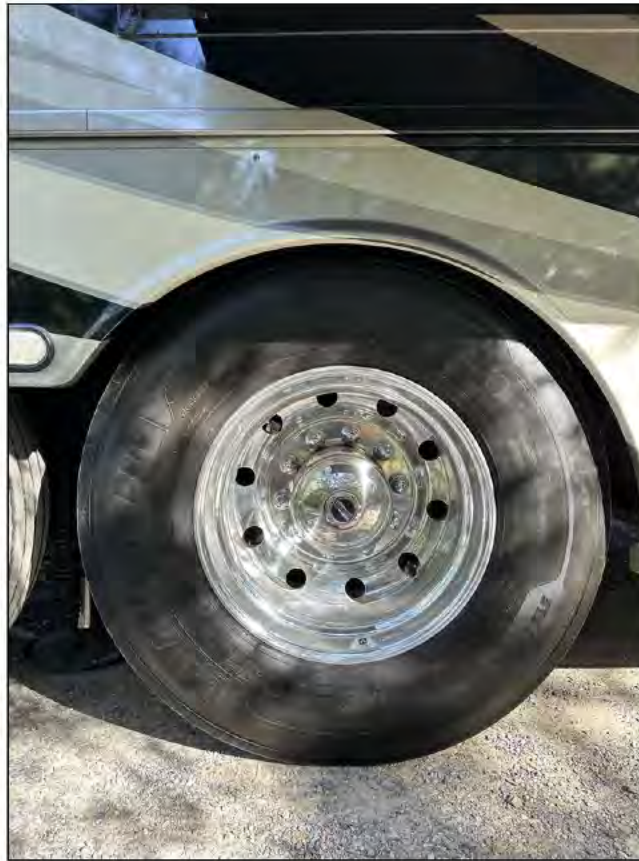
Streetside drive axle outside tire and wheel

**+** Inspector was unable to determine the DOT date of manufacture of the drive axle outside streetside tire due to direction tire is mounted. It is recommended that a qualified tire technician determine whether the condition of the tire and wheel is suitable for use before the RV is driven.

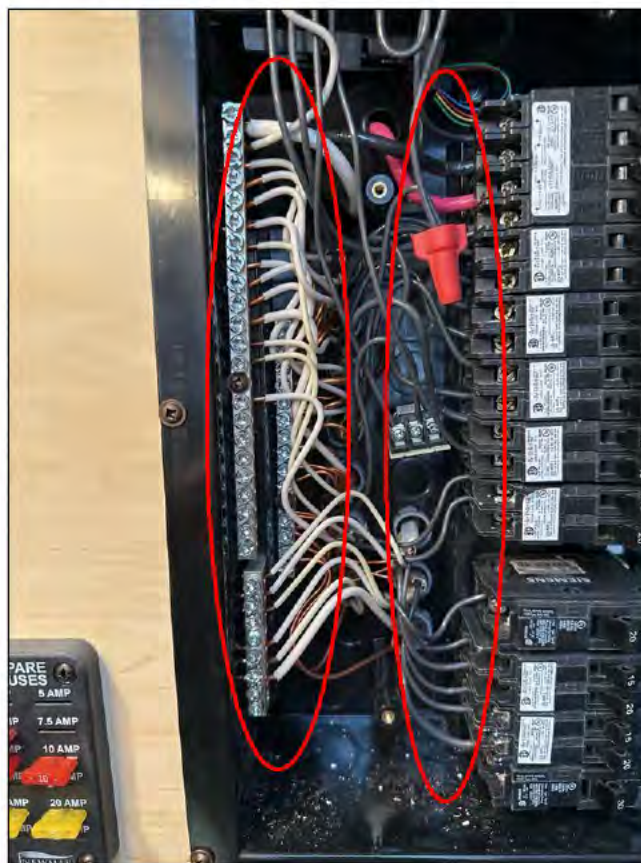
Wires in circuit breaker box showing NO signs of heat damage

Inside of circuit breaker box in bathroom
