RV Inspection Report

24 May 2024: 2024 Pleasure Way Plateau TS

5Js RV LLC

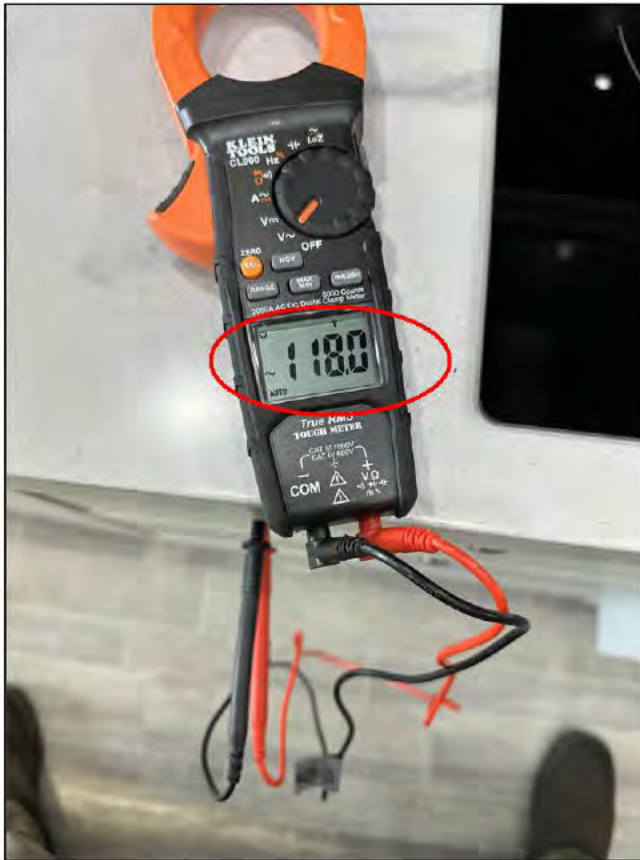
Generator voltage under load at kitchen outlet forward of cooktop

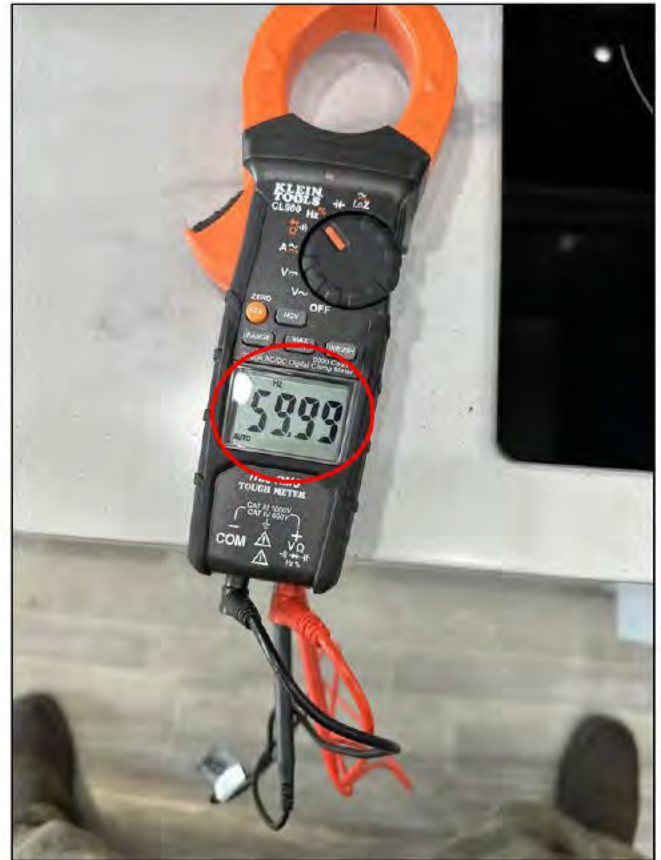
Generator frequency under load at kitchen outlet forward of cooktop

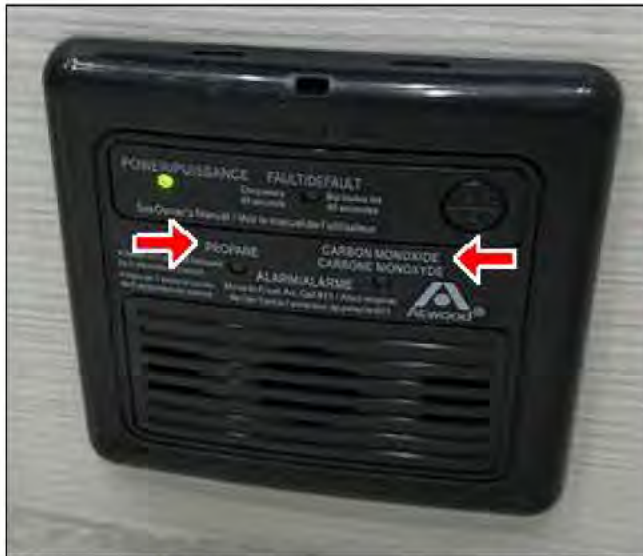
Combo LP/CO detector on streetside under chair (front)

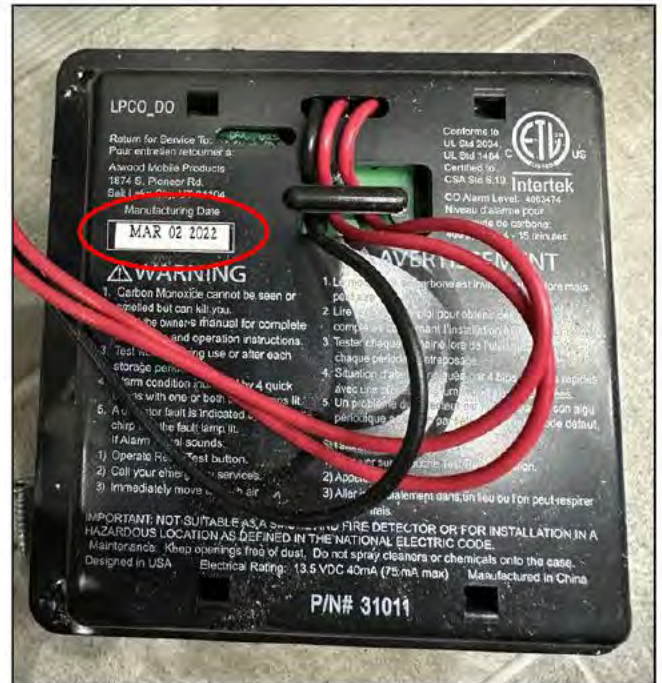
Combo LP/CO detector on streetside under chair (rear)

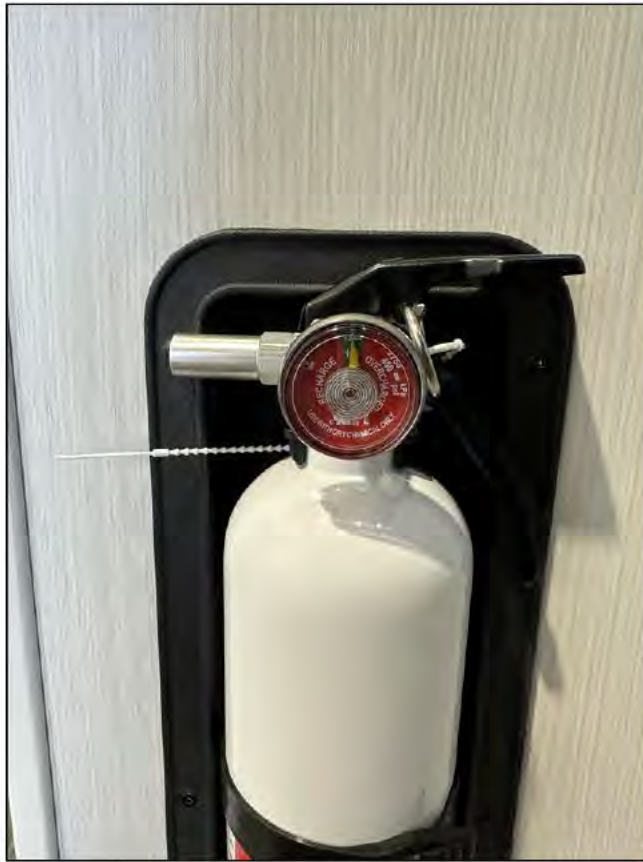
Fire extinguisher inside sliding door (gauge close up)

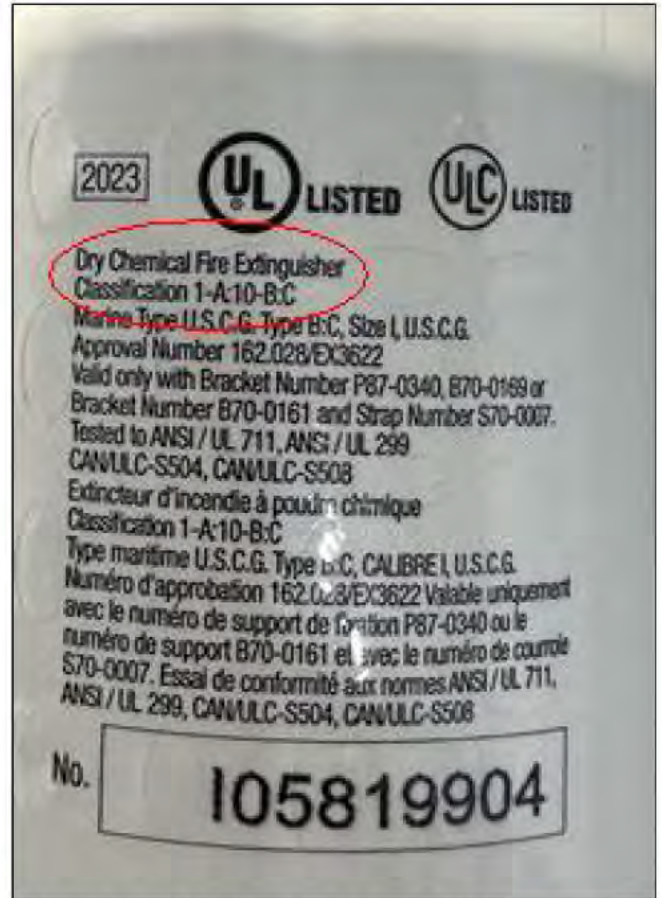
Fire extinguisher inside sliding door (label close up)

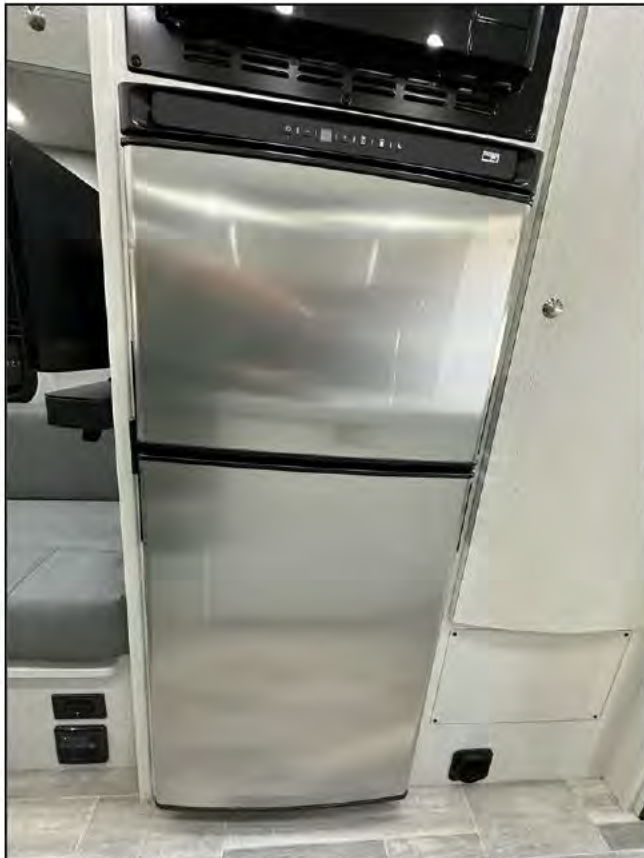
Refrigerator / Freezer Exterior
