# RV Inspection Report

Inspection Date / RV Model:  
**22 Apr 2024: 2024 Dynamax Isata 3 24FW**

5Js RV LLC

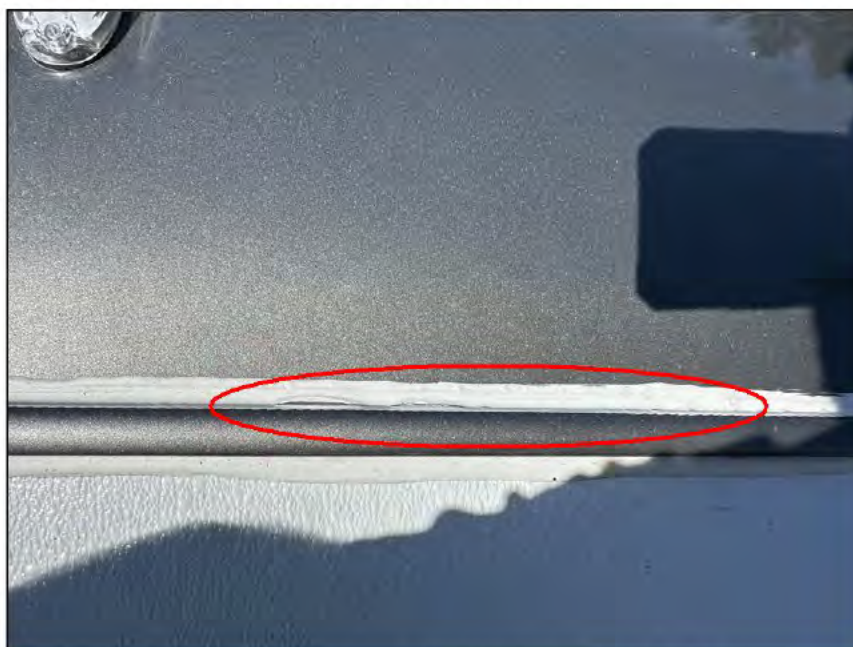
- 🔧 (1) Inspector noted that there was a triangular substance on the streetside-most light of the center three top marker lights on the front cap.
- 🔧 (2) Inspector noted gaps in the sealant along the front cap seam toward the curbside. It is recommended that a qualified RV technician repair to prevent possible future water intrusion.

Close up of front cap seam toward curbside

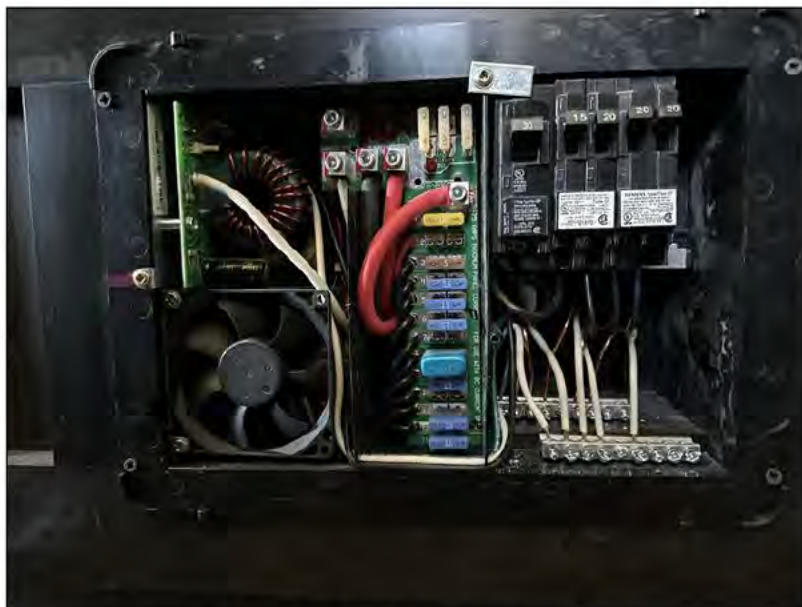
Comments: Yes  
Electrical Panel.

Electrical panel under cooktop

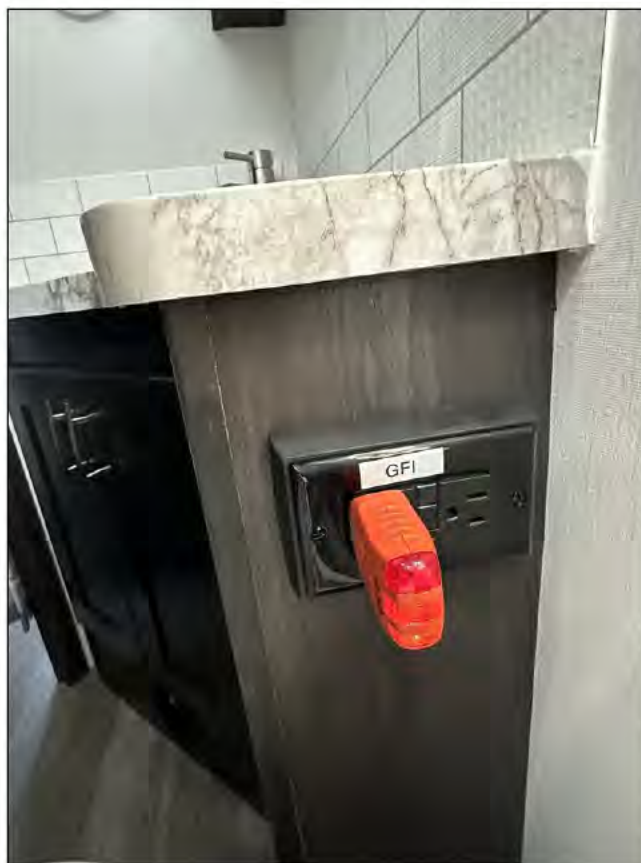
## GFCI Testing in Bathroom

Comments: Yes

Bathroom outlet next to toilet

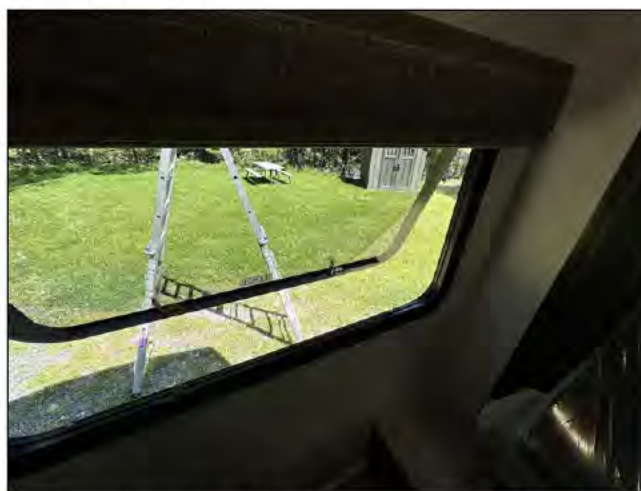
Emergency Exit in the Rear Wall of the Rig.

Comments: Yes

Emergency exit in the rear wall of the rig
