RV Inspection Report

24 May 2024: 2024 Pleasure Way Plateau TS

5Js RV LLC

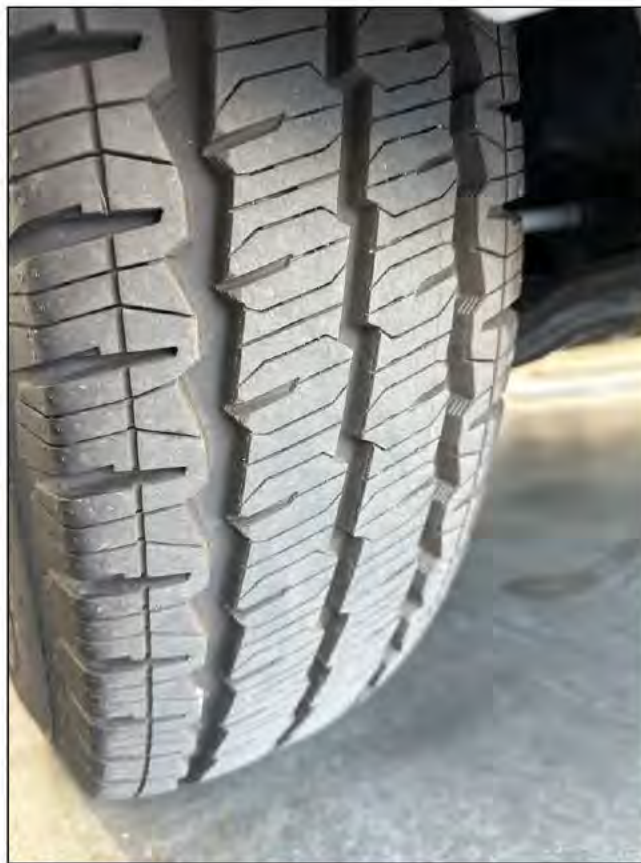
7.1.A Tire Tread Condition
Comments: Acceptable

Front curbside tire tread

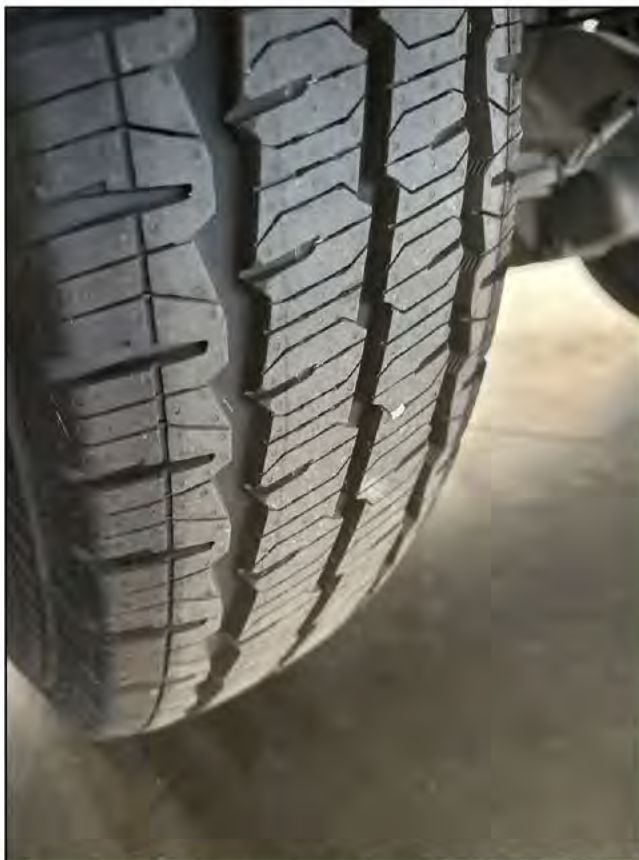
7.1.B Tire Tread Condition

Comments: Acceptable
Rear curbside inside tire tread

Rear curbside inside tire tread

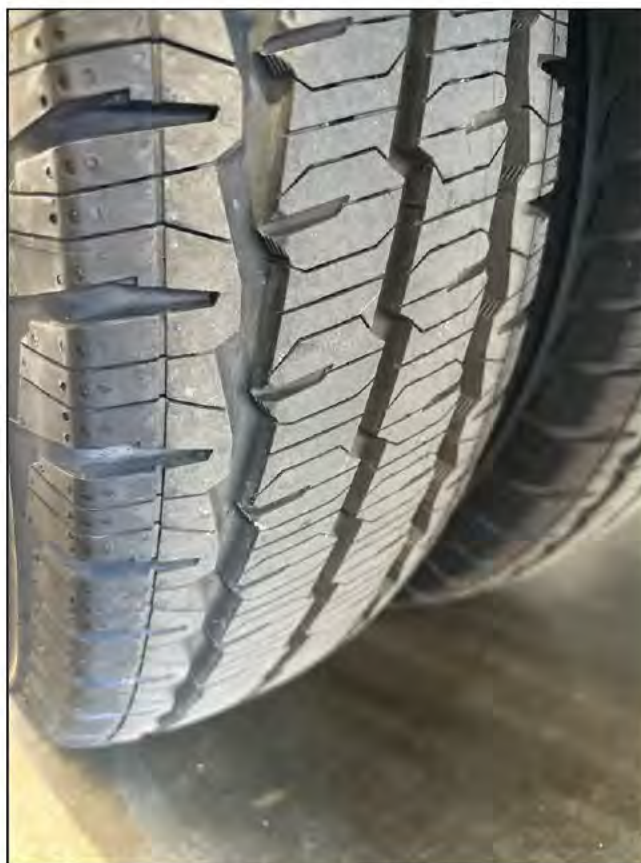
7.1.C Tire Tread Condition

Inspector was unable to visually verify the DOT manufacture date on the outside rear curbside tire due to the mounting direction of the tire. It is recommended that a qualified tire technician verify the DOT manufacture date before the RV is driven.

Comments: Acceptable

Rear curbside outside tire tread

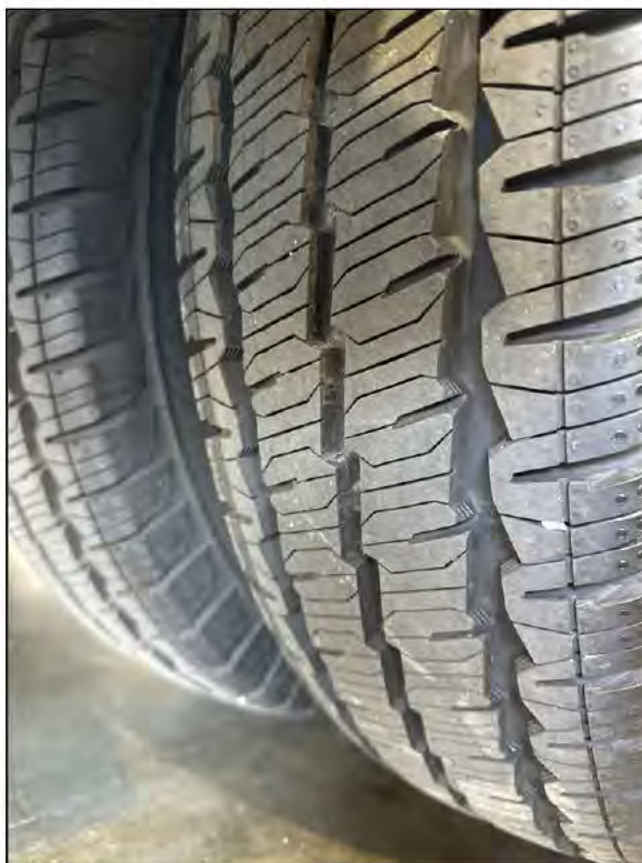
7.1.D Tire Tread Condition
Comments: Acceptable

+ Inspector was unable to visually verify the DOT manufacture date on the outside rear streetside tire due to the mounting direction of the tire. It is recommended that a qualified tire technician verify the DOT manufacture date before the RV is driven.

Rear streetside outside tire tread

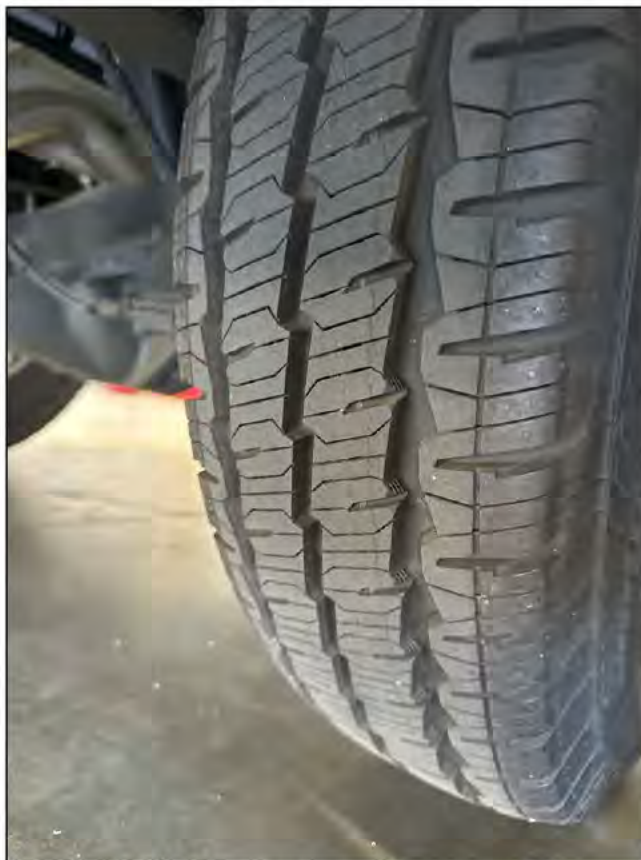
7.1.E Tire Tread Condition

+ Inspector was unable to visually verify the DOT manufacture date on the inside rear streetside tire due to the mounting direction of the tire. It is recommended that a qualified tire technician verify the DOT manufacture date before the RV is driven.

Comments: Acceptable
Rear streetside inside tire tread

Rear streetside inside tire tread

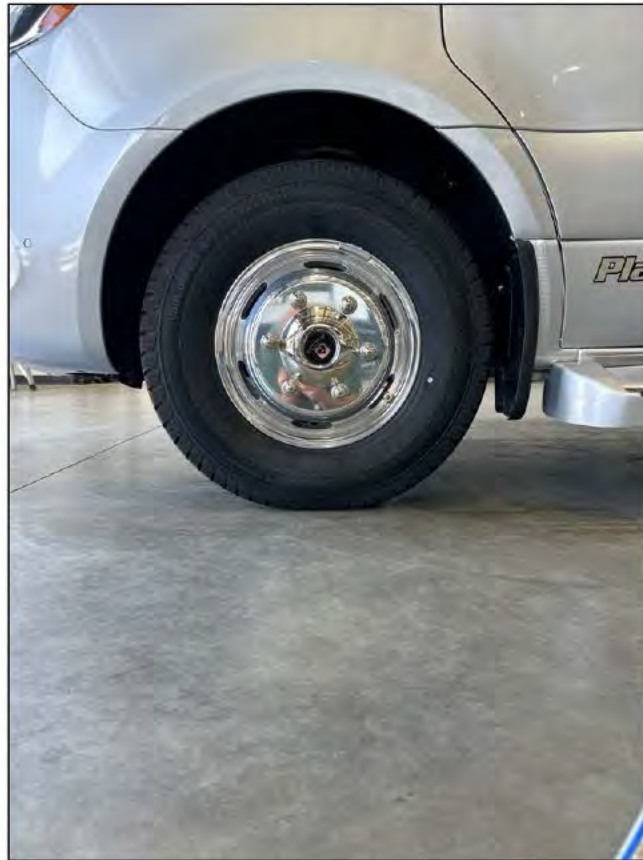
7.0.F Tire/Rim Condition
Comments: Acceptable

Front streetside wheel assembly

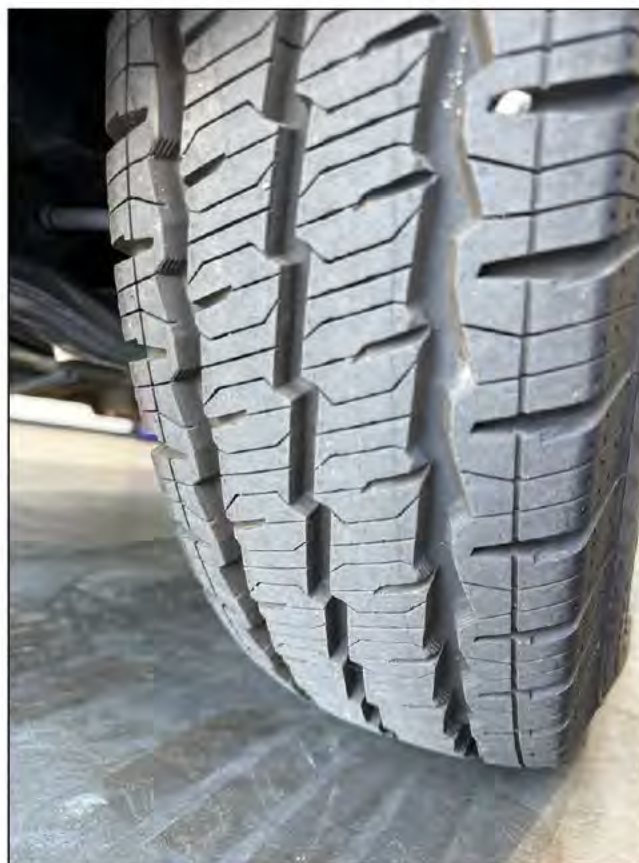
7.1.F Tire Tread Condition

Comments: Acceptable

Front streetside tire tread

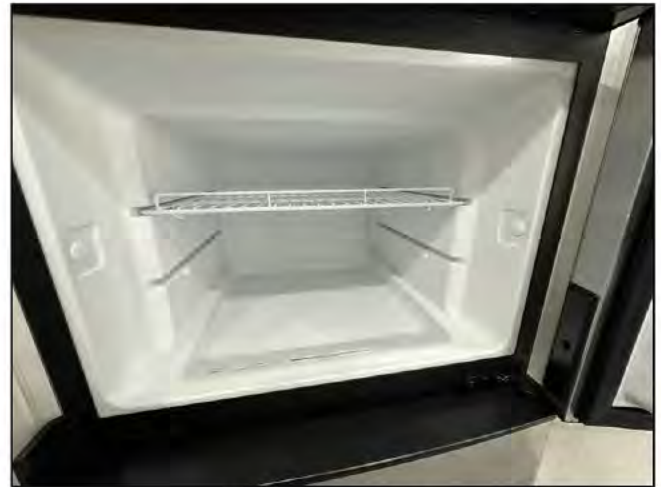
Freezer interior

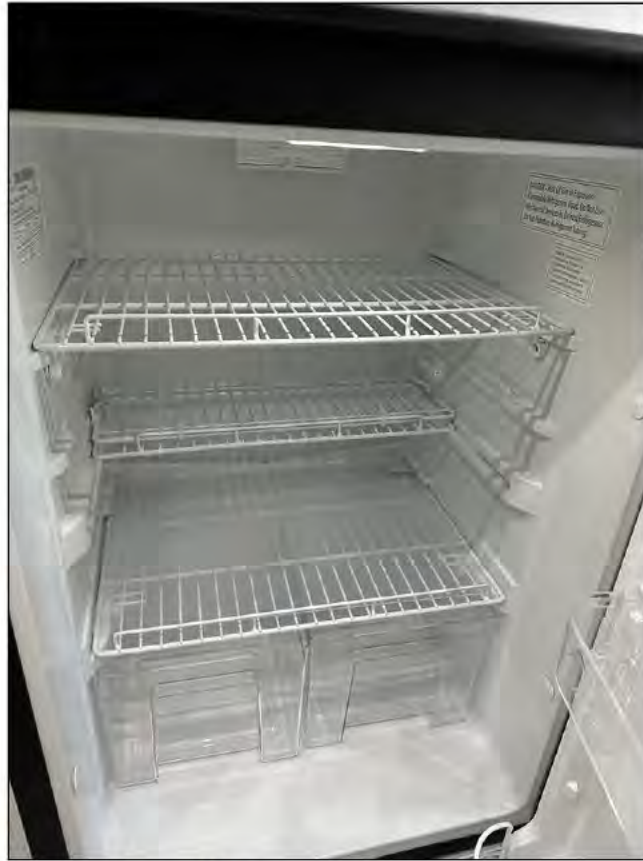
Refrigerator interior

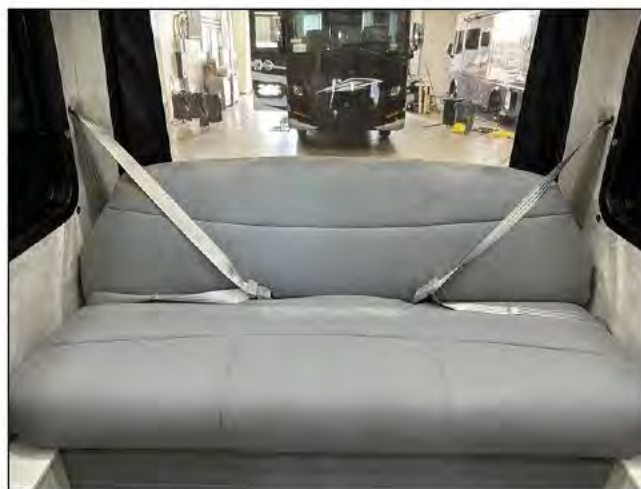
Sofa at rear with seat belts buckled

Sofa at rear
