# RV Inspection Report

Inspection Date / RV Model:  
**22 Apr 2024: 2024 Dynamax Isata 3 24FW**

5Js RV LLC

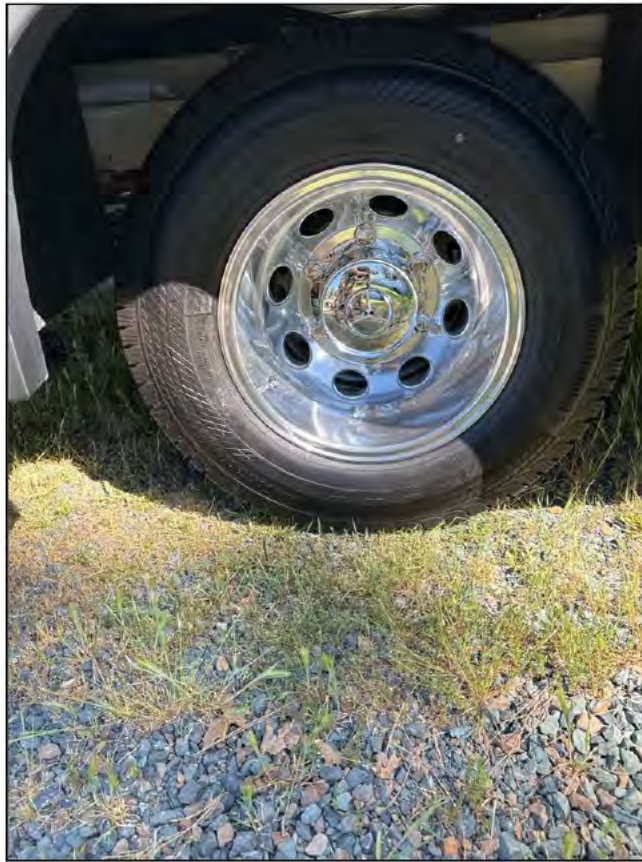
Rear Streetside Outside Wheel and Tire

**8.0.D Tire/Rim Condition**  
**Comments:** Acceptable

Rear streetside outside wheel and tire

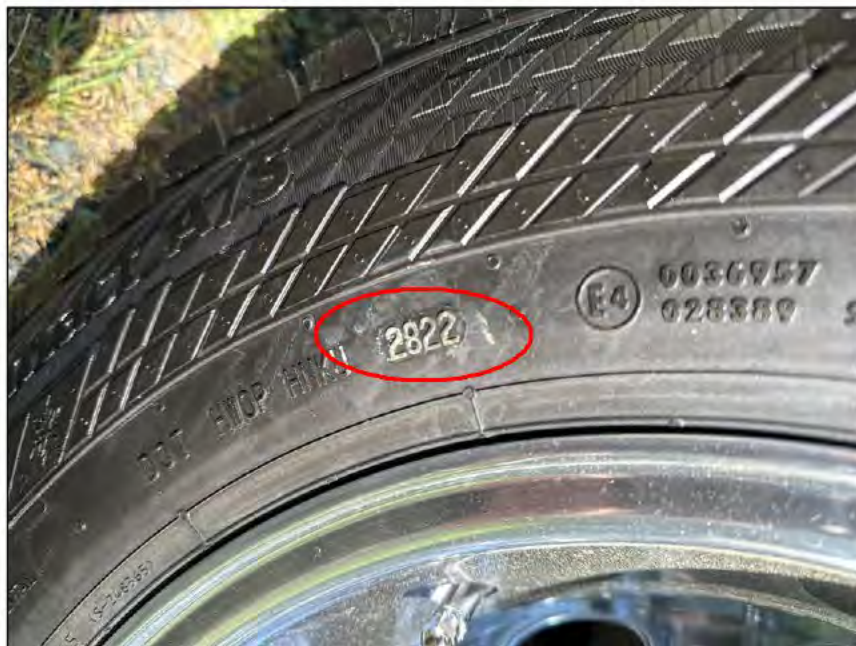
Rear streetside outside tire DOT date

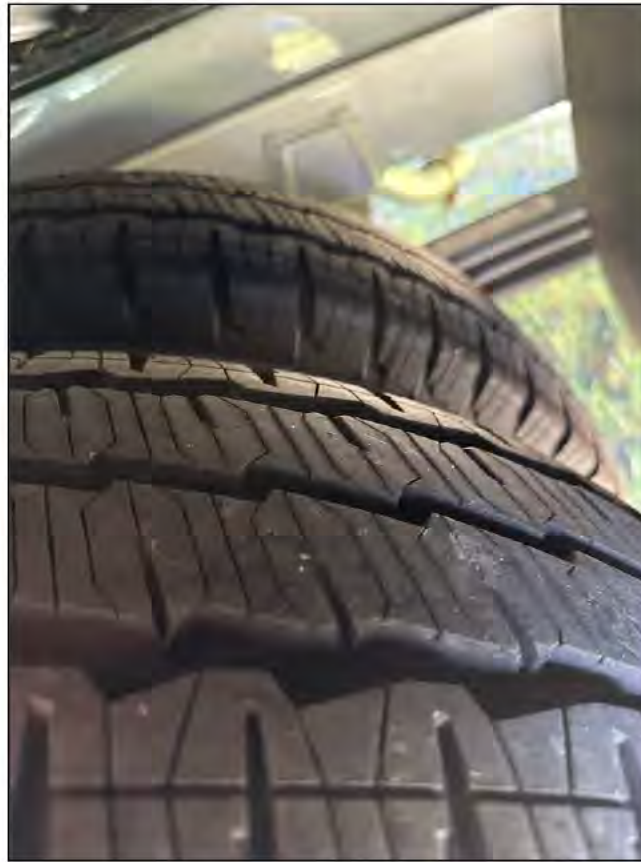
Rear Streetside Outside Tire Tread

Comments: Acceptable

Rear streetside outside tire representative tread

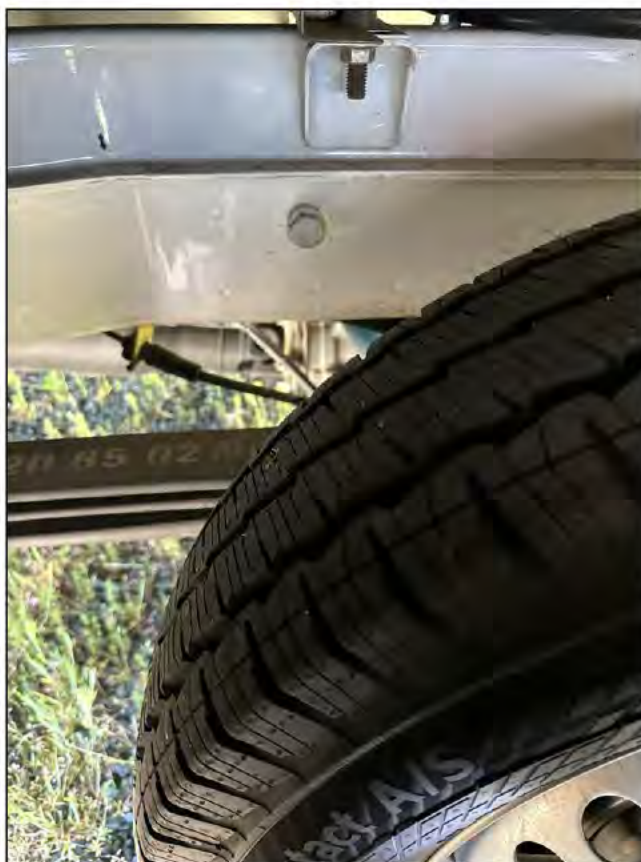
**Comments:** Acceptable  
Rear Streetside Inside Tire Tread

Rear streetside inside tire representative tread

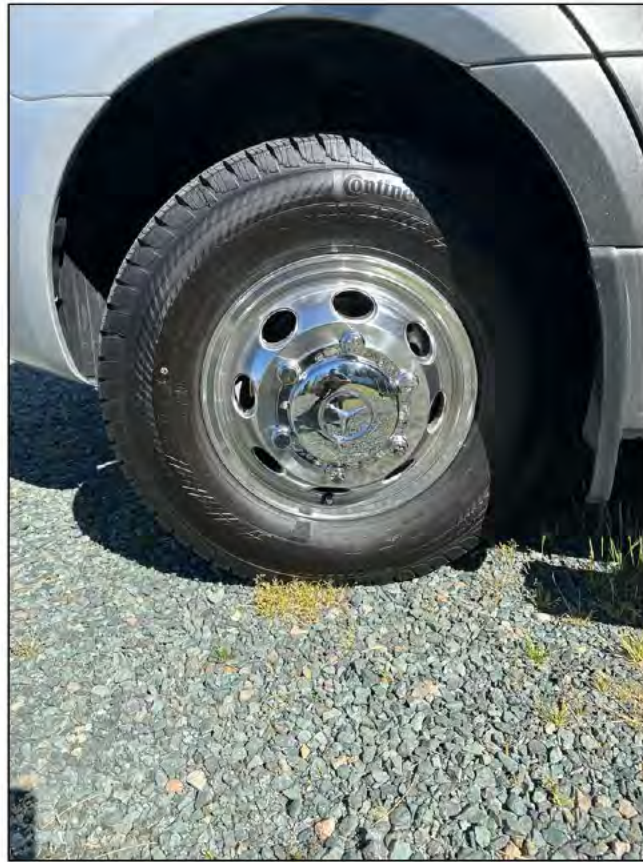
Front Streetside Wheel and Tire

**Comments:** Acceptable

Front streetside wheel and tire

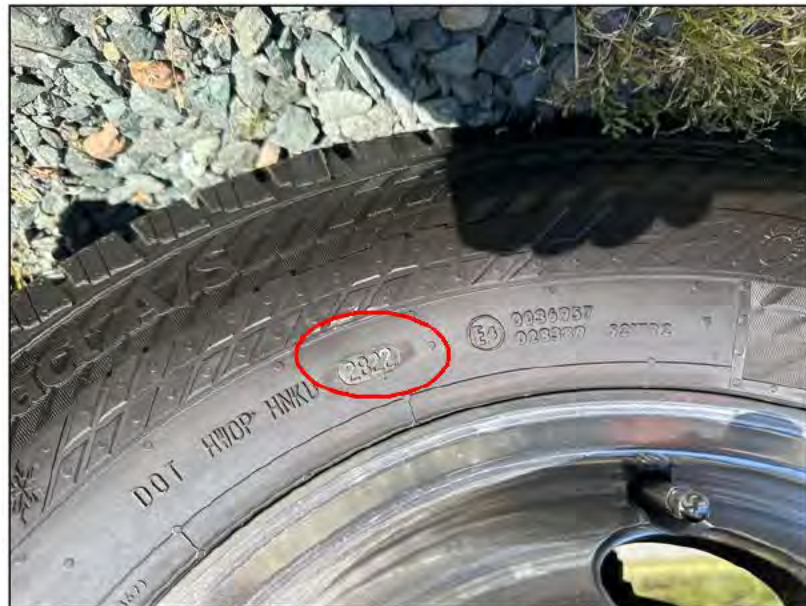
Front streetside tire DOT date

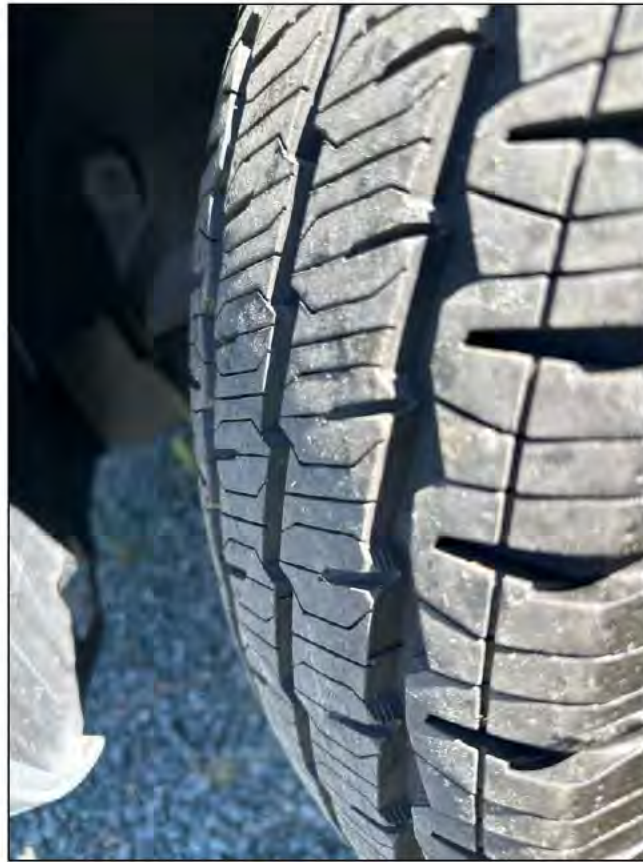
Front Streetside Tire Tread

Comments: Acceptable

Front streetside tire representative tread

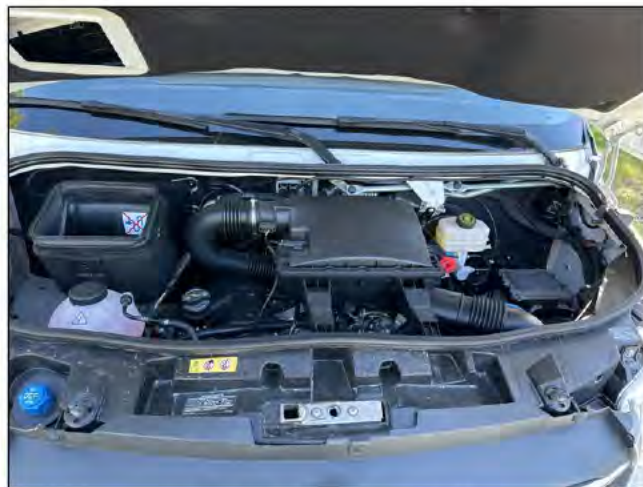
Engine Compartment

**Comments:** Acceptable

Engine compartment

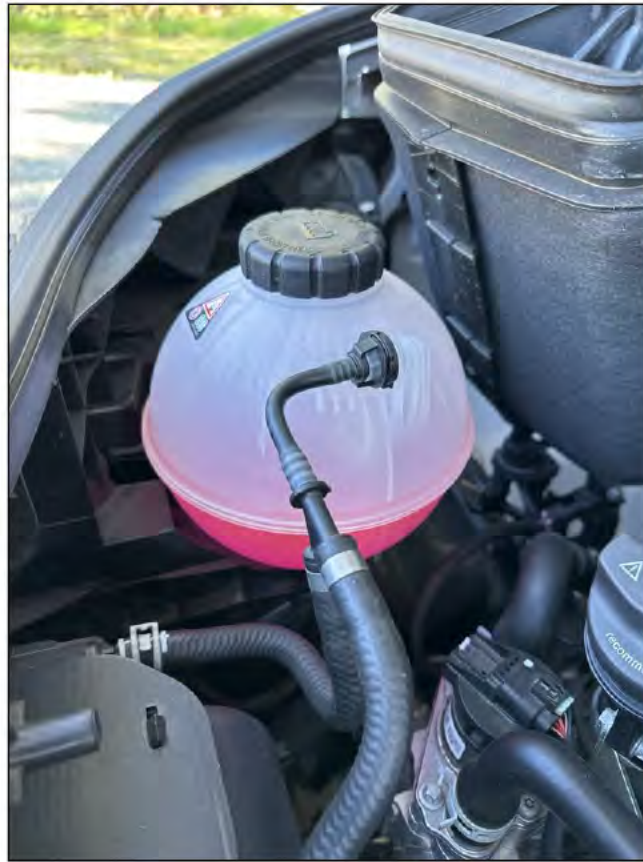
Coolant Reservoir

**Comments:** Acceptable

Coolant reservoir

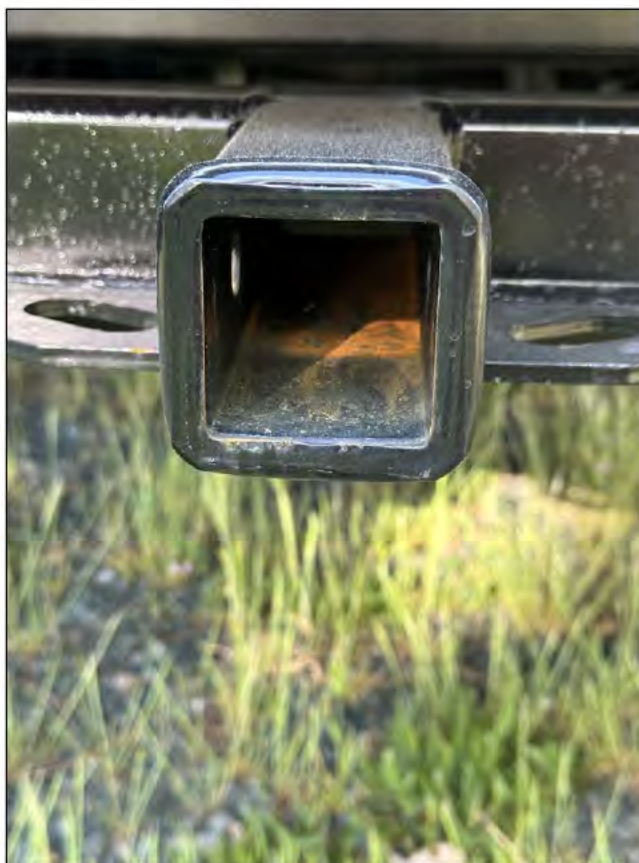
## Hitch at Rear

**Comments:** Acceptable

Close up of hitch

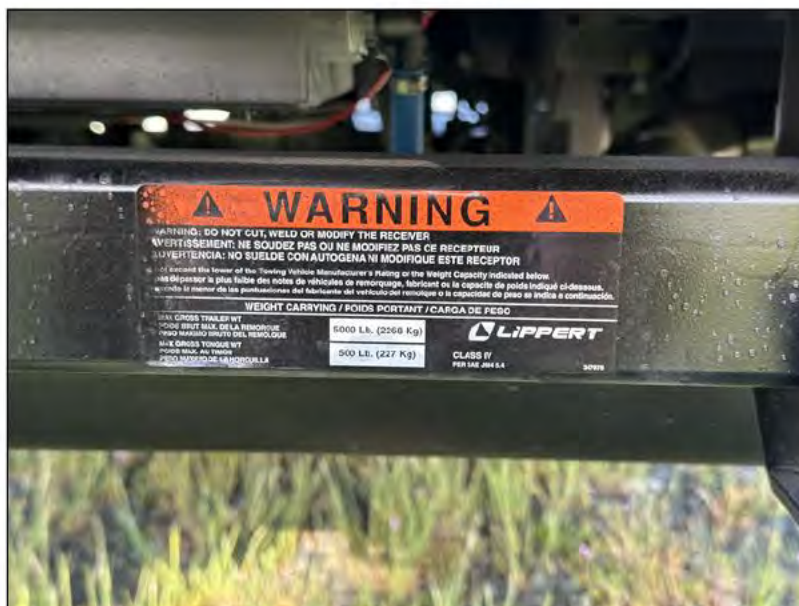
Hitch data plate

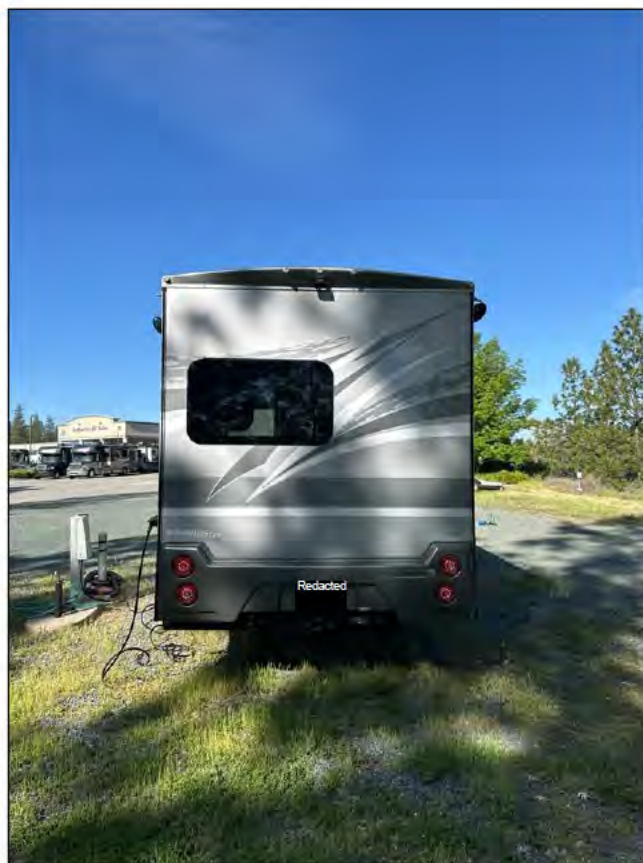
Rear Clearance Lights

Rear clearance lights (top lights are on, just hard to see)

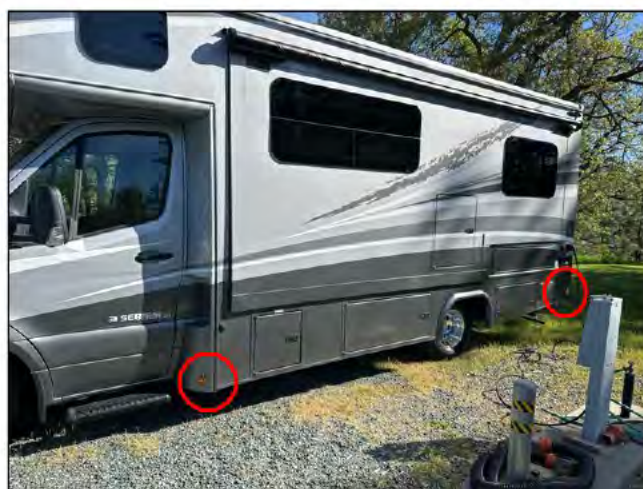
Streetside Marker Lights

Comments: Yes

Streetside marker lights

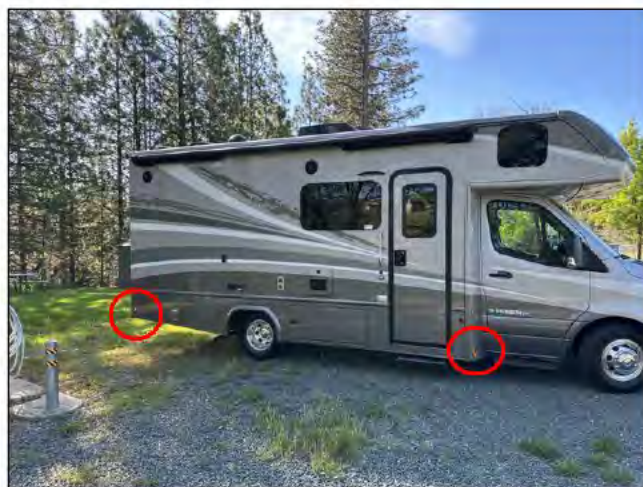
Curbside Marker Lights

Comments: Yes

Curbside marker lights

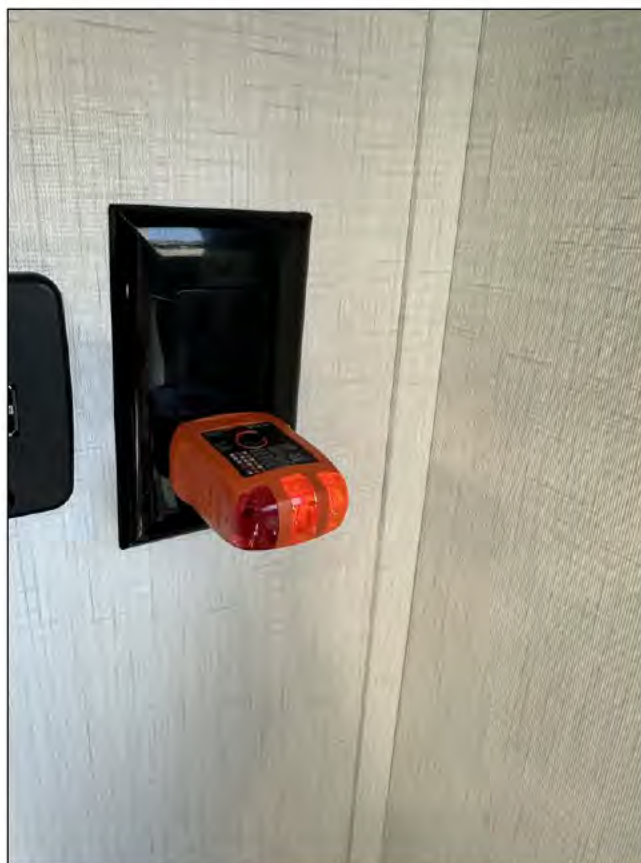
Living Room Polarity/Voltage Test

Comments: Yes

Polarity testing in living room

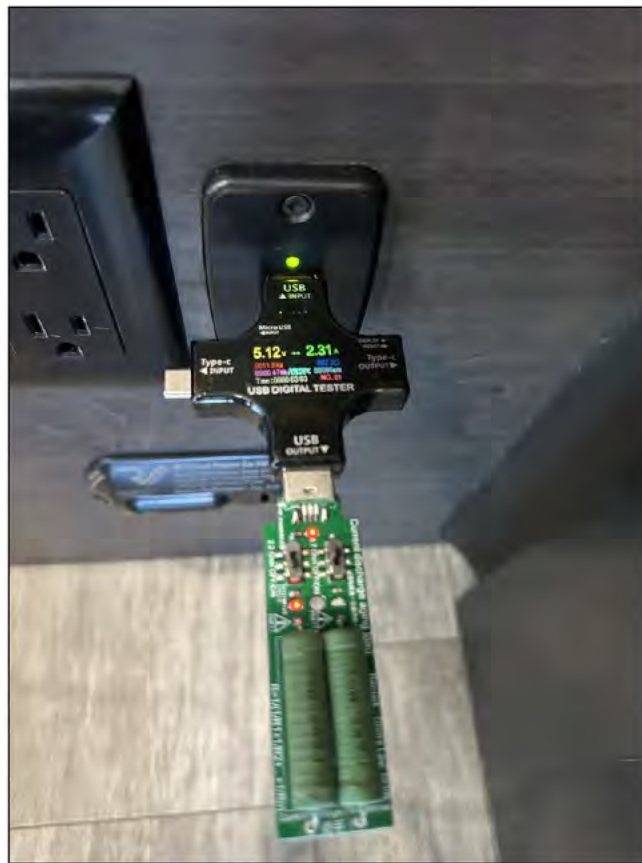
USP Testing.

Comments: Yes

USB port under front edge of bed

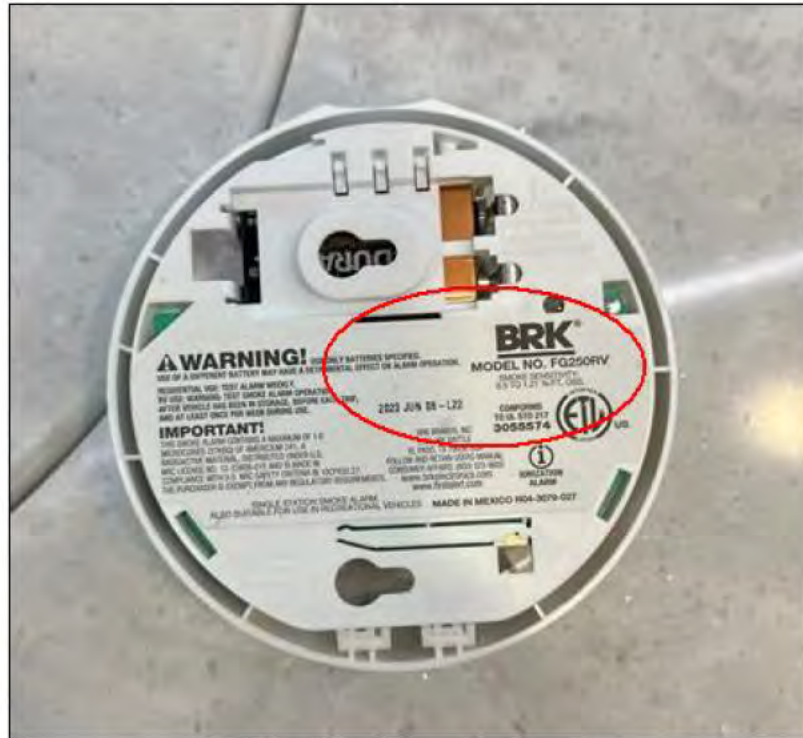
Smoke Detector from over Dinette

**Items****15.0 ASME Tank****Comments:** Acceptable**15.1 LP Leak System Test****Comments:** Acceptable**15.4 Combination LP / CO Detector****Comments:** Acceptable**15.5 Smoke Detector****Comments:** Acceptable

Smoke detector over dinette

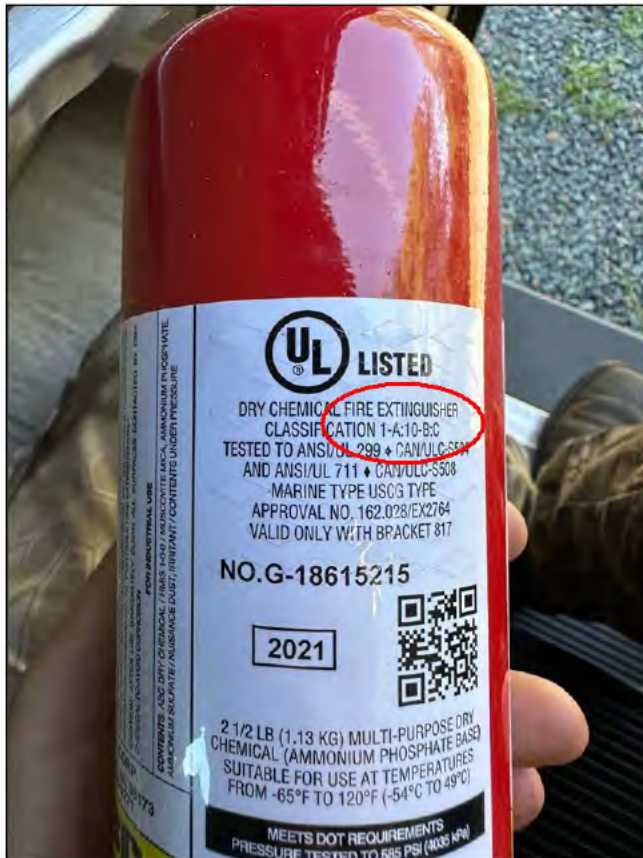
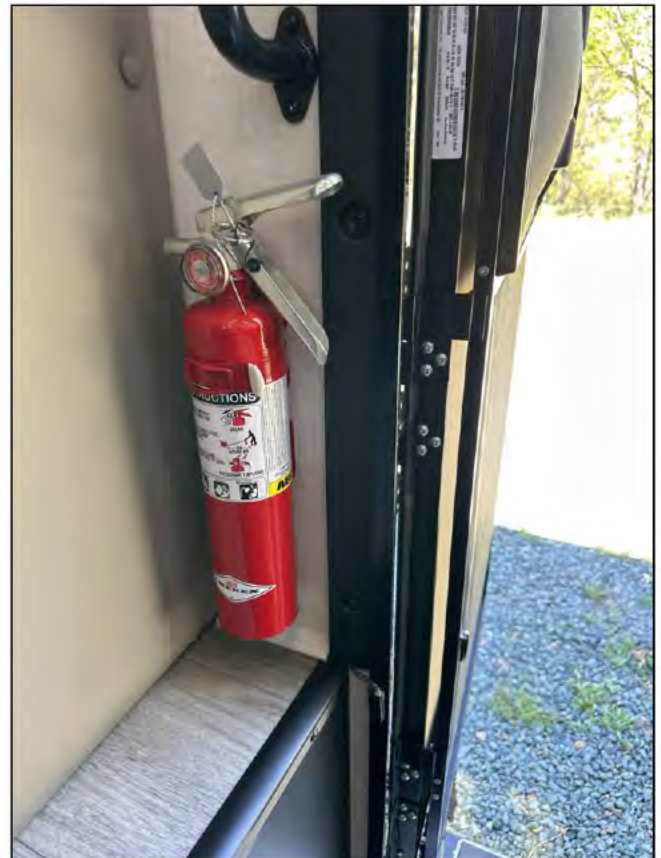
Comments: Acceptable  
Fire Extinguisher

Fire extinguisher from forward of main door

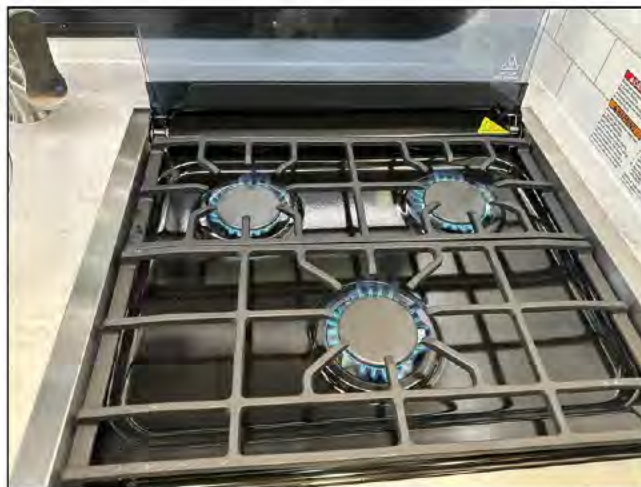
Cooktop with Flames Lit.

Comments: Acceptable

Cooktop
